## **SECTION 5.0      EXISTING CONDITION REPORTS**

## **SECTION 5.1A    CENTER SCHOOL EVALUATION REPORT**

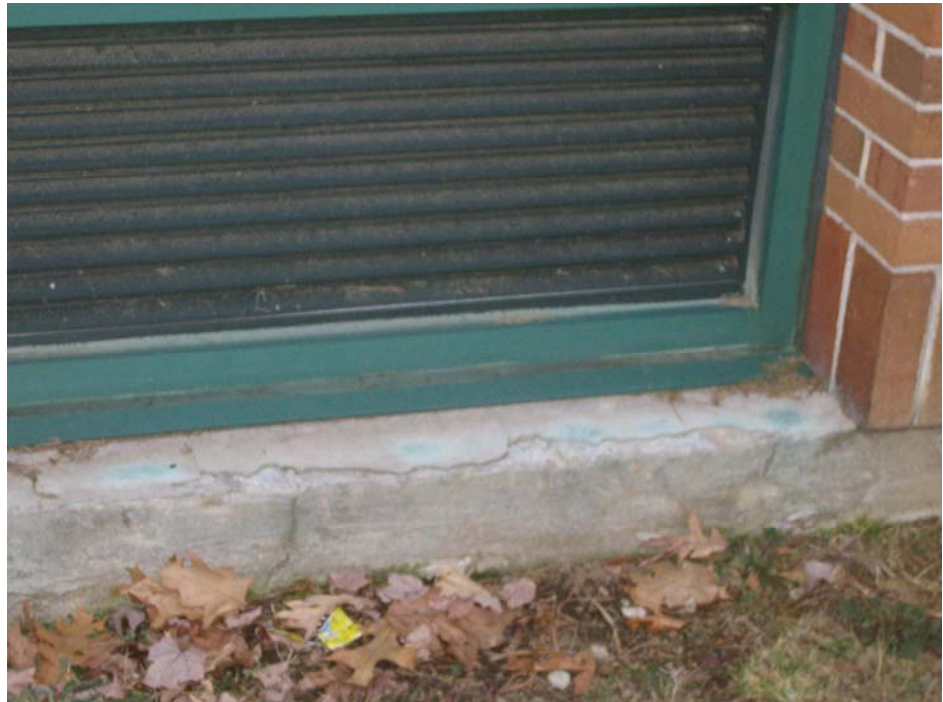
*Concrete sill deterioration at existing curtain wall at grade.*

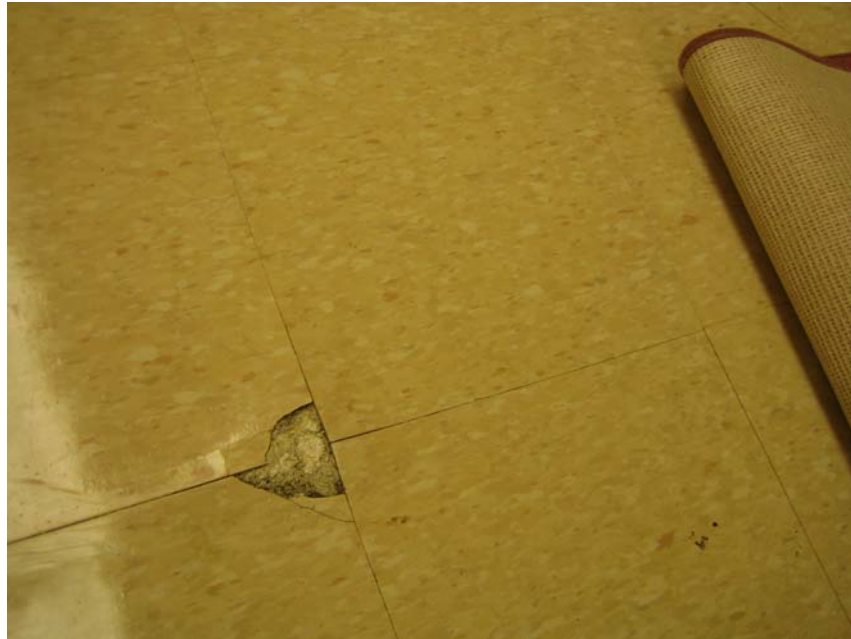
*Moisture penetrates the slab on grade eventually leading to cracking and uplifting of the floor tiles. The powder-like substance below the tile is most likely salts that were dissolved in the water and are left behind when the water evaporates.*

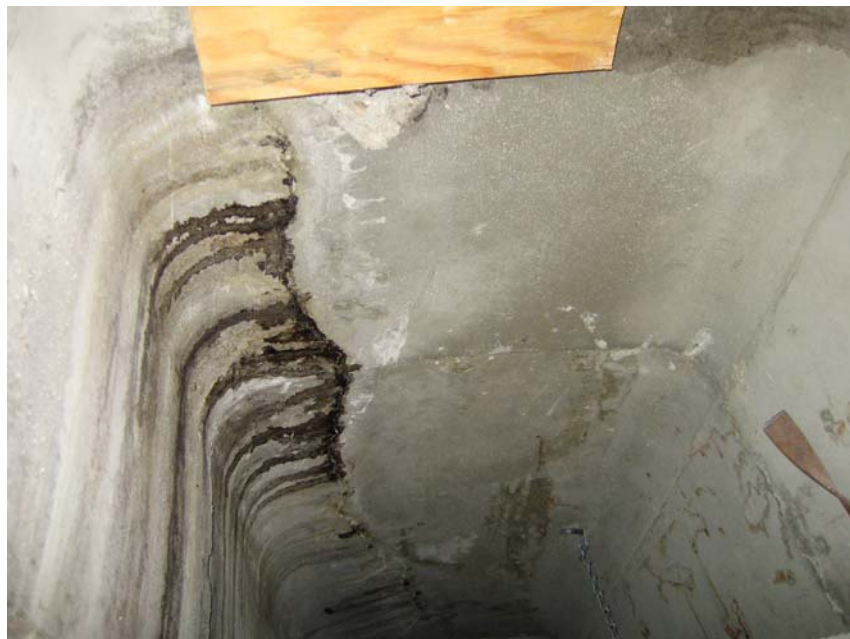
There are also cracks in the underside of the concrete slab directly above this room, which were observed above the suspended ceiling. There are pieces of plywood installed to the slab that do little more than cover up spalling concrete. It appears that at some point water has penetrated the top of the concrete slab, and eventually caused the steel reinforcing bars to rust. The rusting bars in turn, expanded and cracked the concrete.

*Longitudinal cracks are visible on the underside of the concrete slab. Water permeating through the cracks has left rust stains on the concrete slab and beams. The plywood at the top of the photo covers what appears to be spalling concrete.*
