General Information

Name of Project	Spring Hill Estates – Pennie Lane	CGP Tracking No.	MAR100101V	Inspection Date	6/3/2021
Inspector Name, Title & Contact Information	Ryan Proctor, E.I.T. – Staff Engineer – 978-779-6091 – rproctor@dillisandroy.com				
Present Phase of Construction	Site Work / Material Stockpiling/ House Construction/Lot Clearing				
Inspection Location (if multiple inspections are required, specify location where this inspection is being conducted)	Map: R-1, Parcel: 27 Stow, MA 01775				
<p>Inspection Frequency <i>(Note: you may be subject to different inspection frequencies in different areas of the site. Check all that apply.)</i></p> <p>Standard Frequency: <input checked="" type="checkbox"/> Weekly <input type="checkbox"/> Every 14 days and within 24 hours of a 0.25" rain</p> <p>Increased Frequency: <input type="checkbox"/> Every 7 days and within 24 hours of a 0.25" rain (for areas of sites discharging to sediment or nutrient-impaired waters or to waters designated as Tier 2, Tier 2.5, or Tier 3)</p> <p>Reduced Frequency:</p> <ul style="list-style-type: none"> - <input type="checkbox"/> Once per month (for stabilized areas) - <input type="checkbox"/> Once per

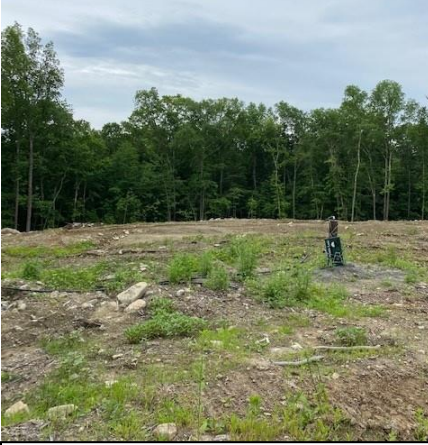
(A) Future site for Lot #2 dwelling. Existing Well for Lot #2 can be seen on the right side of the picture.

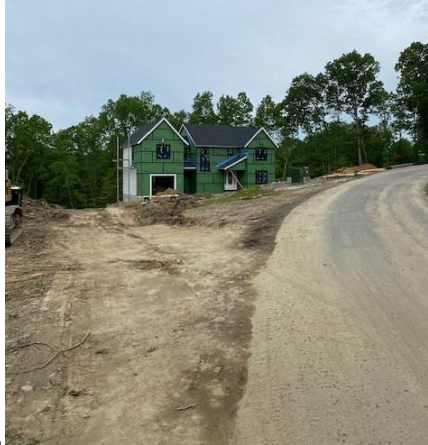
(B) Construction of Lot #3 dwelling. Some mud-tracking observed on shared driveway.

1. Construction Entrance	<input type="checkbox"/> Yes <input checked="" type="checkbox"/> No	<input type="checkbox"/> Yes <input checked="" type="checkbox"/> No		The site is accessed by a Road (Pennie Lane) as proposed on the recorded Subdivision plans dated June 16, 2021 Prepared by Ducharme & Dillis Civil Design Group. The construction vehicles are parked adjacent to the house that is currently being constructed in a gravel parking area. If runout or mud-tracking is observed, a construction entrance to the Lot #3 dwelling will be recommended.

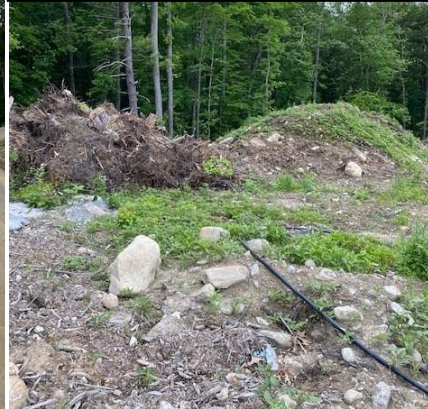
(C) Brush, Stump, & topsoil Stockpile on east side of Lot #2. No erosion or washout was observed. (See attached plan for location)

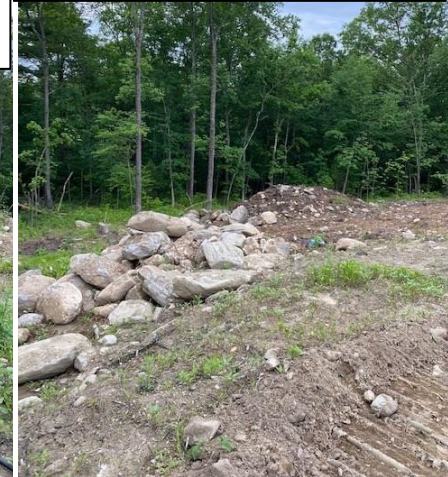
(D) Boulder Stockpile on Lot #2. (See attached plan for location)

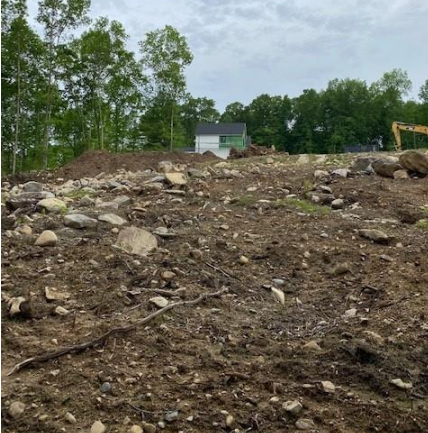
(E) Lot #2 has been cleared & grubbed for proposed house & septic area. No erosion or washout was observed downgradient of Lot #2

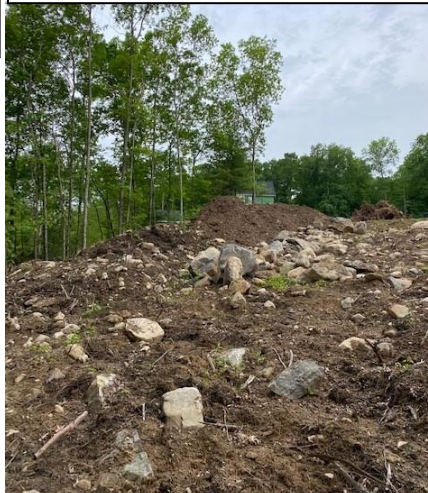
(F) Material Stockpile on west side of Lot #2.

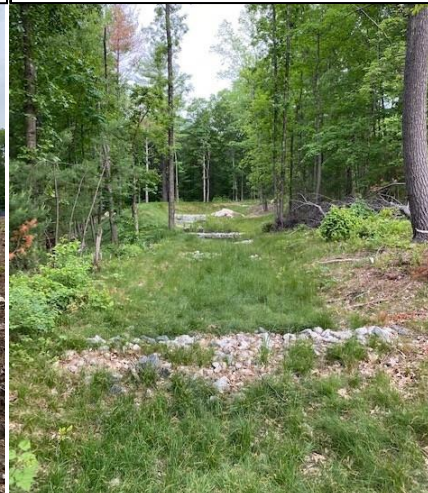
(G) Grassed swale routing stormwater to Stormwater Management Area #1.

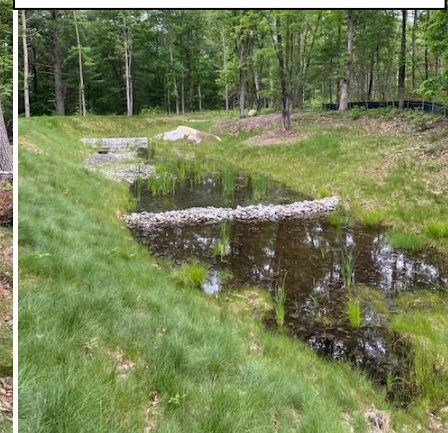
(H) Standing water observed in Stormwater Management Area #1. ~1.5" of rainfall occurred from 5/29-5/31.

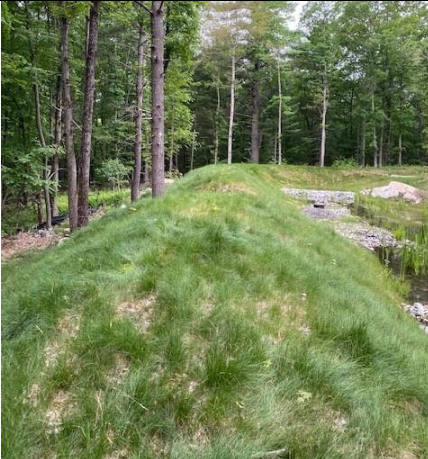
(I) Side slopes of Stormwater Management Area #1 have been stabilized with loam & seed.

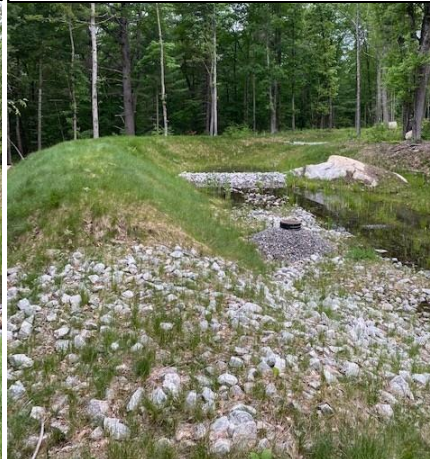
(J) Emergency Spillway in Stormwater Management Area #1. Outlet structure is visible in the middle of the picture.

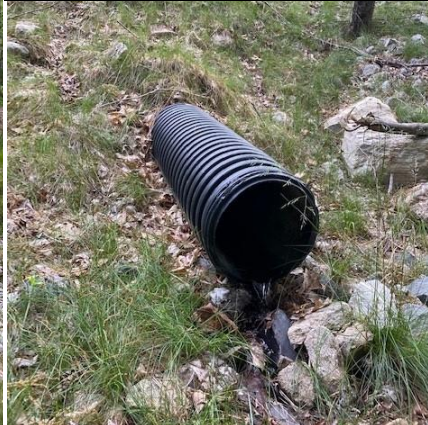
(K) Outlet culvert for Stormwater Management Area #1. Steady flow from was observed. No erosion or scour was observed.

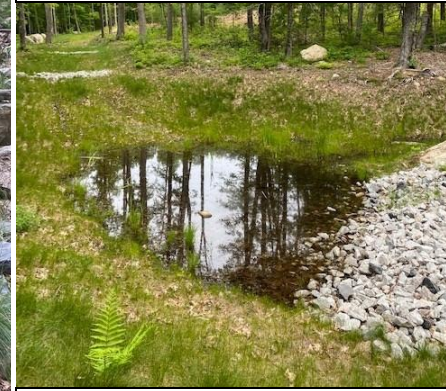
(L) Water observed in Sediment Forebay for Stormwater Management Area #1. As mentioned previously, the outlet control structure is functioning properly.

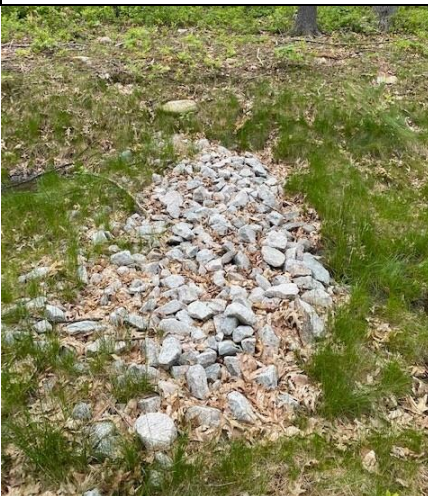
(M) Typical Check Dam in grassed swale.

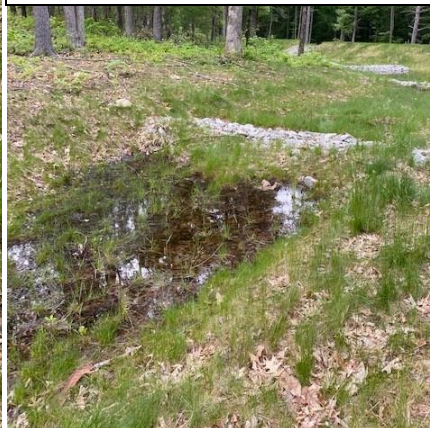
(N) Standing water was observed upgradient of rip rap check dam. Water was observed flowing toward Stormwater Management Area #1.

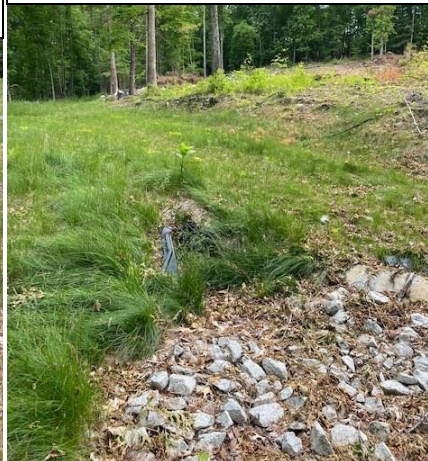
(O) Flared End section. Rip-rap was installed at culvert outfall to prevent erosion & scour.

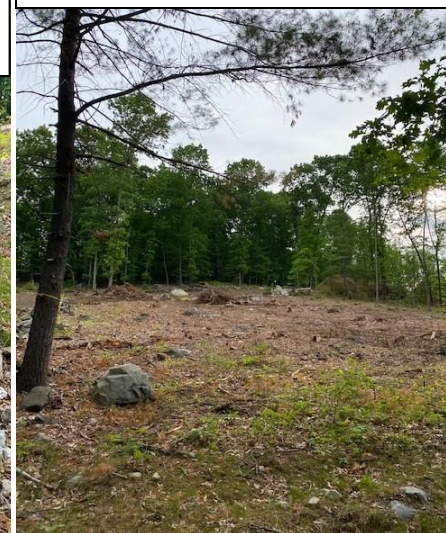
(P) Lot #4 has been cleared & grubbed.

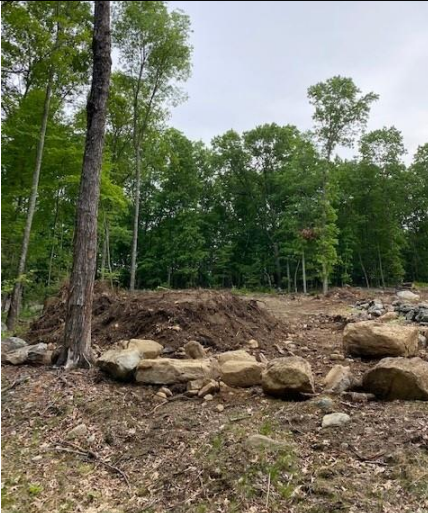
(Q) Topsoil stockpile on Lot #4

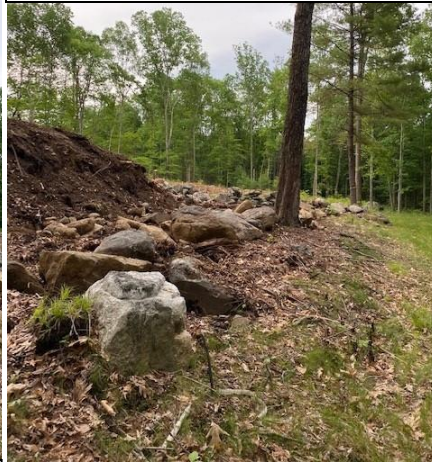
(R) Natural berm at bottom of Lot #4 will help prevent potential sediment washout from construction activities.

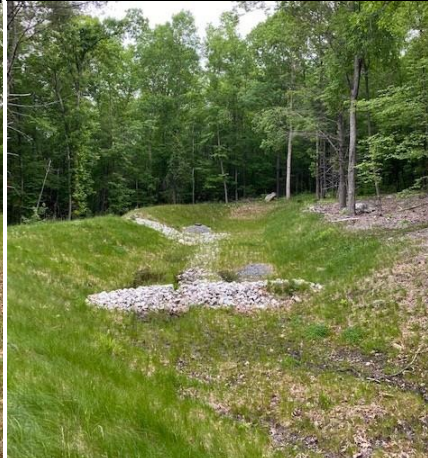
(S) Stormwater Management Area #2. Sediment Forebay is visible in the bottom of the picture.

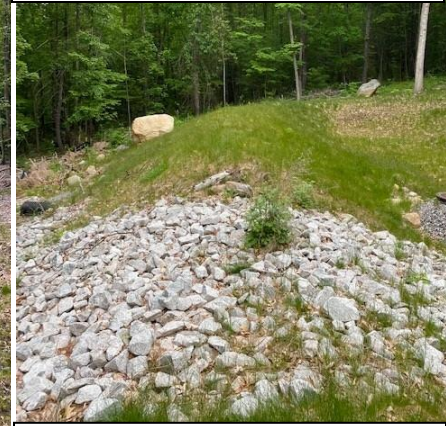
(T) Emergency Spillway for Stormwater Management Area #2. Side slopes in and around the basin have been stabilized with loam & seed.

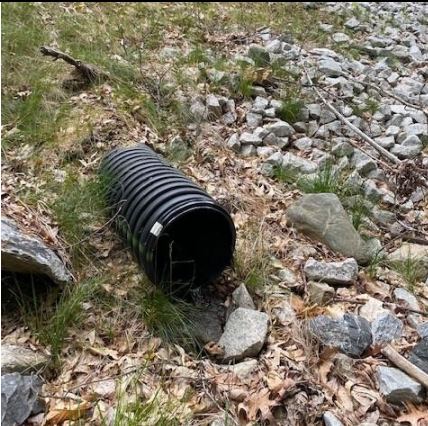
(U) Outlet Culvert for Stormwater Management Area #2. Flow was observed from Outlet Culvert #2, no erosion or scour was observed.

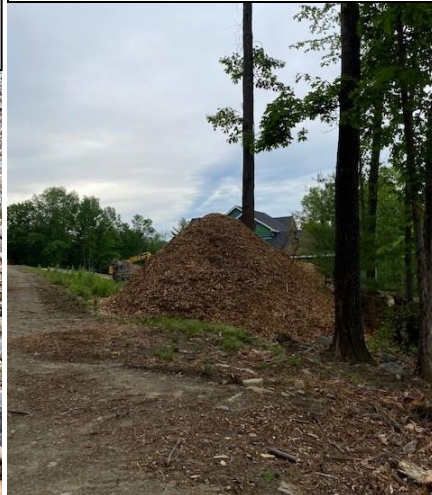
(V) Woodchip Stockpile between Lot #3 & Lot #4.

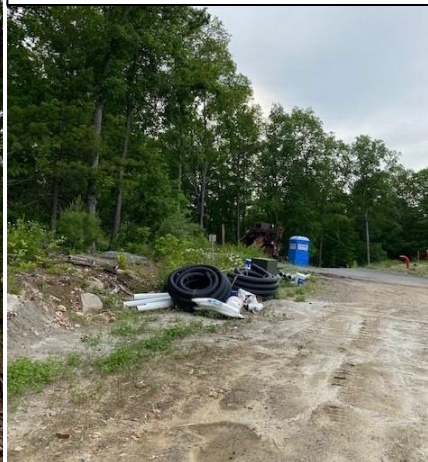
(W) Material stockpile adjacent to shared driveway. (See attached plan for location)

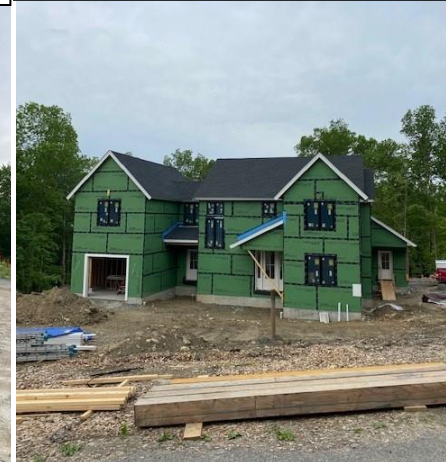
(X) Current construction of Lot #3 house. Roofing appears to be completed and siding has begun.
