TOWN OF STOW, MASSACHUSETTS

Dry Weather Outfall Screening Report

APRIL 2022

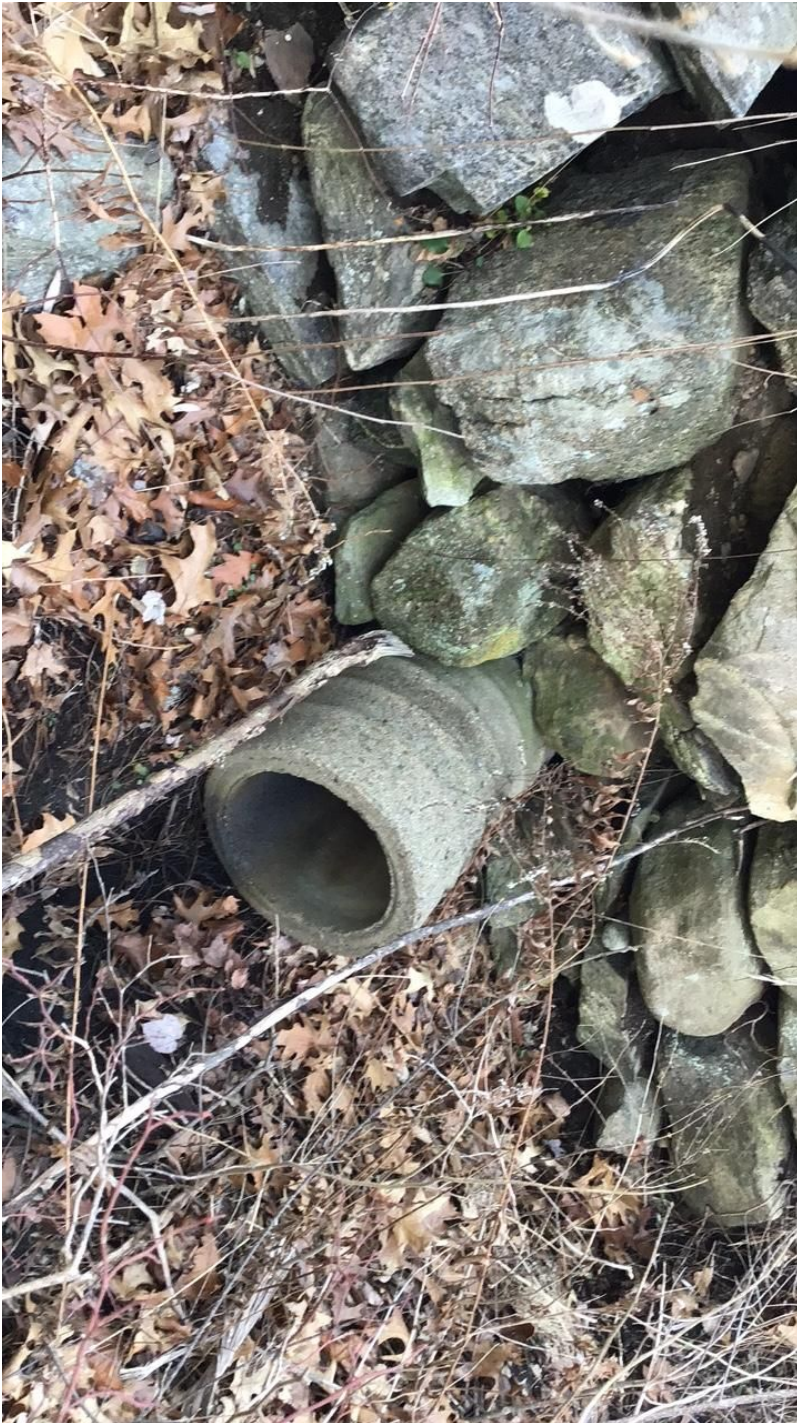
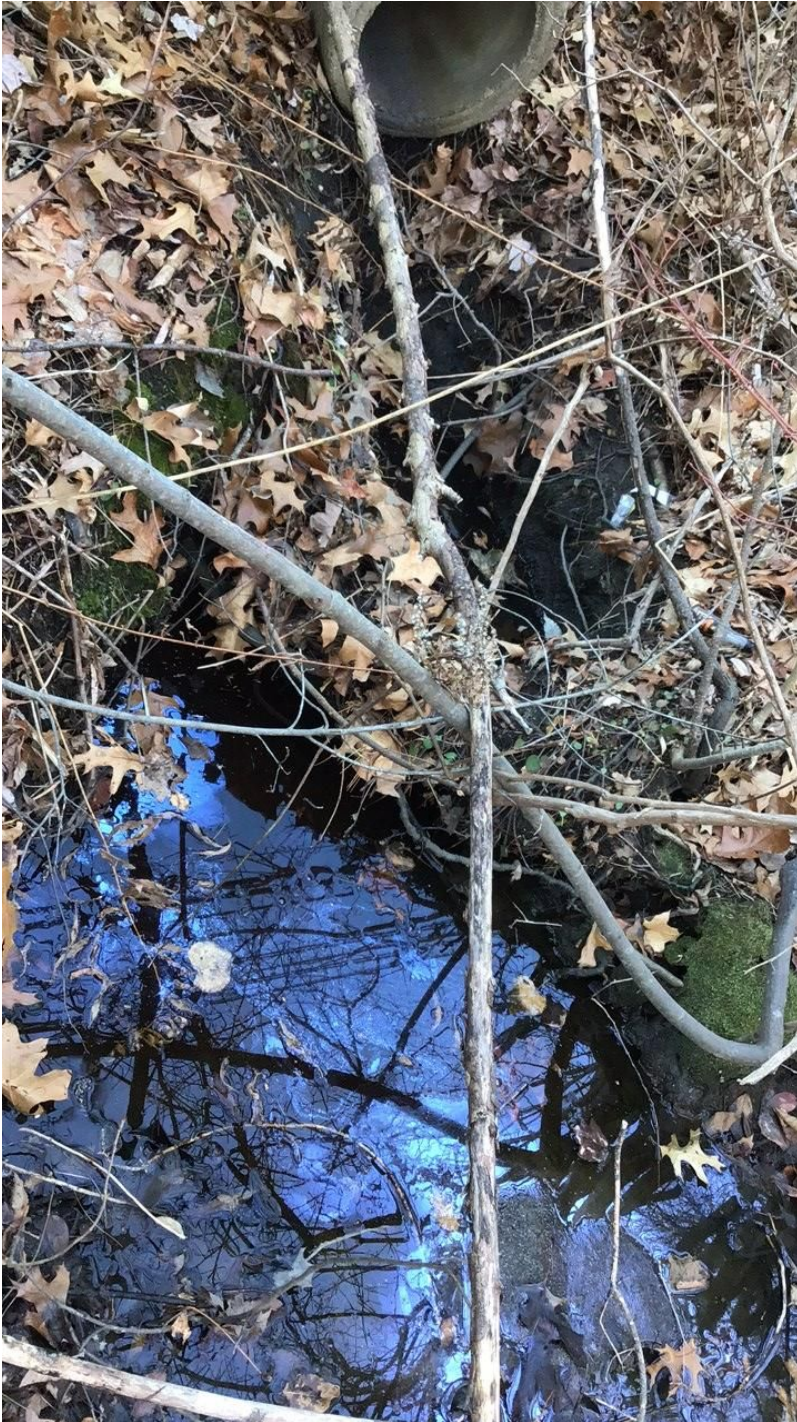
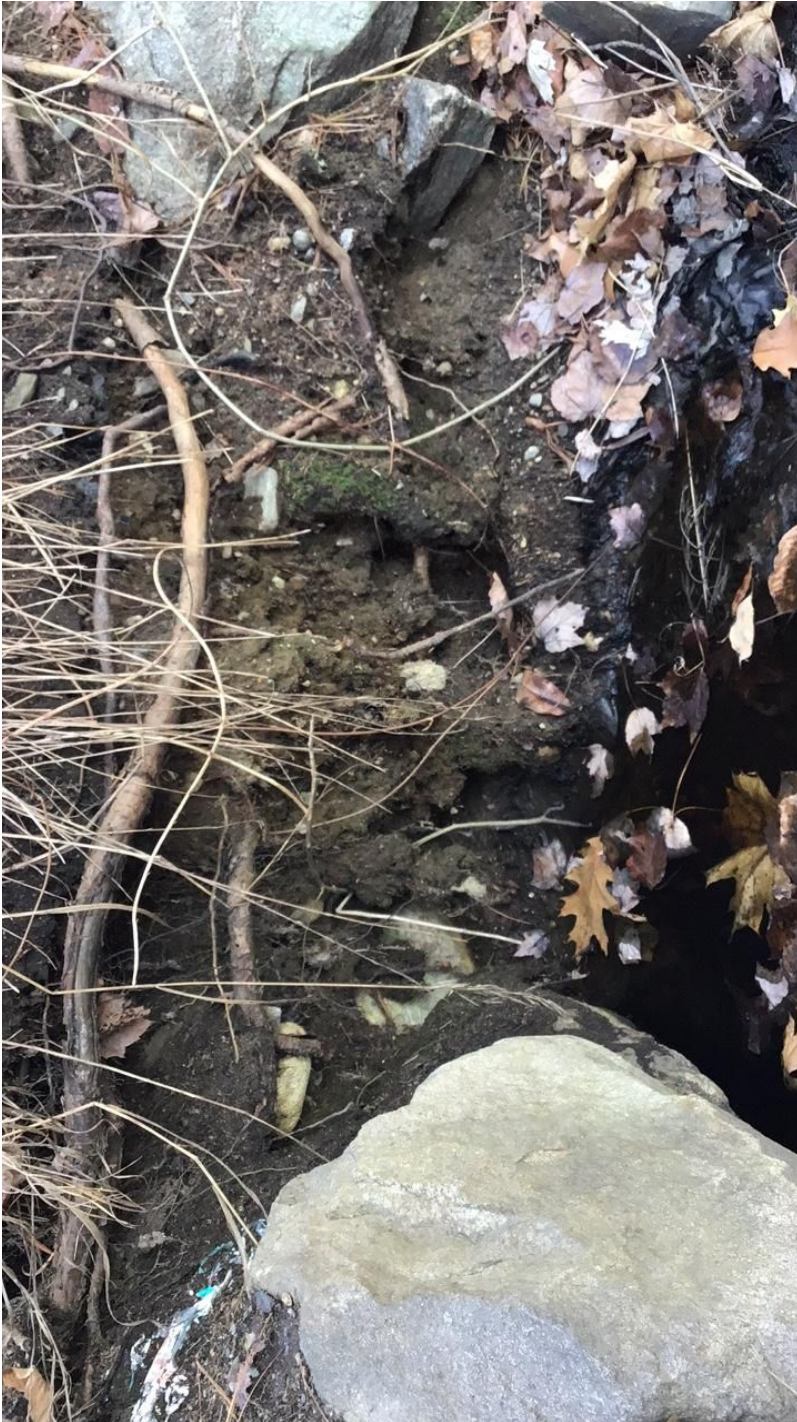
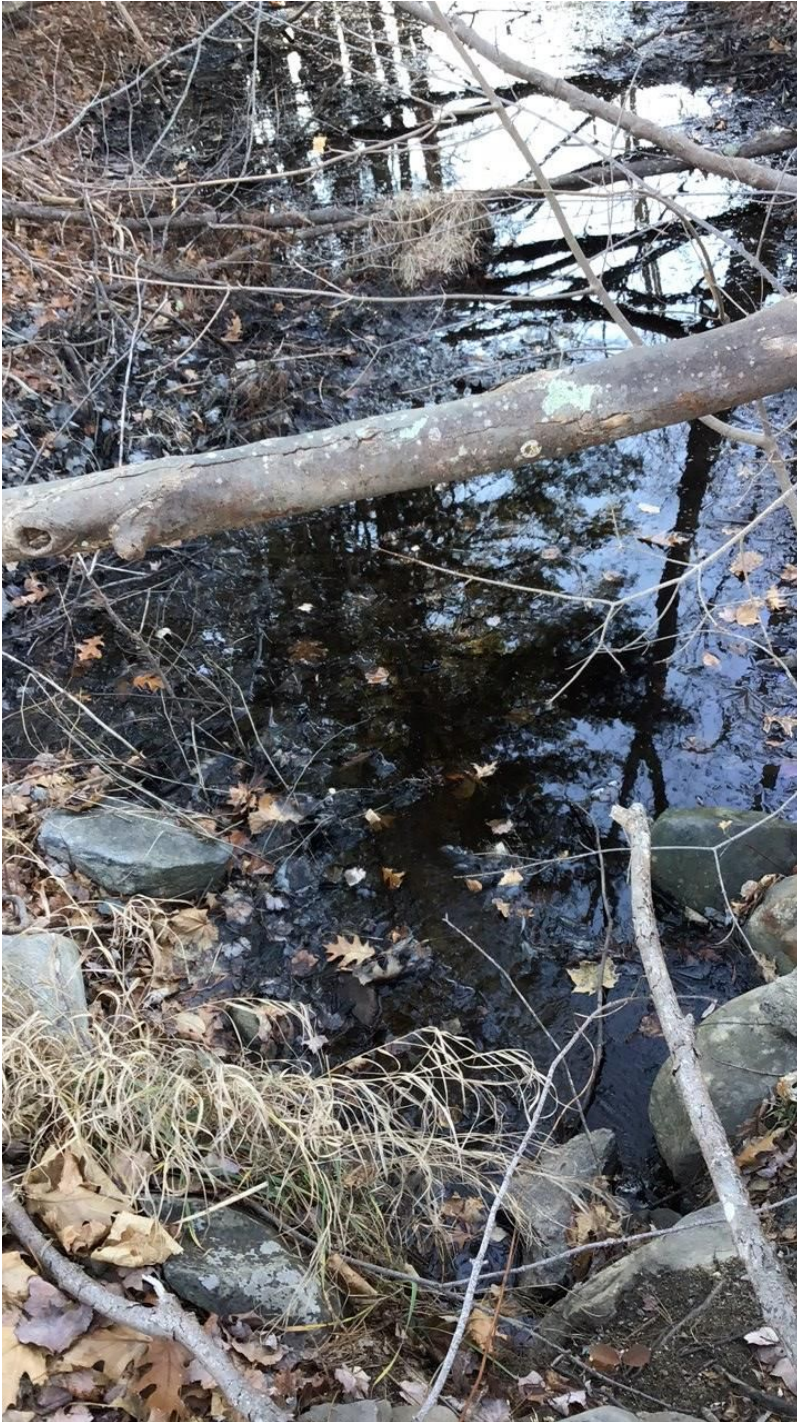
<b>Ownership</b>	Public
<b>Outfall Type</b>	Pipe End
<b>Other Outfall Type</b>	
<b>Material</b>	RCP
<b>Shape</b>	Circular
<b>Diameter/Dimension (in)</b>	12
<b>Condition</b>	Good
<b>Sediment</b>	Open/None
<b>Erosion/Scouring</b>	No
<b>BMP Visible</b>	Other
<b>Other BMP Type</b>	None

<b>Evidence of Pollution (select all that apply)</b>	Oil Sheen
<b>Odor</b>	None
<b>Flow Clarity</b>	N/A (not flowing)
<b>Flow Color</b>	N/A (not flowing)
<b>Flow Color Description</b>	
<b>Evidence of Staining</b>	No
<b>Evidence of Abnormal Vegetation</b>	No
<b>Outfall Damage, Deposits, Growth on Outfall, or Other Indicators of Illicit Discharge</b>	No
<b>If yes, please describe:</b>	
<b>Potential Sources/Actions Taken</b>	Large notable oil sheen in water. Sheen came back together when disturbed.
<b>Needs follow up?</b>	Yes
<b>Reason for follow up:</b>	Come back to sample, illicit discharge evidence noted during first visit.
<b>General Comments</b>	Based on the flow of the pipe on the western side of the road, the pipe on the eastern side is an outfall, not a culvert. Oil sheen noted on first visit evidence of illicit discharge. Oil sheen not seen on second site visit.

- Follow-up sampling of outfalls 1, 5, 13, 15, and 21.
- Compliance with sampling requirements of the MS4 permit.
- Utilizing stormwater mapping to identify which unconfirmed outfalls exist, and where they exist.
- Compliance with mapping requirements of the MS4 permit.
- Repair of Outfalls 11 and 16, and blockage removal at Outfalls 2 and 7.

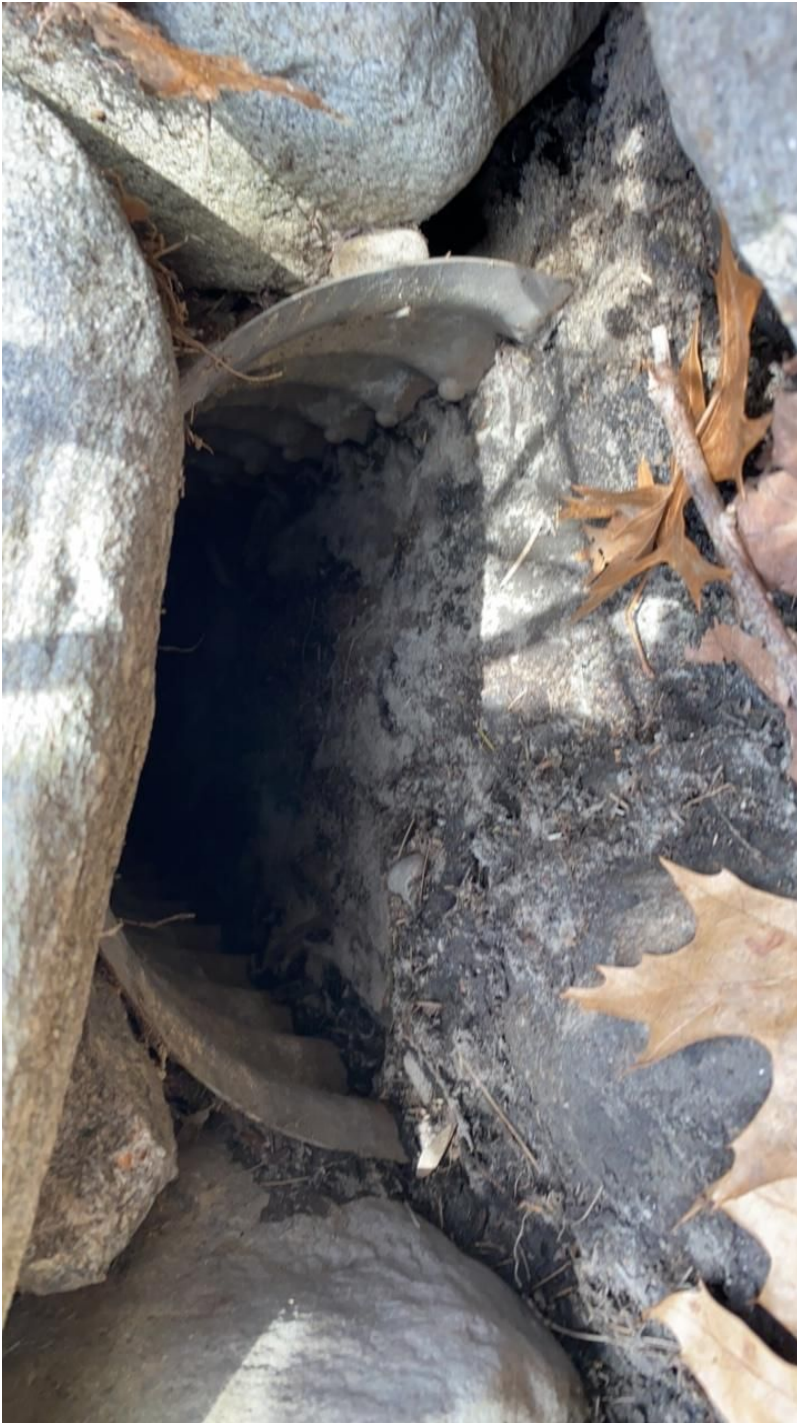
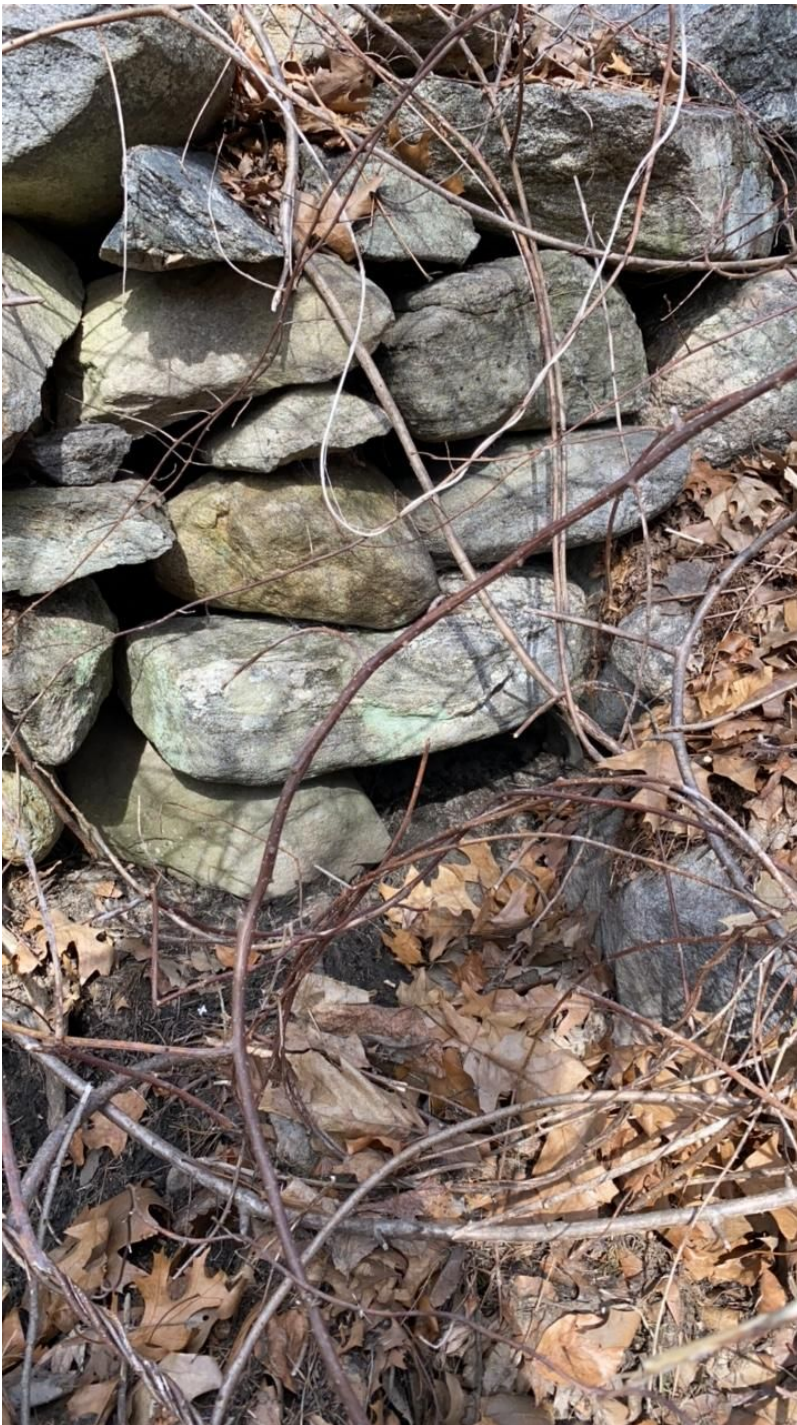
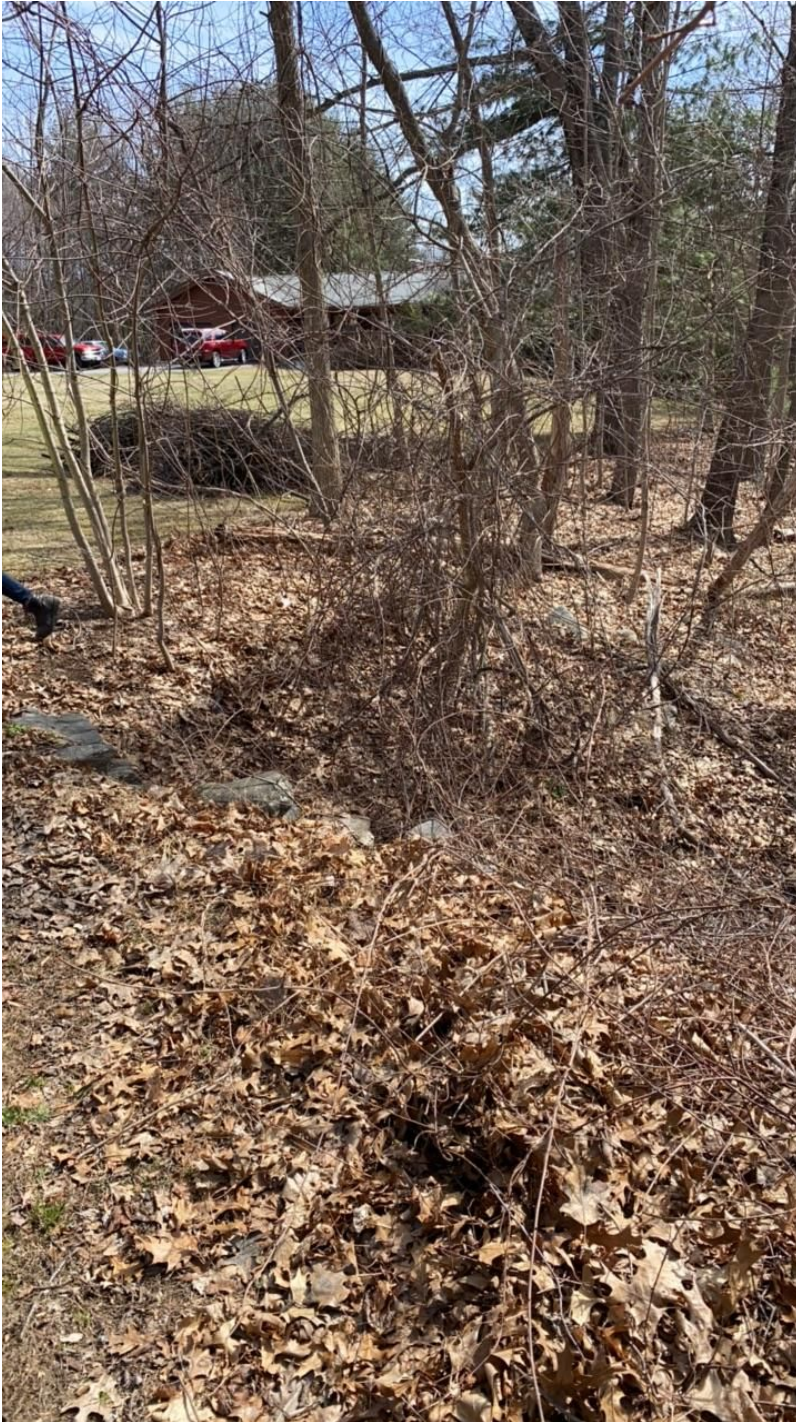
<b>Evidence of Pollution (select all that apply)</b>	None
<b>Odor</b>	None
<b>Flow Clarity</b>	N/A (not flowing)
<b>Flow Color</b>	N/A (not flowing)
<b>Flow Color Description</b>	
<b>Evidence of Staining</b>	No
<b>Evidence of Abnormal Vegetation</b>	No
<b>Outfall Damage, Deposits, Growth on Outfall, or Other Indicators of Illicit Discharge</b>	No
<b>If yes, please describe: Potential Sources/Actions Taken</b>	
<b>Needs follow up?</b>	No
<b>Reason for follow up:</b>	
<b>General Comments</b>	Outfall is full of sediment, no evidence of flow.

<b>Ownership</b>	Public
<b>Outfall Type</b>	Other
<b>Other Outfall Type</b>	Headwall
<b>Material</b>	CMP
<b>Shape</b>	Circular
<b>Diameter/Dimension (in)</b>	12
<b>Condition</b>	Fair
<b>Sediment</b>	3/4
<b>Erosion/Scouring</b>	No
<b>BMP Visible</b>	Other
<b>Other BMP Type</b>	None

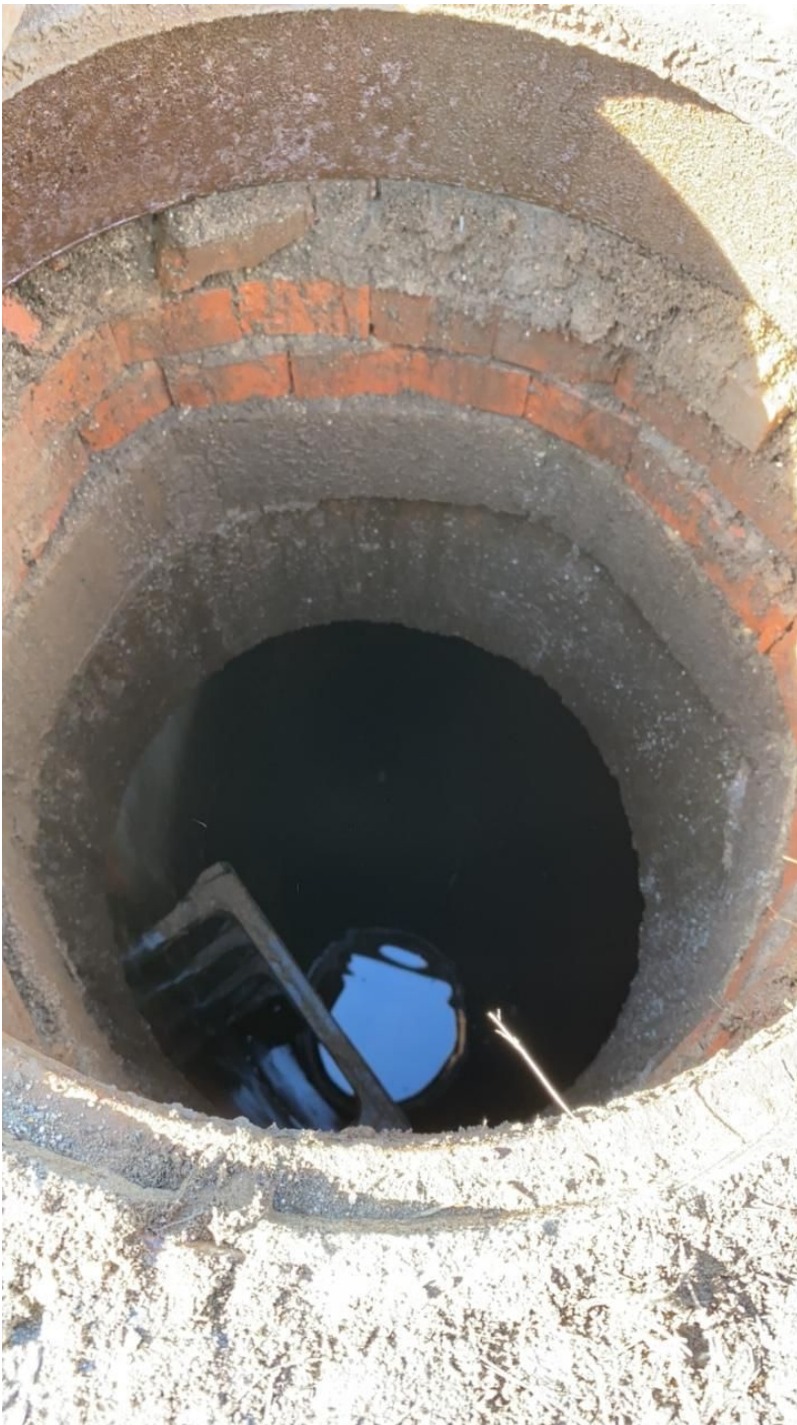
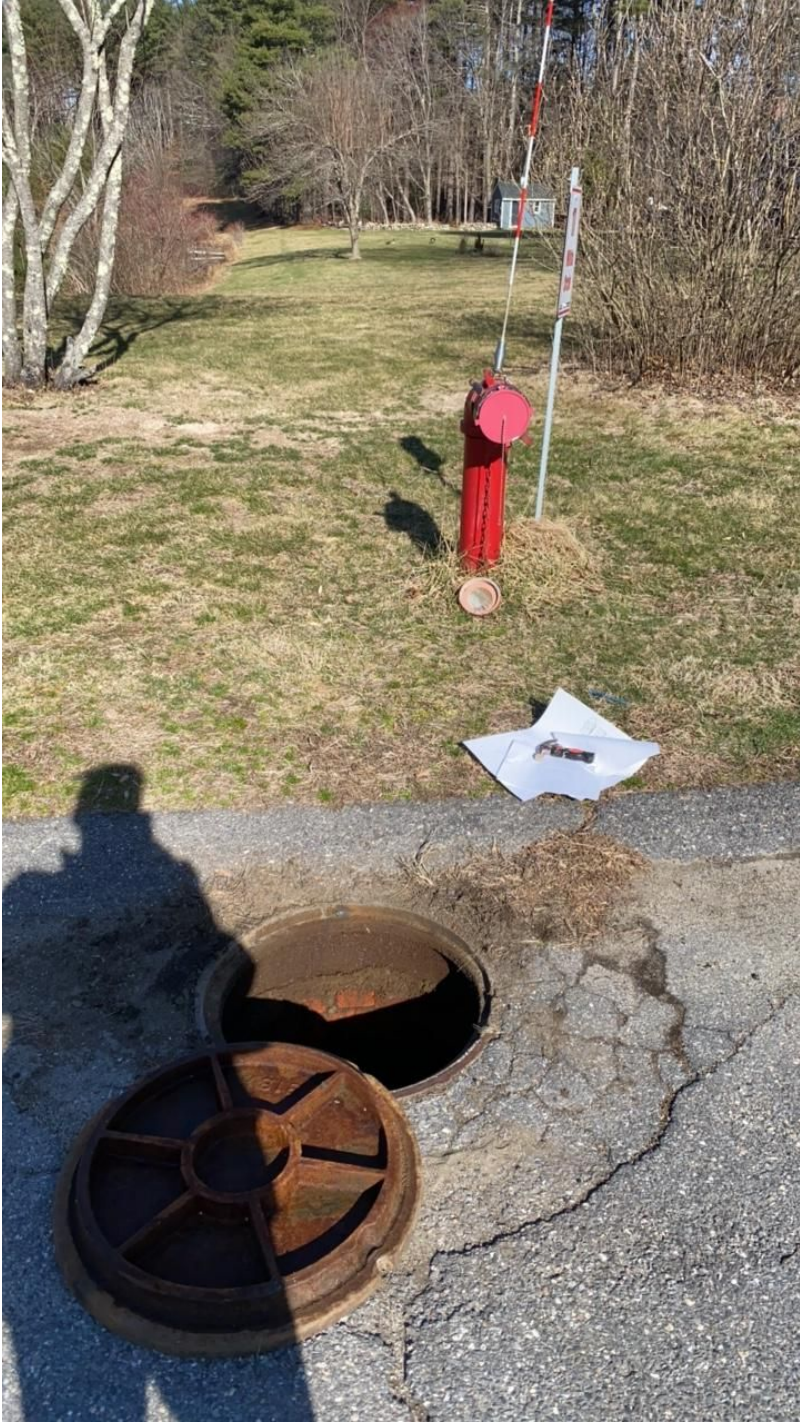
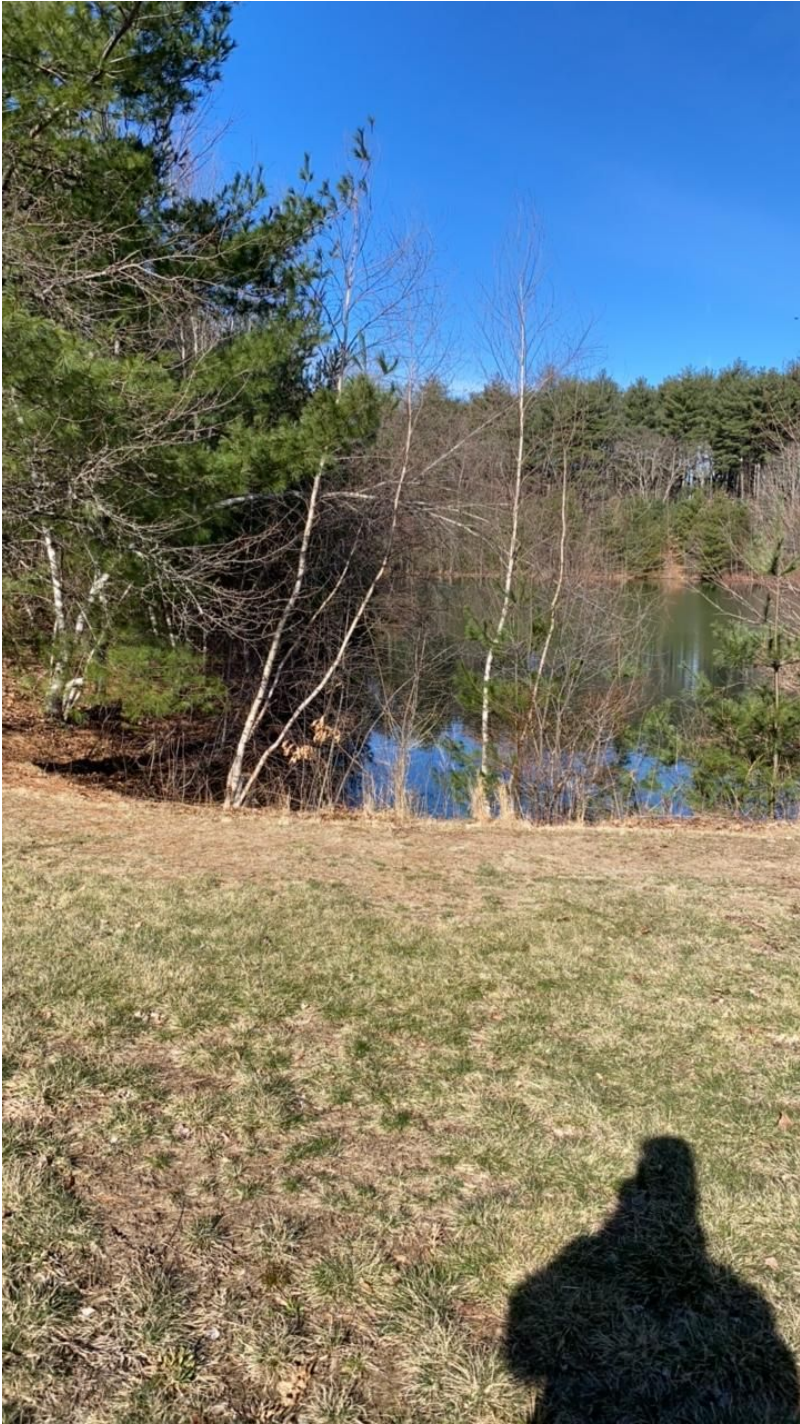
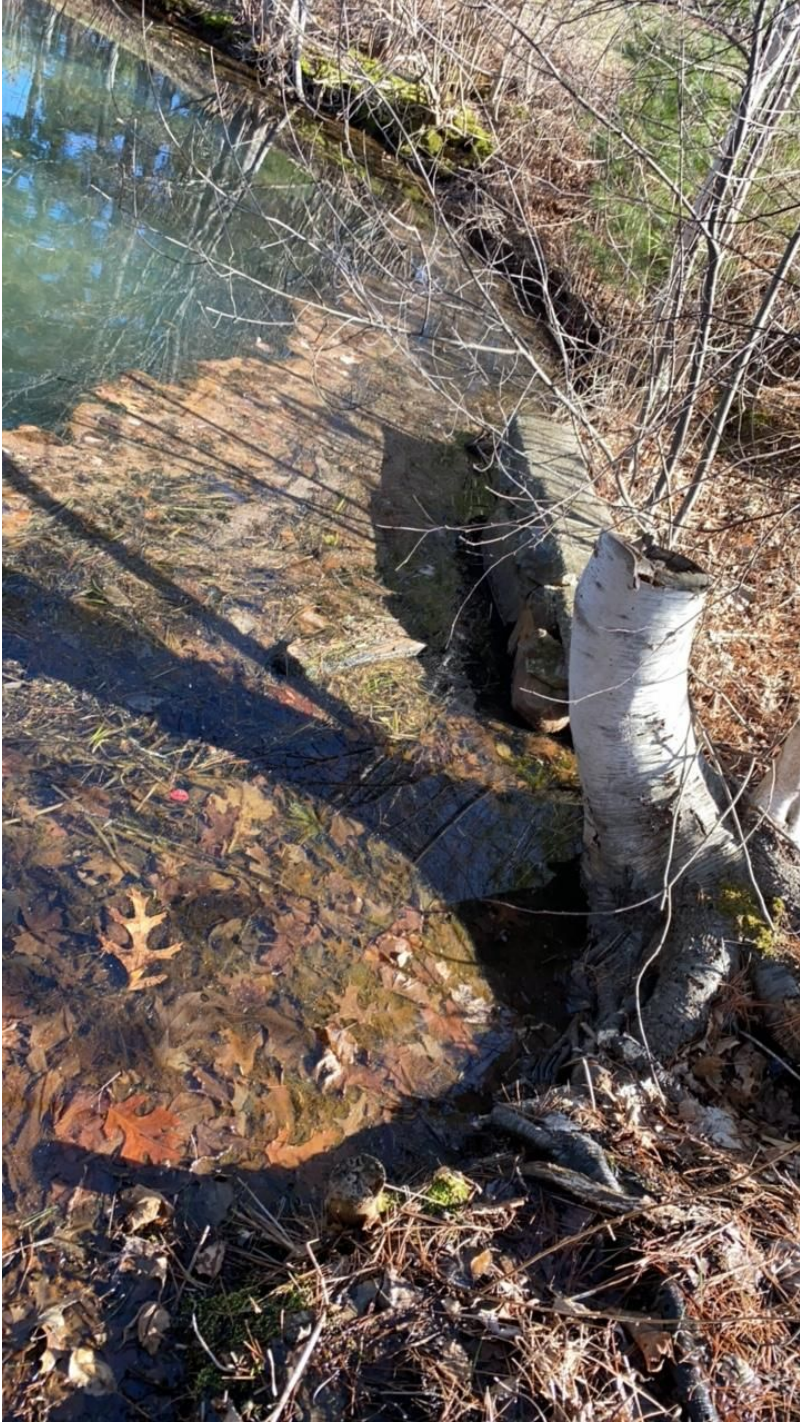
<b>Ownership</b>	Public
<b>Outfall Type</b>	Other
<b>Other Outfall Type</b>	Manhole
<b>Material</b>	RCP
<b>Shape</b>	Circular
<b>Diameter/Dimension (in)</b>	10
<b>Condition</b>	Good
<b>Sediment</b>	Open/None
<b>Erosion/Scouring</b>	No
<b>BMP Visible</b>	Other
<b>Other BMP Type</b>	None

<b>Evidence of Pollution (select all that apply)</b>	Possible pollution. Flow during dry weather, musty smell and off color flow.
<b>Odor</b>	Musty
<b>Flow Clarity</b>	Cloudy
<b>Flow Color</b>	Other
<b>Flow Color Description</b>	Off-color, darker.
<b>Evidence of Staining</b>	No
<b>Evidence of Abnormal Vegetation</b>	No
<b>Outfall Damage, Deposits, Growth on Outfall, or Other Indicators of Illicit Discharge</b>	No
<b>If yes, please describe:</b>	
<b>Potential Sources/Actions Taken</b>	
<b>Needs follow up?</b>	Yes
<b>Reason for follow up:</b>	Return for sampling due to flow.
<b>General Comments</b>	Could not find outfall discharging into pond. Found headwall but no pipe, expected to be submerged or broken. Inspected upstream manhole. Trickle of off color flow seen, damp and musty smell. Return for sampling due to flow.

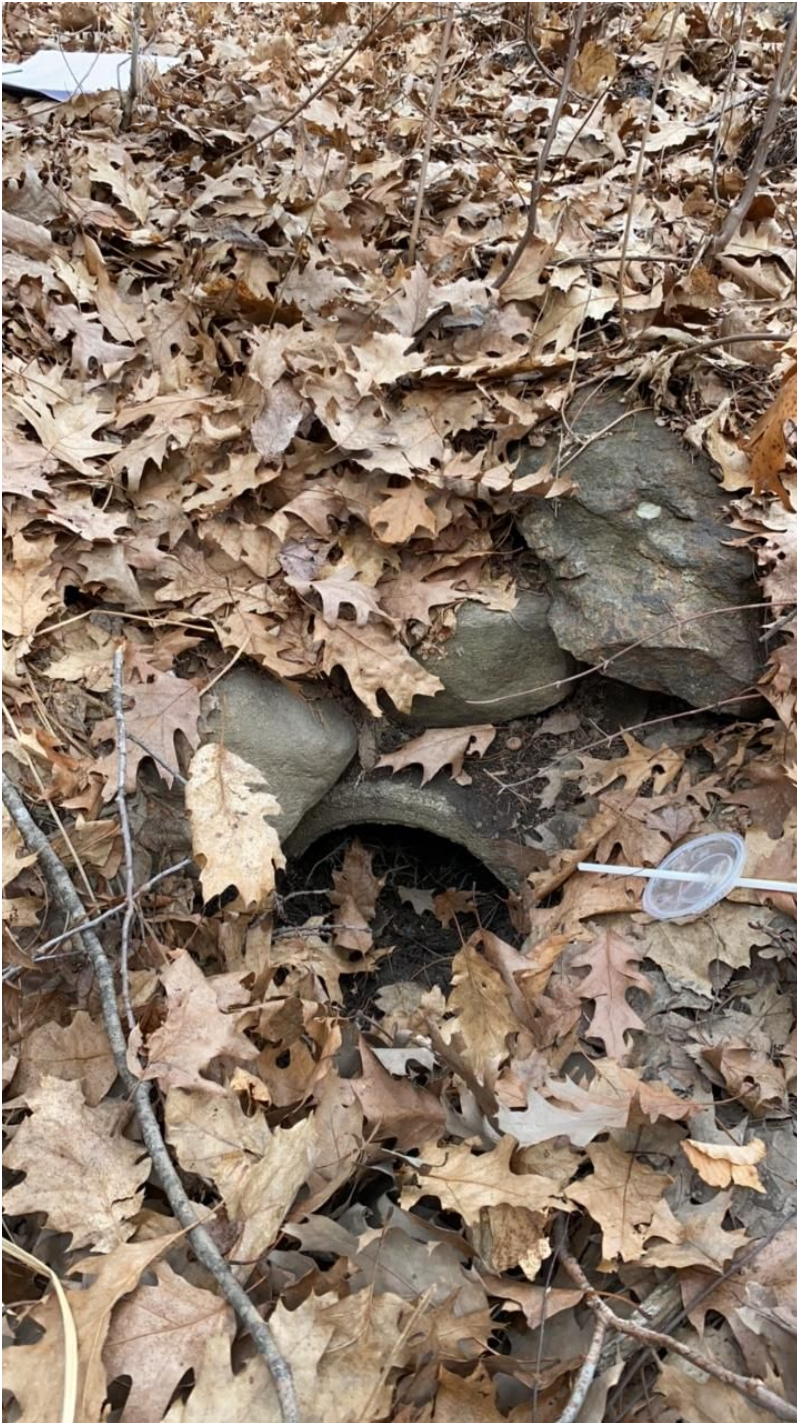
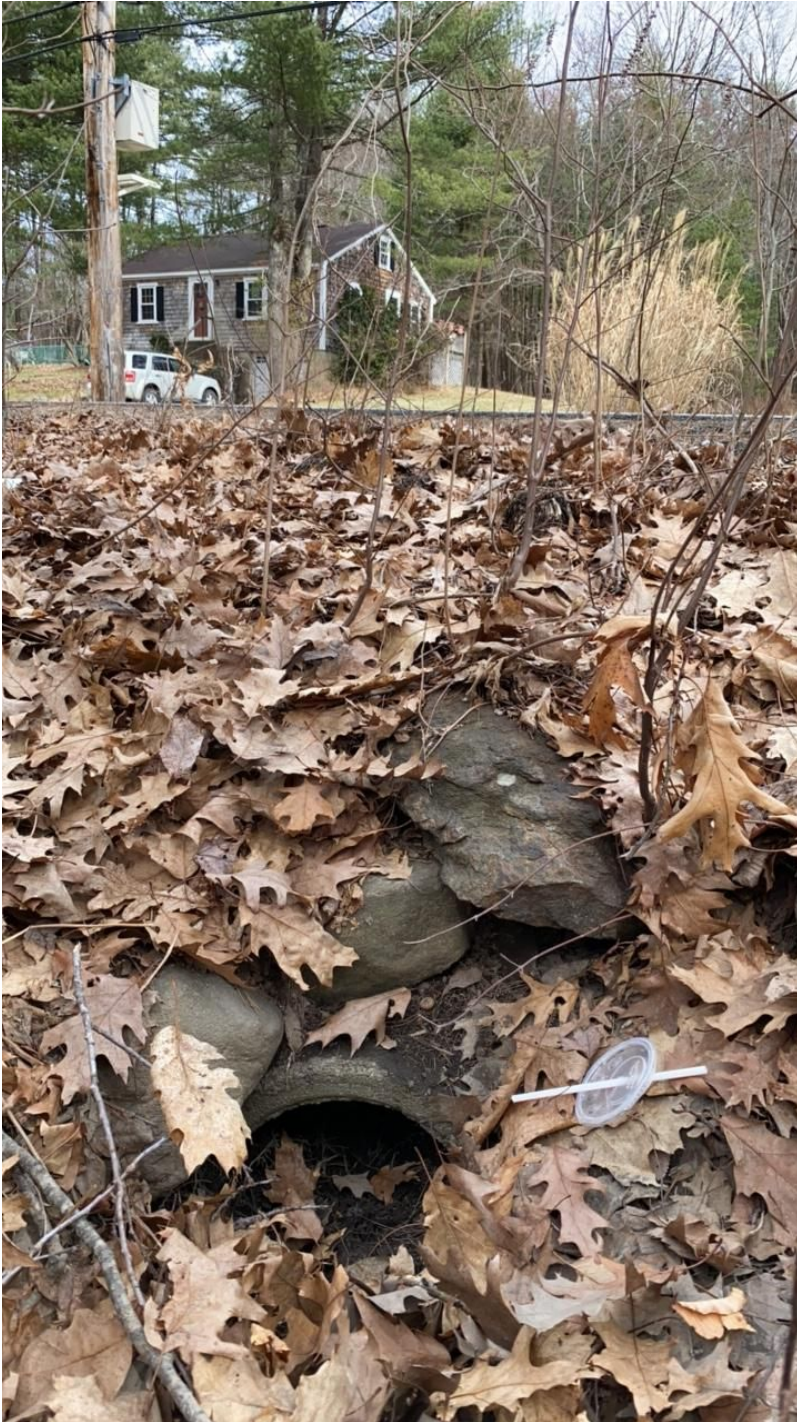
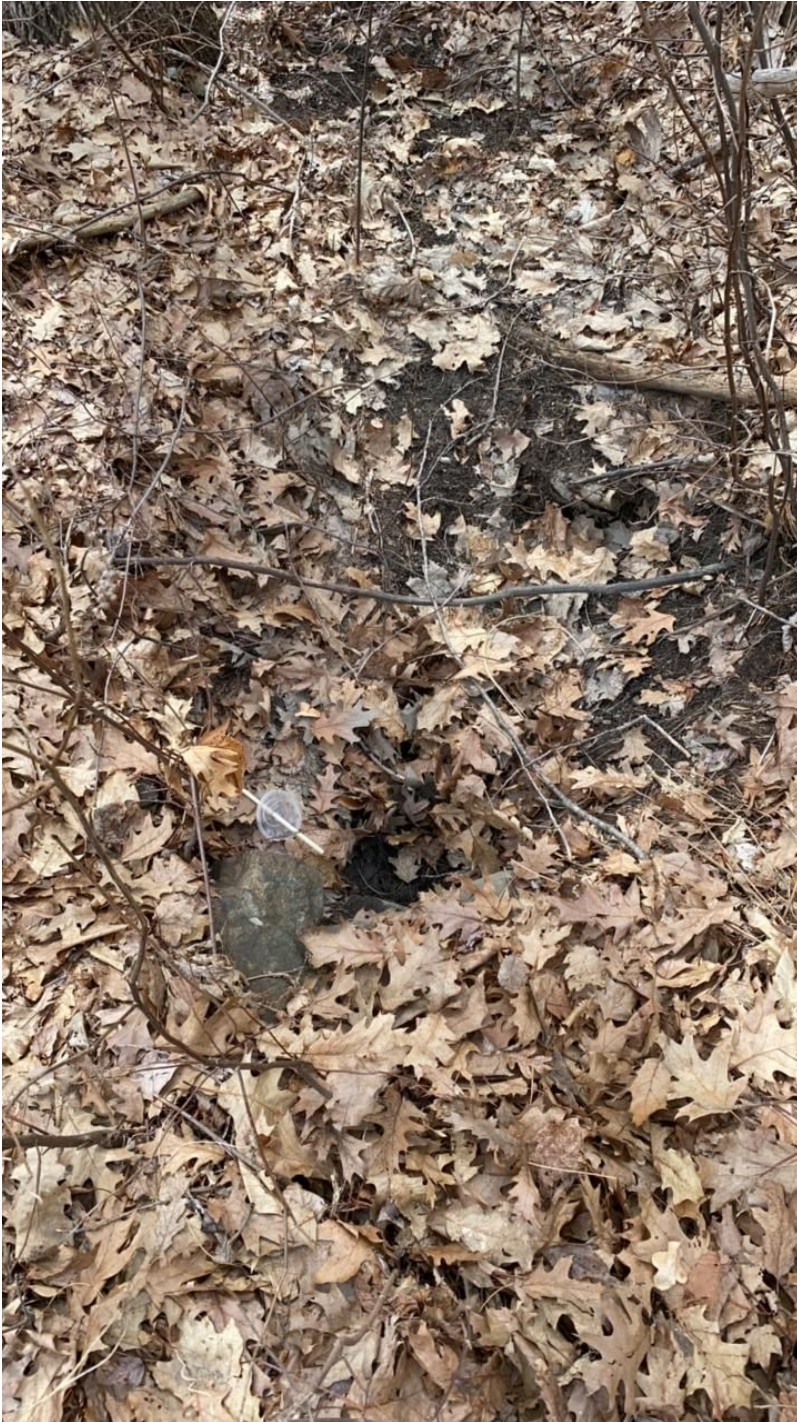
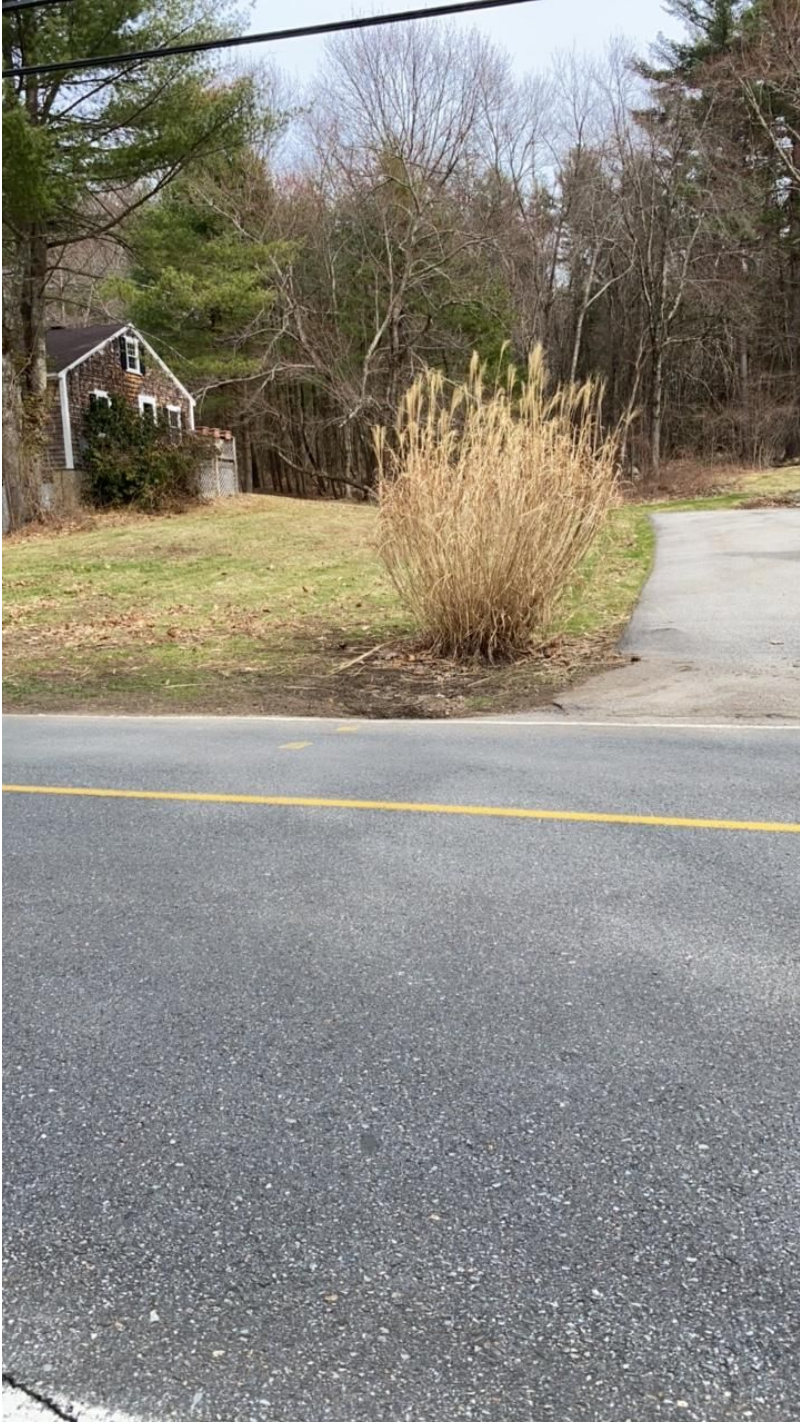
<b>Evidence of Pollution (select all that apply)</b>	None
<b>Odor</b>	None
<b>Flow Clarity</b>	N/A (not flowing)
<b>Flow Color</b>	N/A (not flowing)
<b>Flow Color Description</b>	
<b>Evidence of Staining</b>	No
<b>Evidence of Abnormal Vegetation</b>	No
<b>Outfall Damage, Deposits, Growth on Outfall, or Other Indicators of Illicit Discharge</b>	No
<b>If yes, please describe: Potential Sources/Actions Taken</b>	
<b>Needs follow up?</b>	No
<b>Reason for follow up:</b>	
<b>General Comments</b>	Pipe is full of sediment. Contributing catch basin seems to be buried by grass/dirt.

<b>Ownership</b>	Public
<b>Outfall Type</b>	Pipe End
<b>Other Outfall Type</b>	
<b>Material</b>	RCP
<b>Shape</b>	Circular
<b>Diameter/Dimension (in)</b>	12
<b>Condition</b>	Fair
<b>Sediment</b>	3/4
<b>Erosion/Scouring</b>	No
<b>BMP Visible</b>	Other
<b>Other BMP Type</b>	None

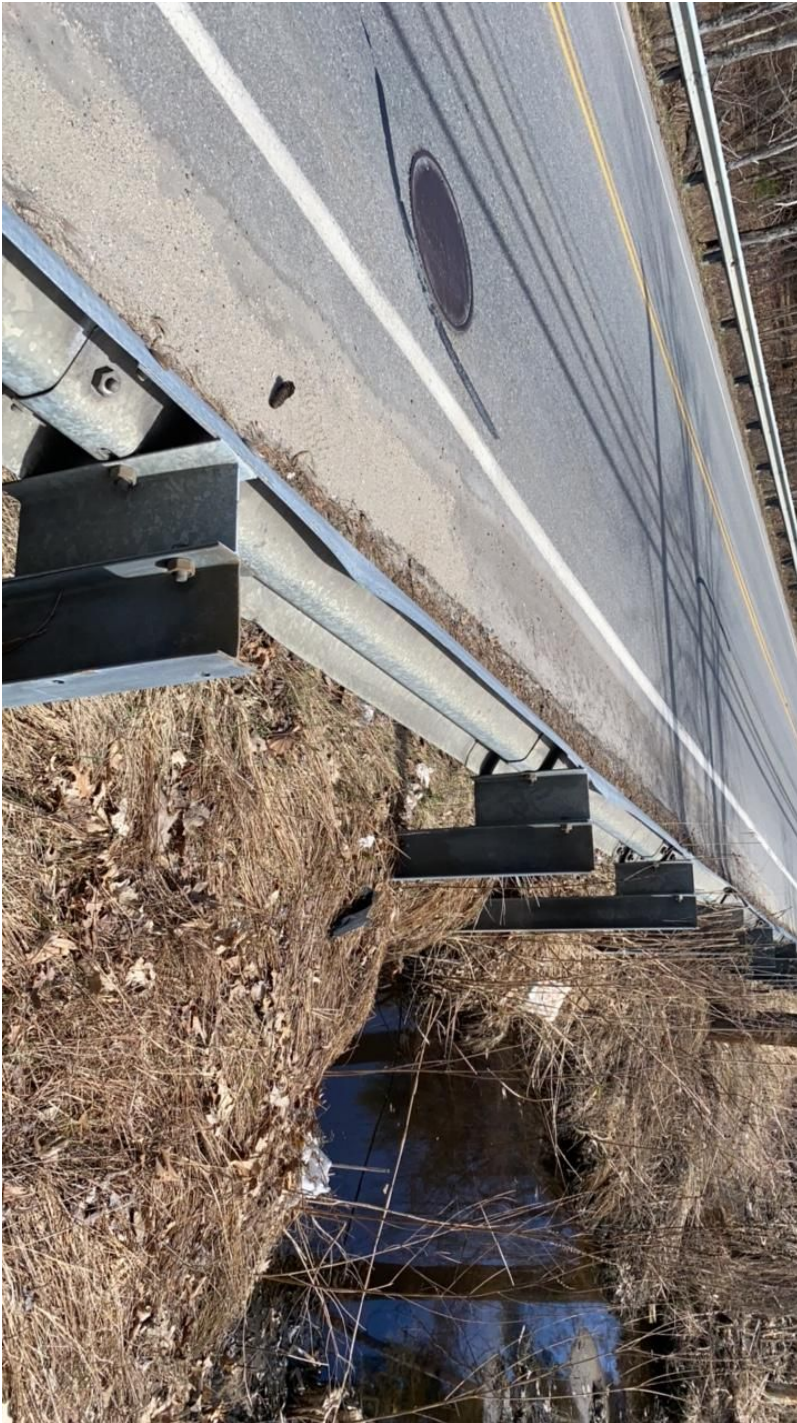
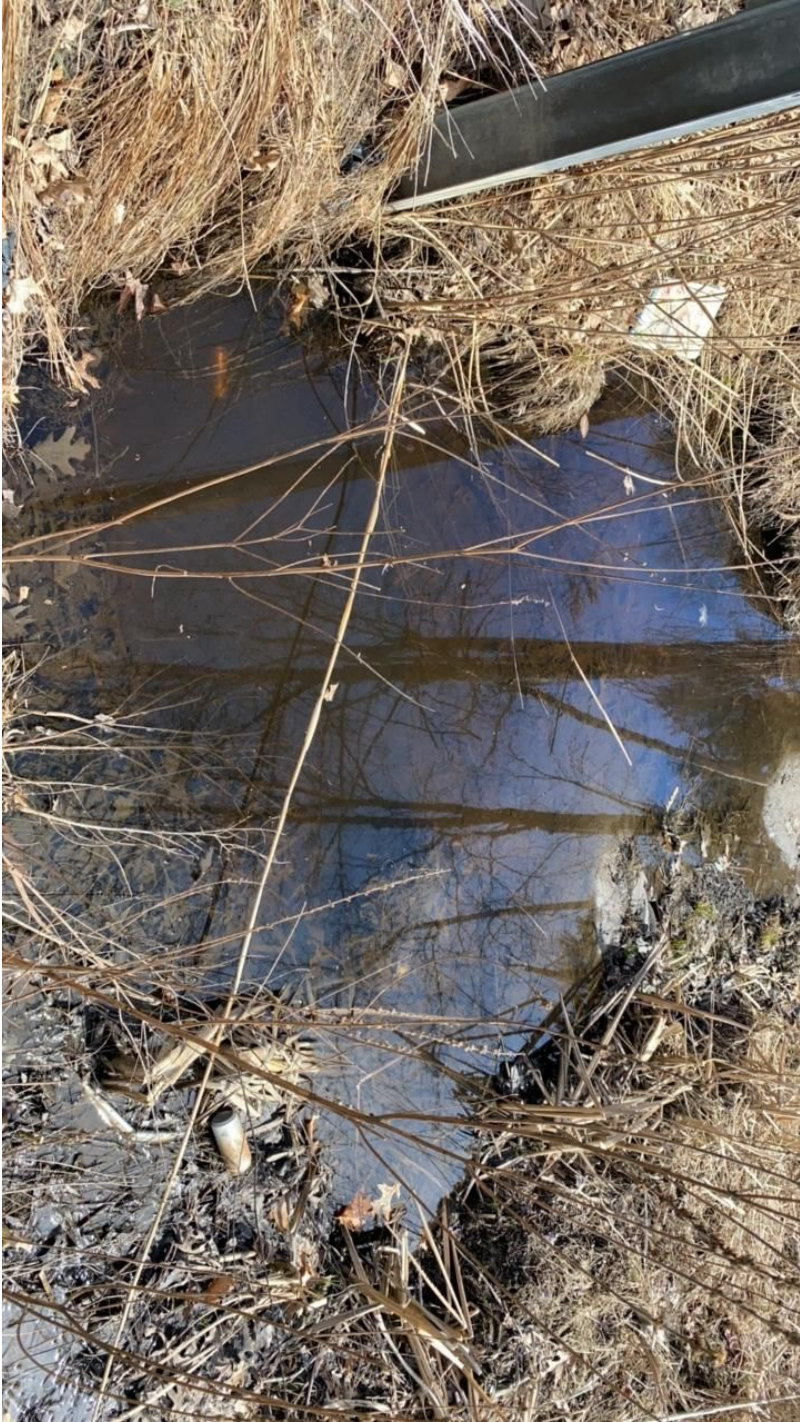
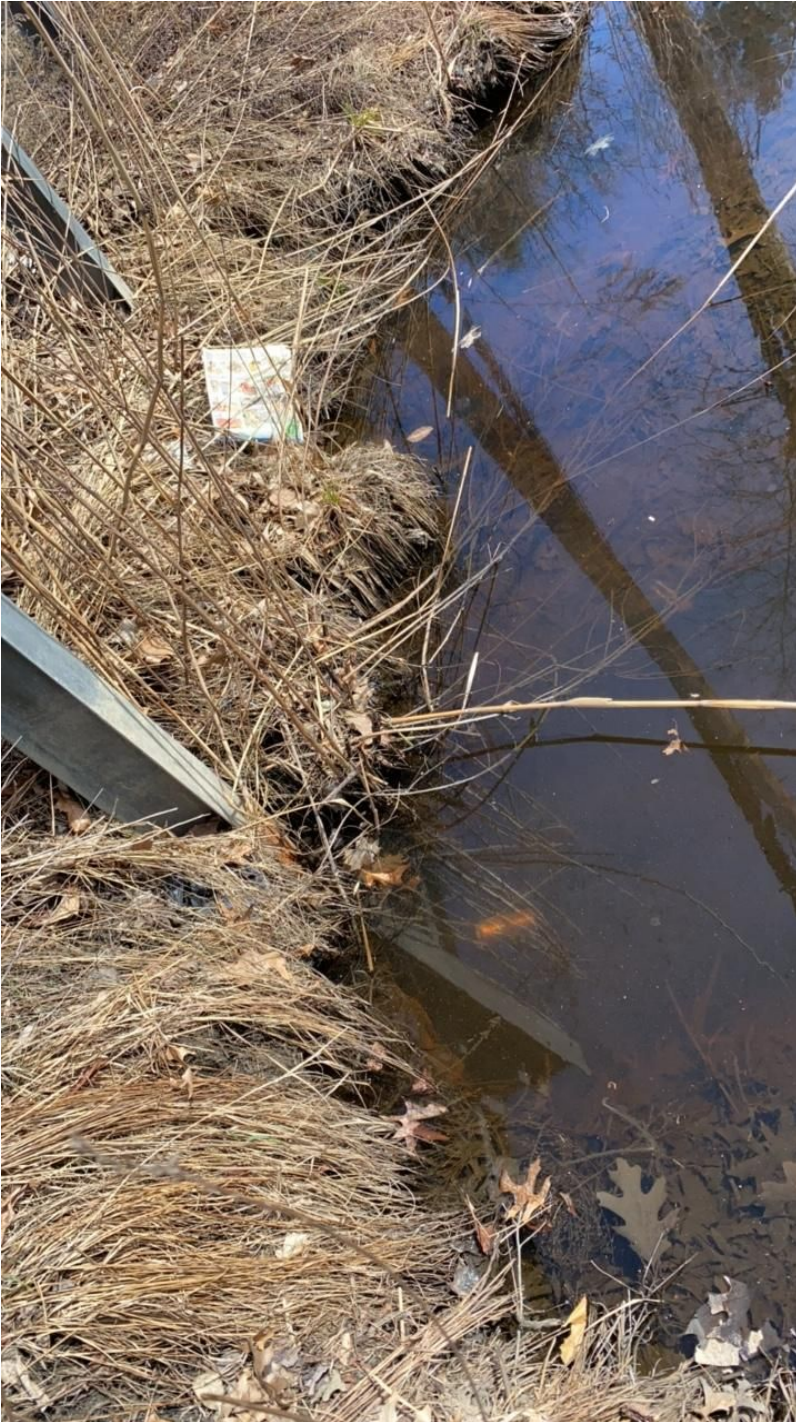
<b>Evidence of Pollution (select all that apply)</b>	None
<b>Odor</b>	None
<b>Flow Clarity</b>	N/A (not flowing)
<b>Flow Color</b>	N/A (not flowing)
<b>Flow Color Description</b>	
<b>Evidence of Staining</b>	Yes
<b>Evidence of Abnormal Vegetation</b>	No
<b>Outfall Damage, Deposits, Growth on Outfall, or Other Indicators of Illicit Discharge</b>	No
<b>If yes, please describe:</b>	
<b>Potential Sources/Actions Taken</b>	
<b>Needs follow up?</b>	No
<b>Reason for follow up:</b>	
<b>General Comments</b>	Outfall is a manhole that takes in catch basins to the northwest. Outfall dumps into manhole which also conveys a culvert across the road. Town staff confirmed that previous inspections indicated no flow from contributing catch basins.

<b>Ownership</b>	Public
<b>Outfall Type</b>	Pipe End
<b>Other Outfall Type</b>	
<b>Material</b>	CMP
<b>Shape</b>	Circular
<b>Diameter/Dimension (in)</b>	12
<b>Condition</b>	Poor
<b>Sediment</b>	Full/Plugged
<b>Erosion/Scouring</b>	No
<b>BMP Visible</b>	Other
<b>Other BMP Type</b>	None
