TOWN OF STOW, MASSACHUSETTS

Dry Weather Outfall Screening Report

APRIL 2022

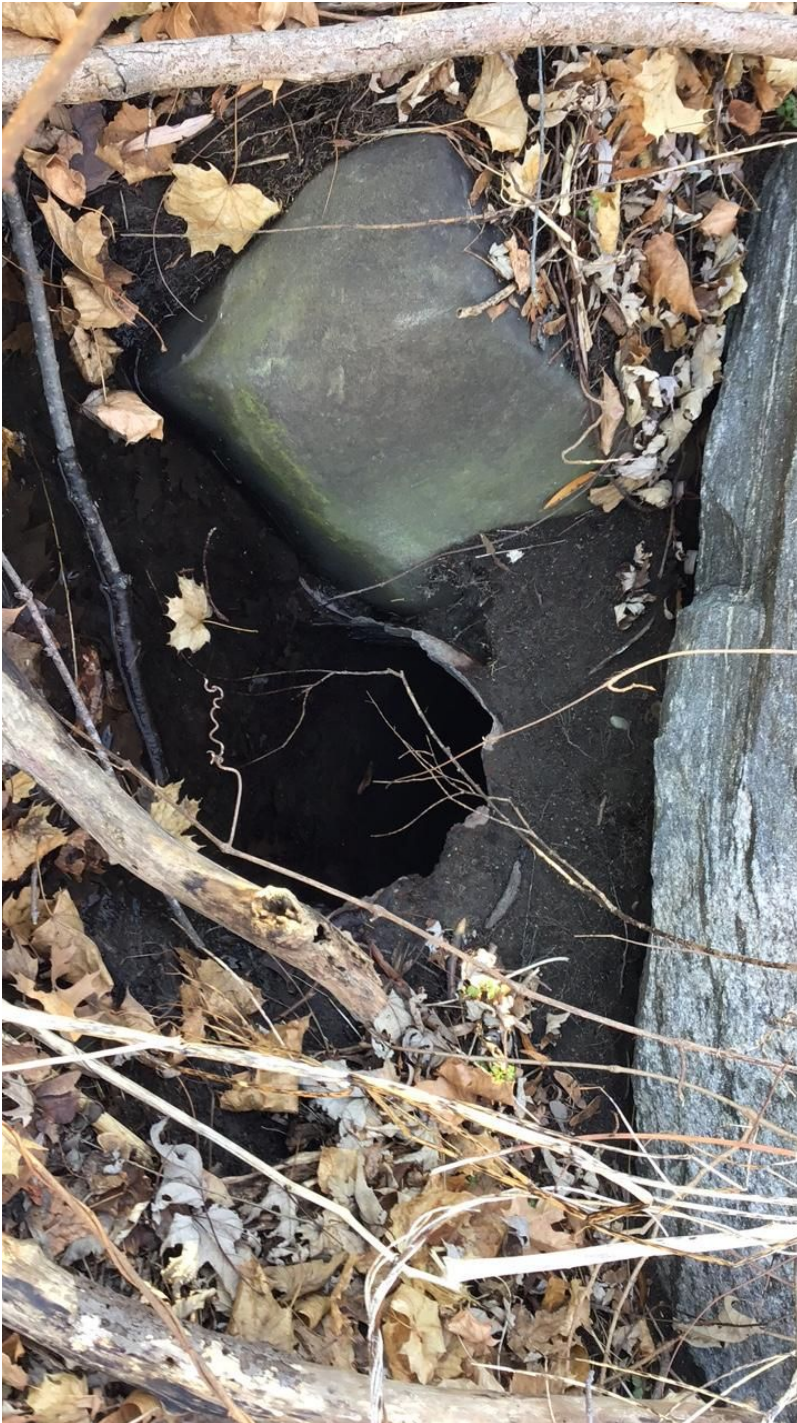
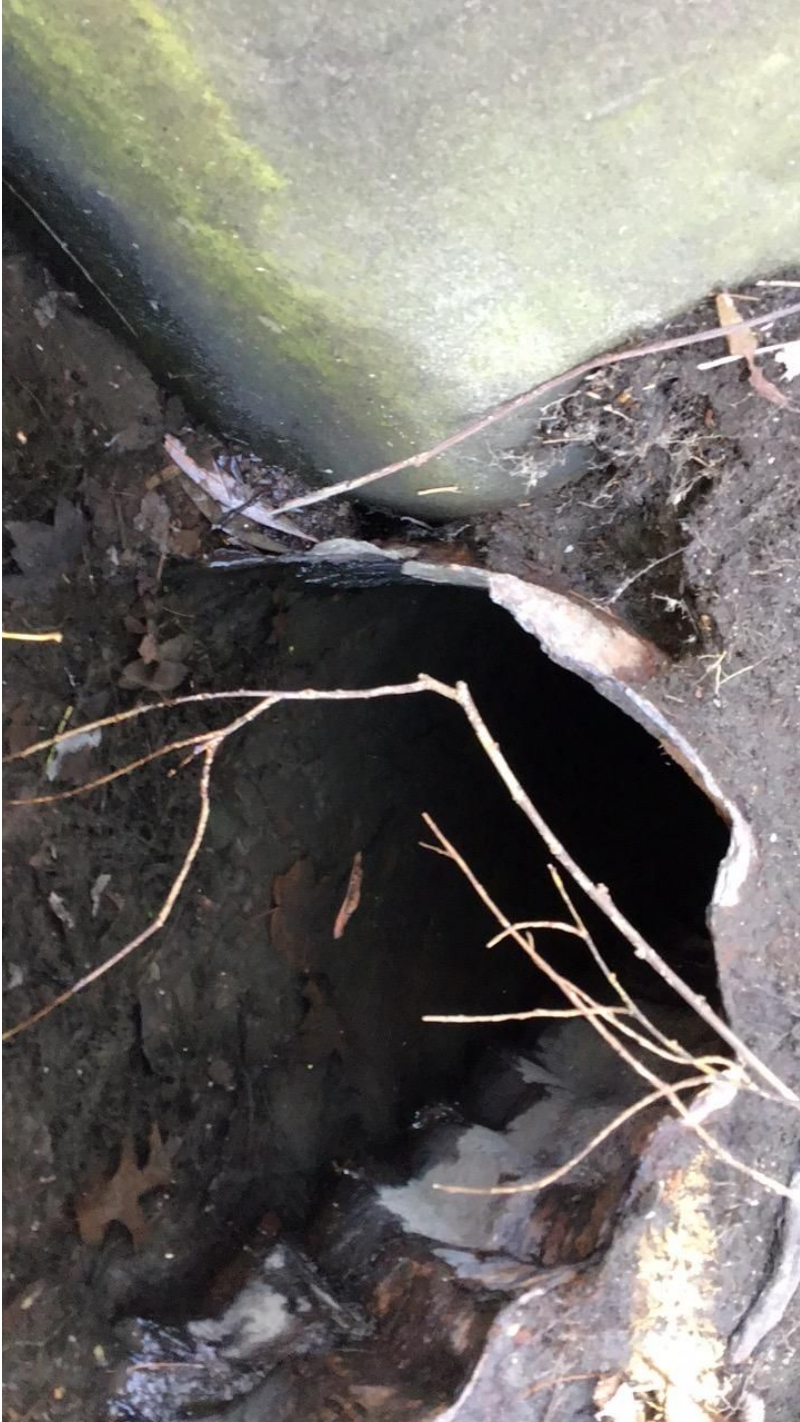
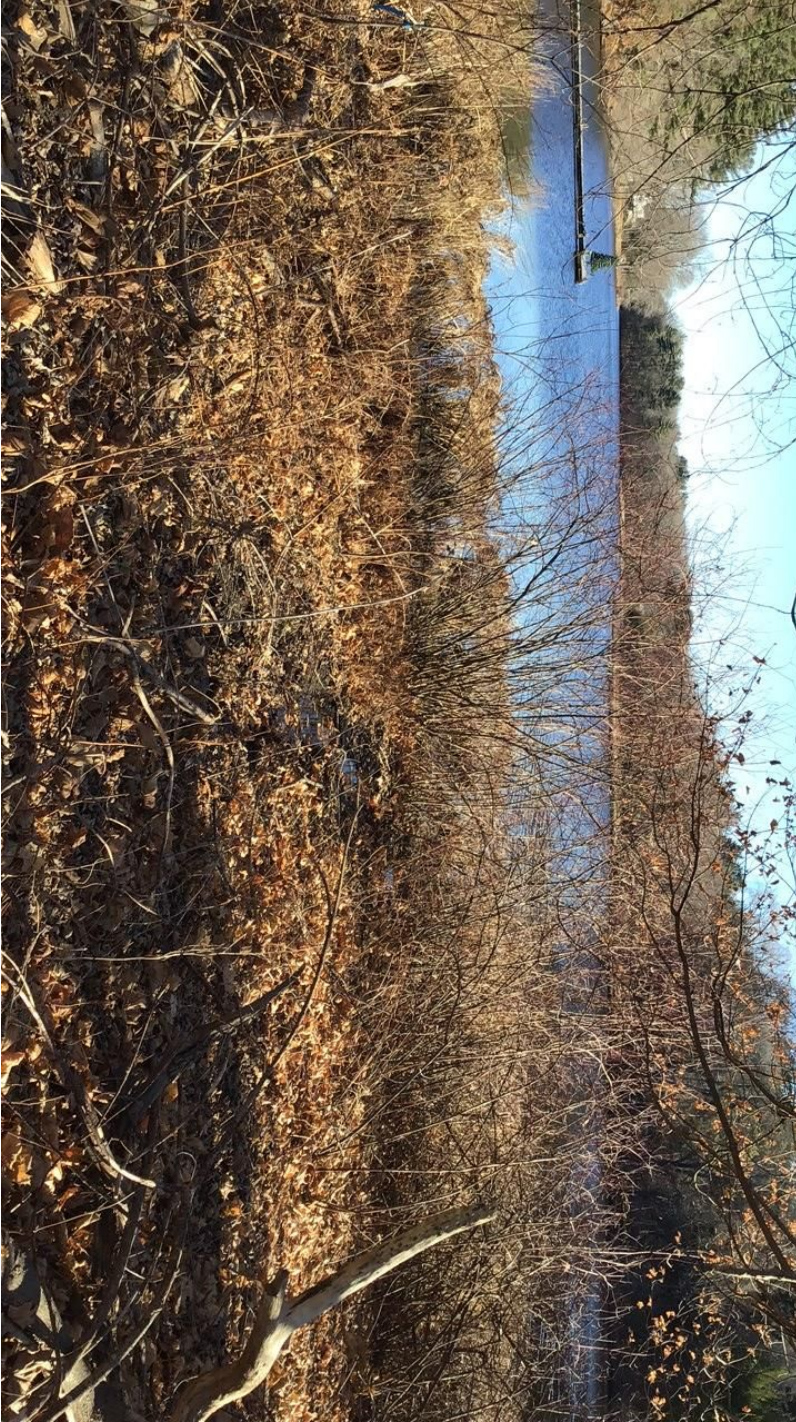
Ownership	Public
Outfall Type	Headwall
Other Outfall Type	
Material	CMP
Shape	Circular
Diameter/Dimension (in)	12
Condition	Poor
Sediment	1/4
Erosion/Scouring	No
BMP Visible	Other
Other BMP Type	None

Evidence of Pollution (select all that apply)	None
Odor	None
Flow Clarity	N/A (not flowing)
Flow Color	N/A (not flowing)
Flow Color Description	
Evidence of Staining	No
Evidence of Abnormal Vegetation	No
Outfall Damage, Deposits, Growth on Outfall, or Other Indicators of Illicit Discharge If yes, please describe:	Yes Pipe is in poor condition, rim is chipped, pipe is corroded.
Potential Sources/Actions Taken	
Needs follow up?	No
Reason for follow up:	
General Comments	Natural debris blocking flow path.

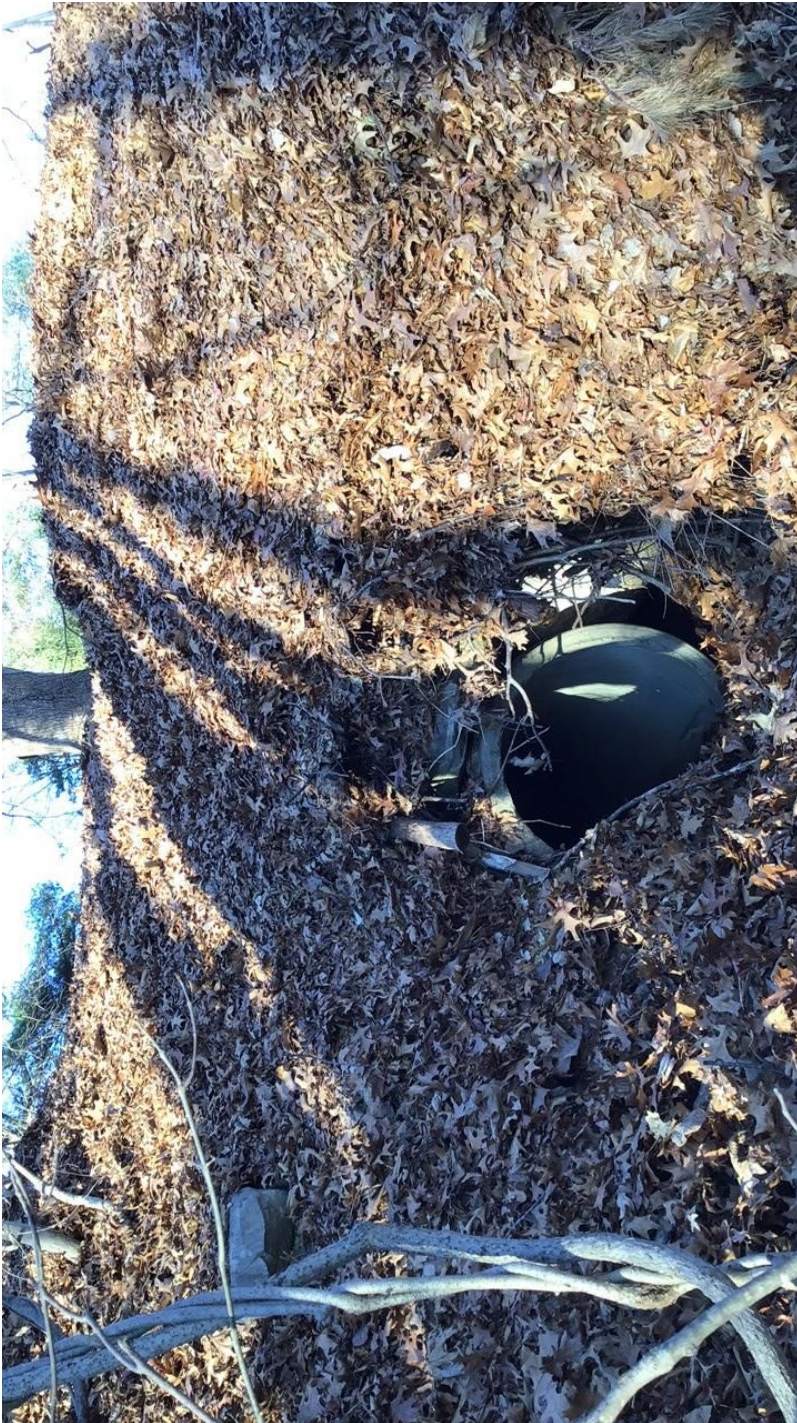
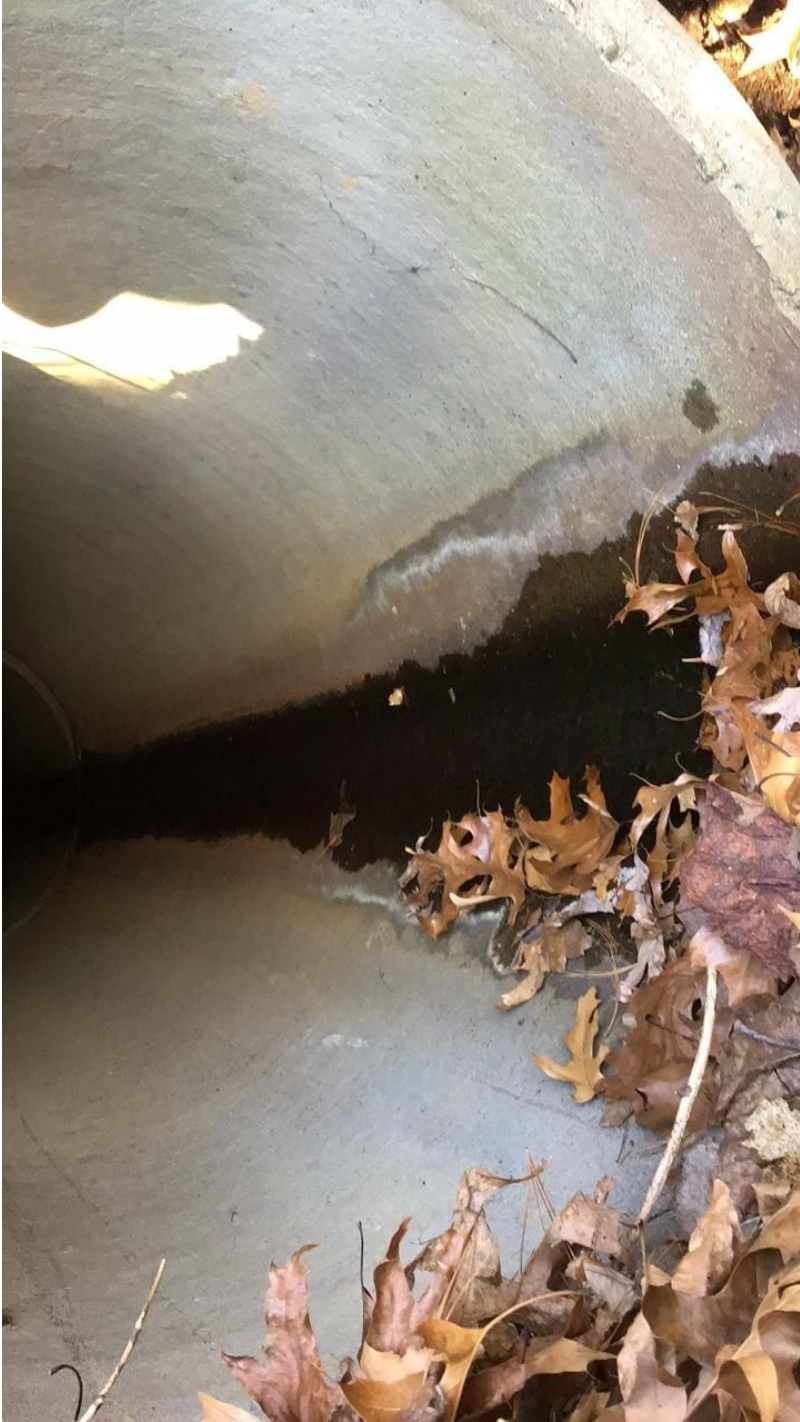
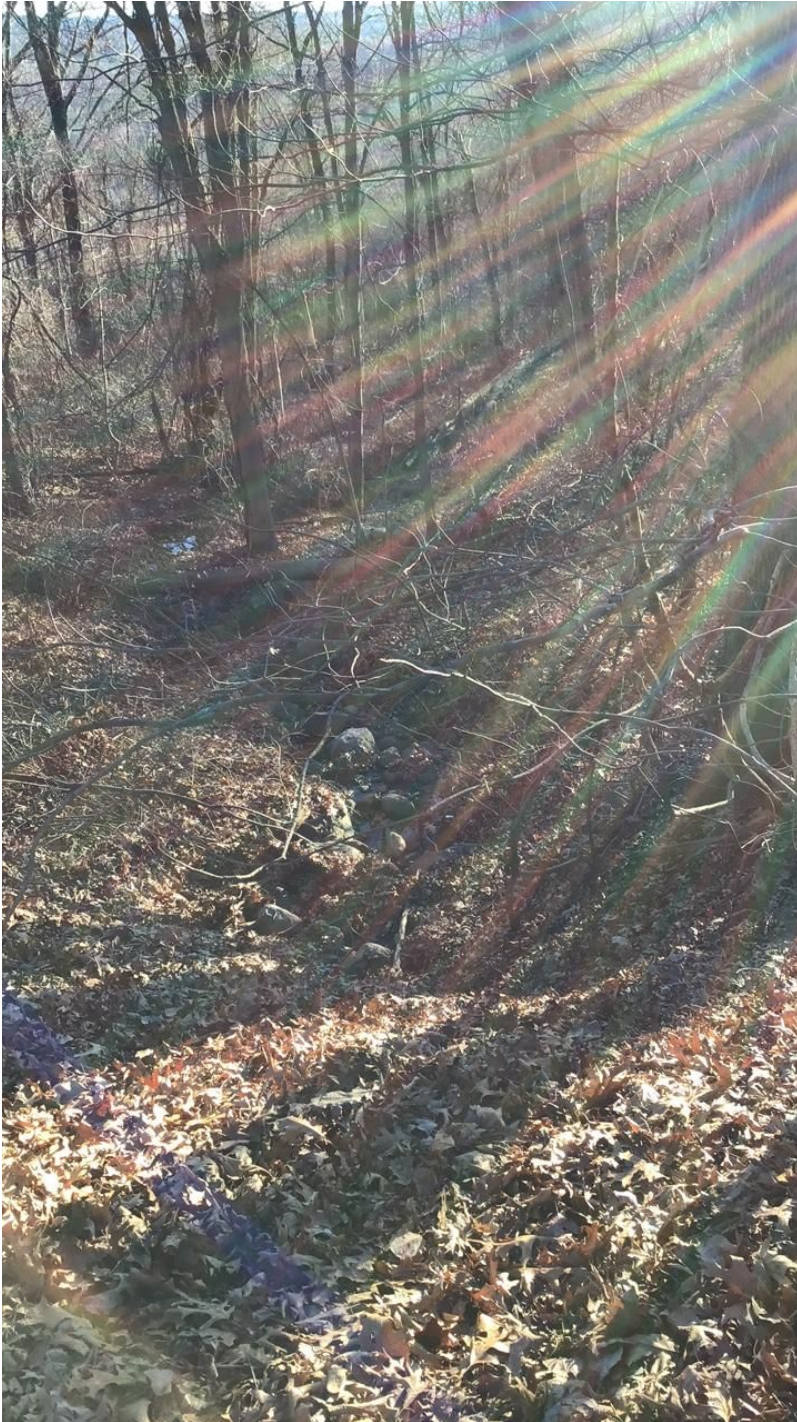
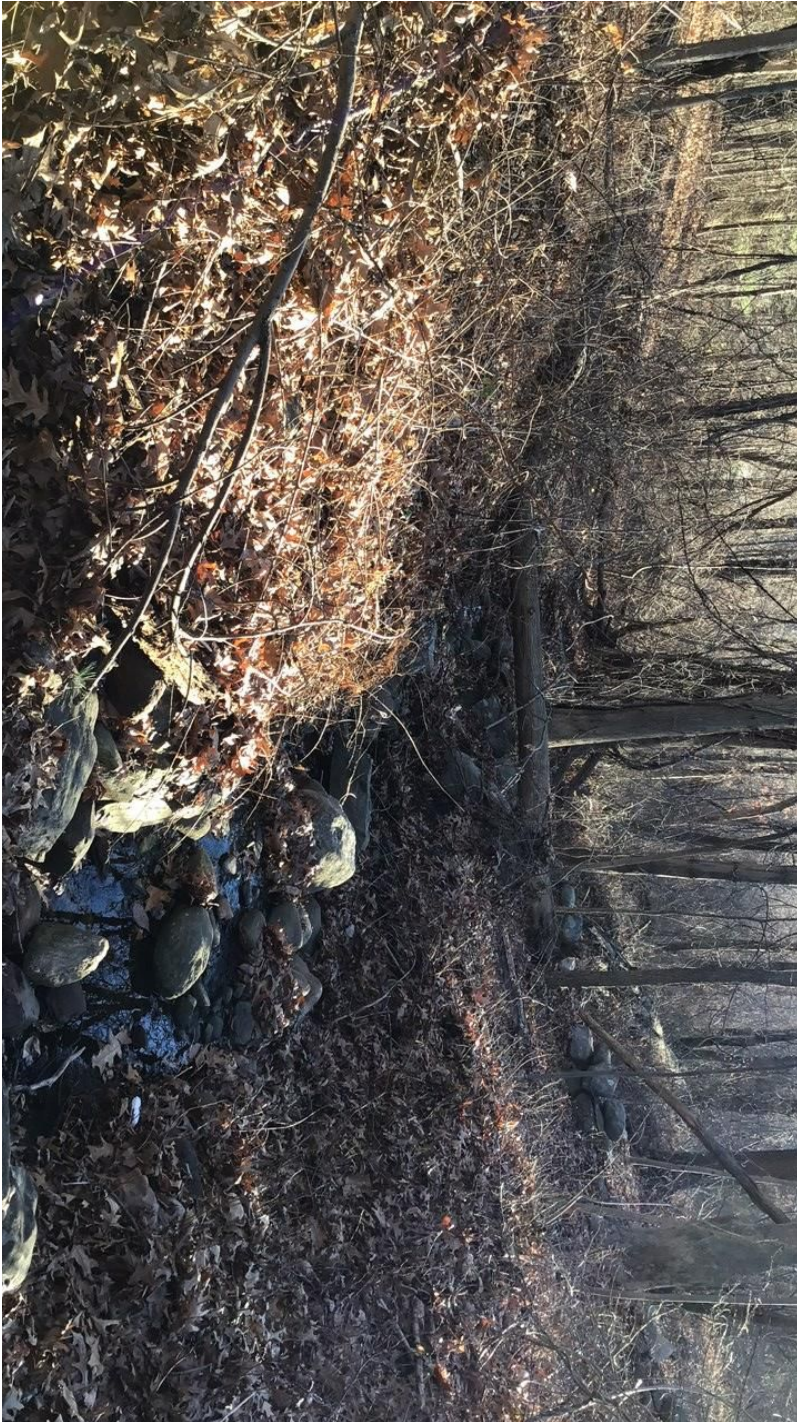
<b>Ownership</b>	Public
<b>Outfall Type</b>	Pipe End
<b>Other Outfall Type</b>	
<b>Material</b>	RCP
<b>Shape</b>	Circular
<b>Diameter/Dimension (in)</b>	32
<b>Condition</b>	Good
<b>Sediment</b>	Open/None
<b>Erosion/Scouring</b>	No
<b>BMP Visible</b>	Other
<b>Other BMP Type</b>	None

<b>Evidence of Pollution (select all that apply)</b>	None
<b>Odor</b>	None
<b>Flow Clarity</b>	Clear
<b>Flow Color</b>	Clear
<b>Flow Color Description</b>	
<b>Evidence of Staining</b>	Yes
<b>Evidence of Abnormal Vegetation</b>	No
<b>Outfall Damage, Deposits, Growth on Outfall, or Other Indicators of Illicit Discharge</b>	Yes
<b>If yes, please describe:</b>	White staining observed on pipe invert.
<b>Potential Sources/Actions Taken</b>	
<b>Needs follow up?</b>	Yes
<b>Reason for follow up:</b>	Return for sampling due to flow.
<b>General Comments</b>	Outfall had small trickle during first site visit and steady flow during second site visit. White staining observed on pipe invert. Return for sampling due to flow.

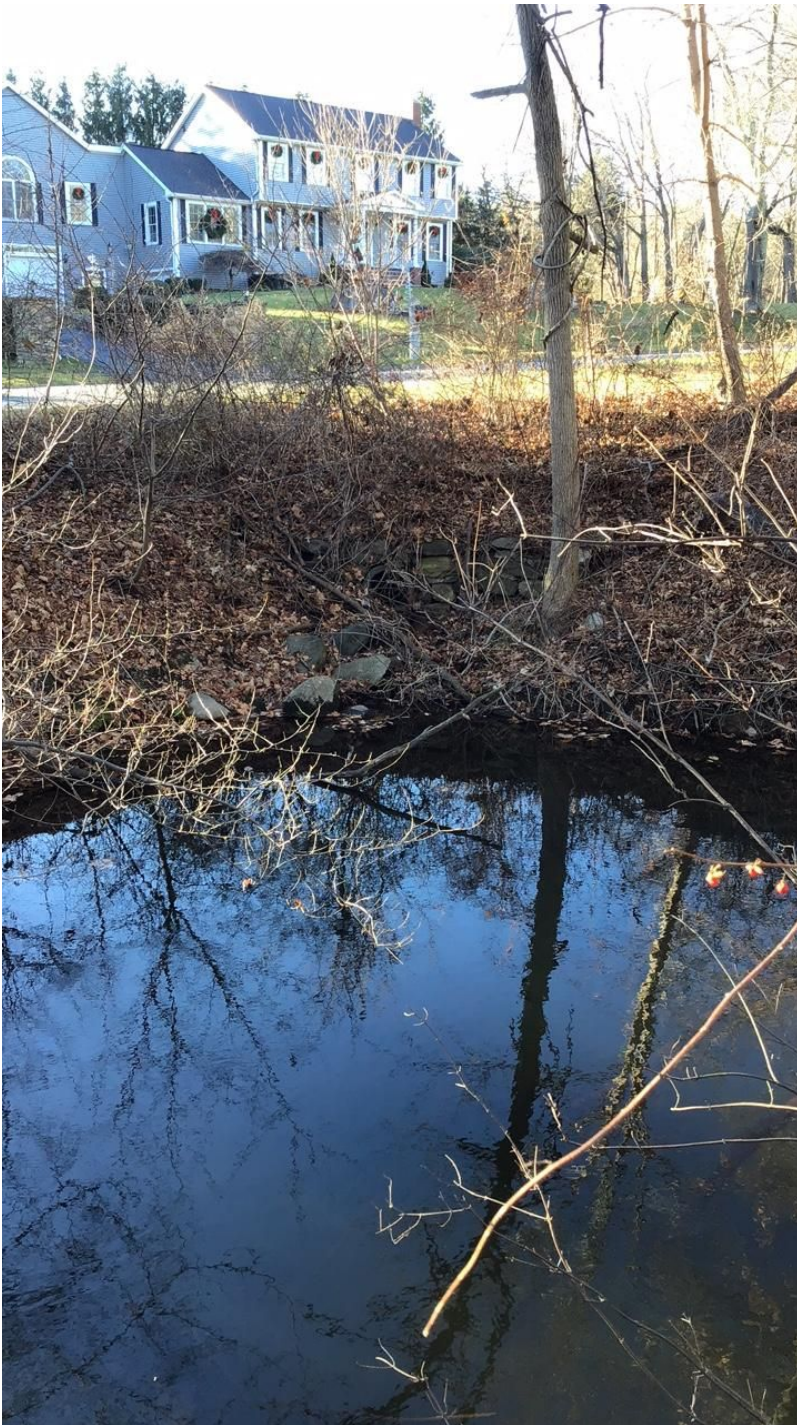
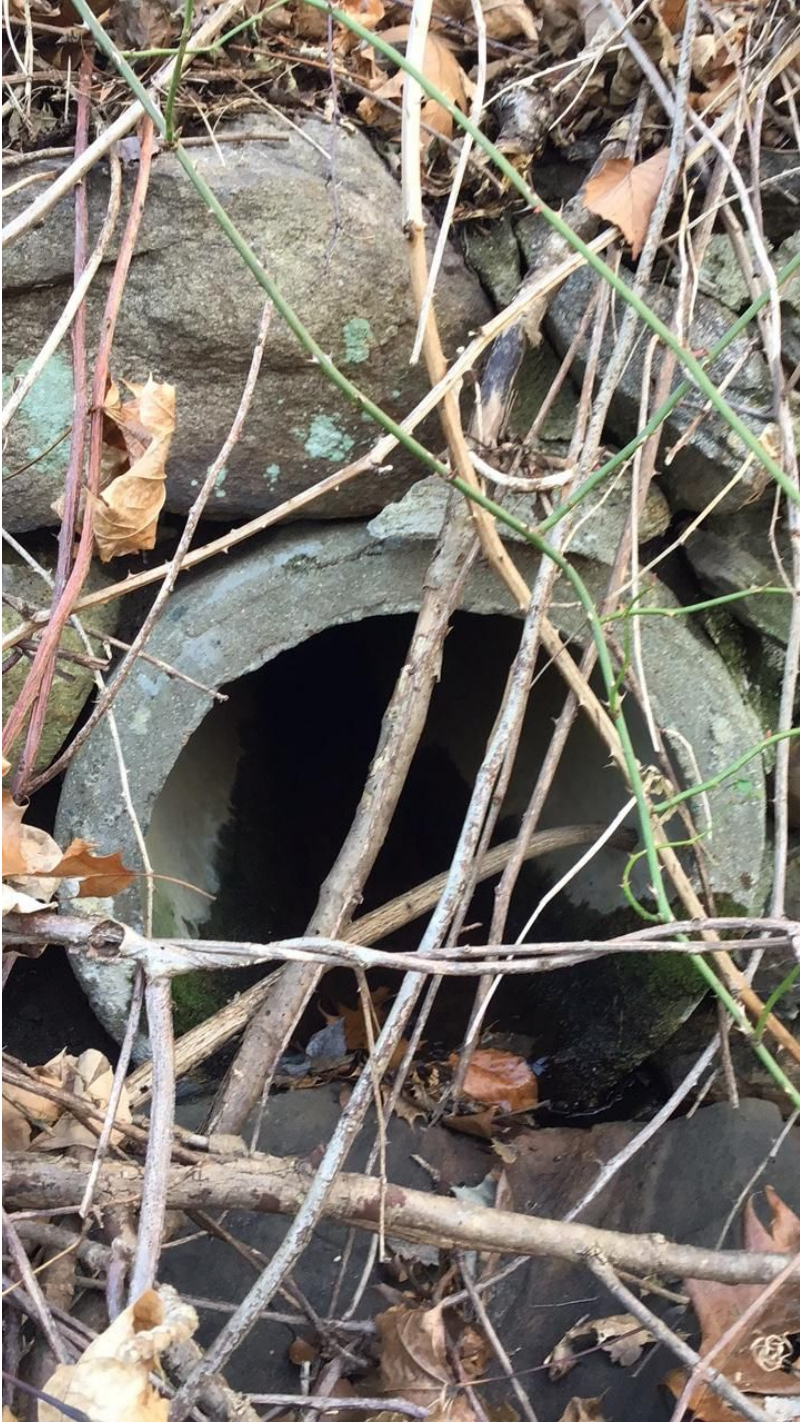
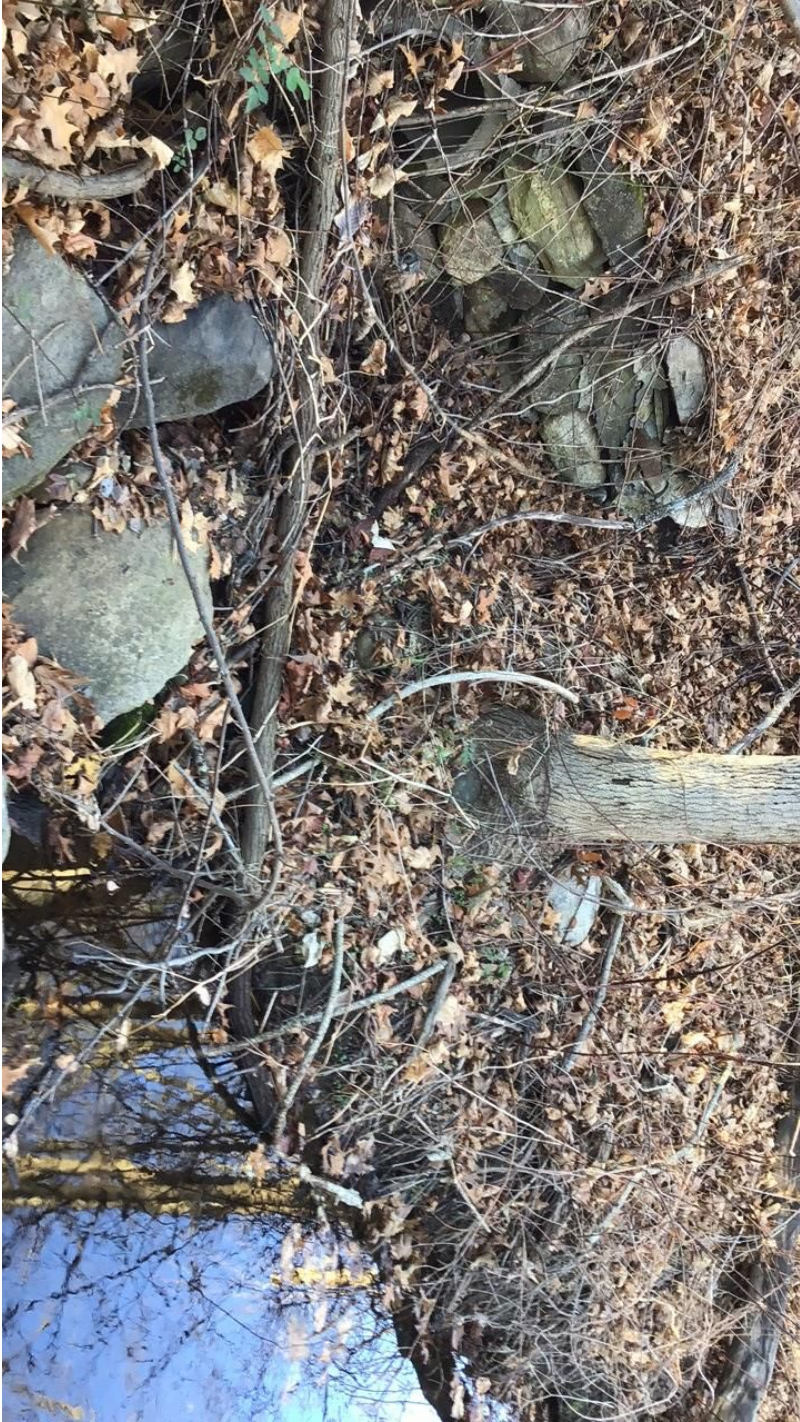
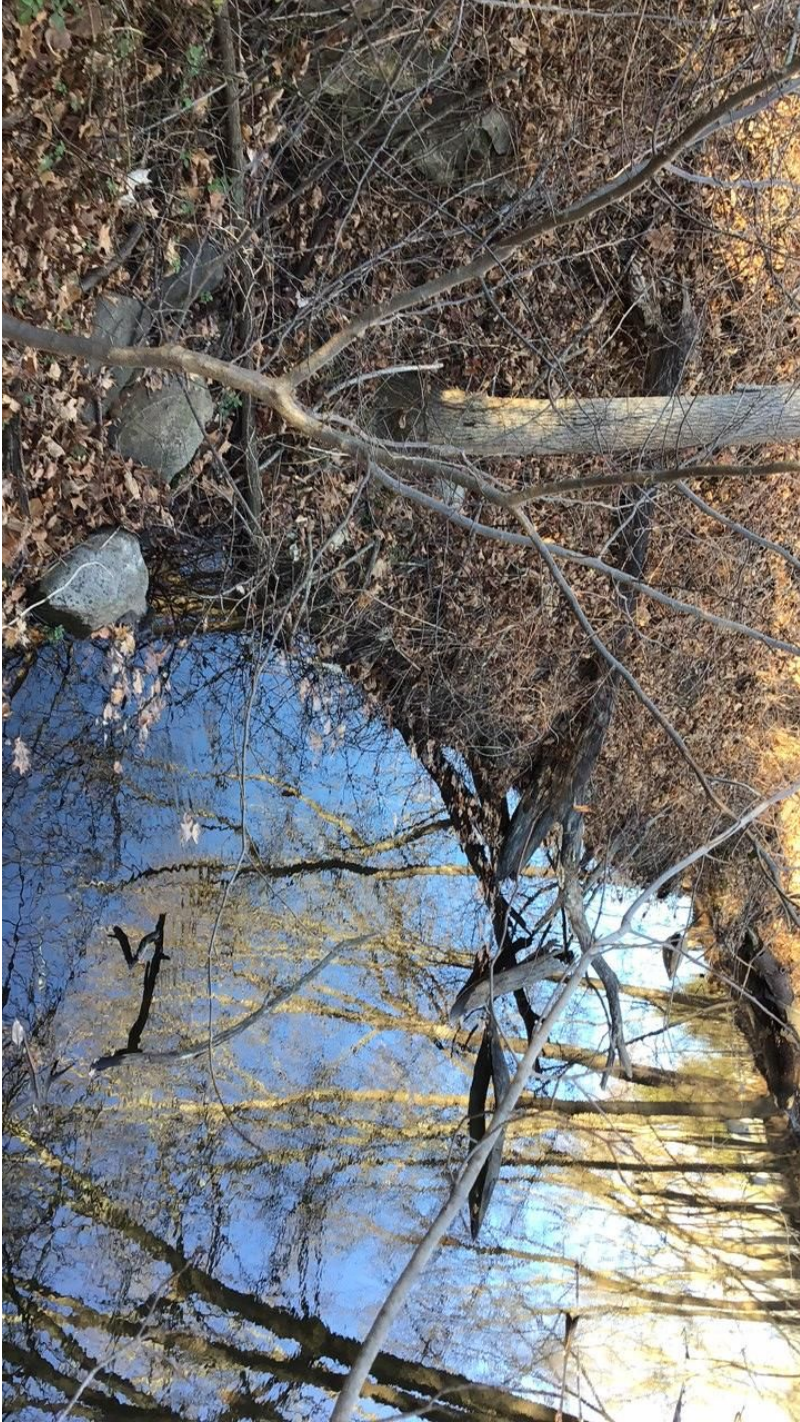
<b>Ownership</b>	Public
<b>Outfall Type</b>	Pipe End
<b>Other Outfall Type</b>	
<b>Material</b>	RCP
<b>Shape</b>	Circular
<b>Diameter/Dimension (in)</b>	15
<b>Condition</b>	Good
<b>Sediment</b>	Open/None
<b>Erosion/Scouring</b>	No
<b>BMP Visible</b>	Other
<b>Other BMP Type</b>	None

<b>Evidence of Pollution (select all that apply)</b>	None
<b>Odor</b>	None
<b>Flow Clarity</b>	Clear
<b>Flow Color</b>	Clear
<b>Flow Color Description</b>	
<b>Evidence of Staining</b>	No
<b>Evidence of Abnormal Vegetation</b>	No
<b>Outfall Damage, Deposits, Growth on Outfall, or Other Indicators of Illicit Discharge</b>	Yes
<b>If yes, please describe:</b>	Moss growth on pipe invert.
<b>Potential Sources/Actions Taken</b>	
<b>Needs follow up?</b>	Yes
<b>Reason for follow up:</b>	Return for sampling due to flow.
<b>General Comments</b>	Outfall had small trickle during first and second site visit. No evidence of illicit discharge. Return for sampling due to flow.

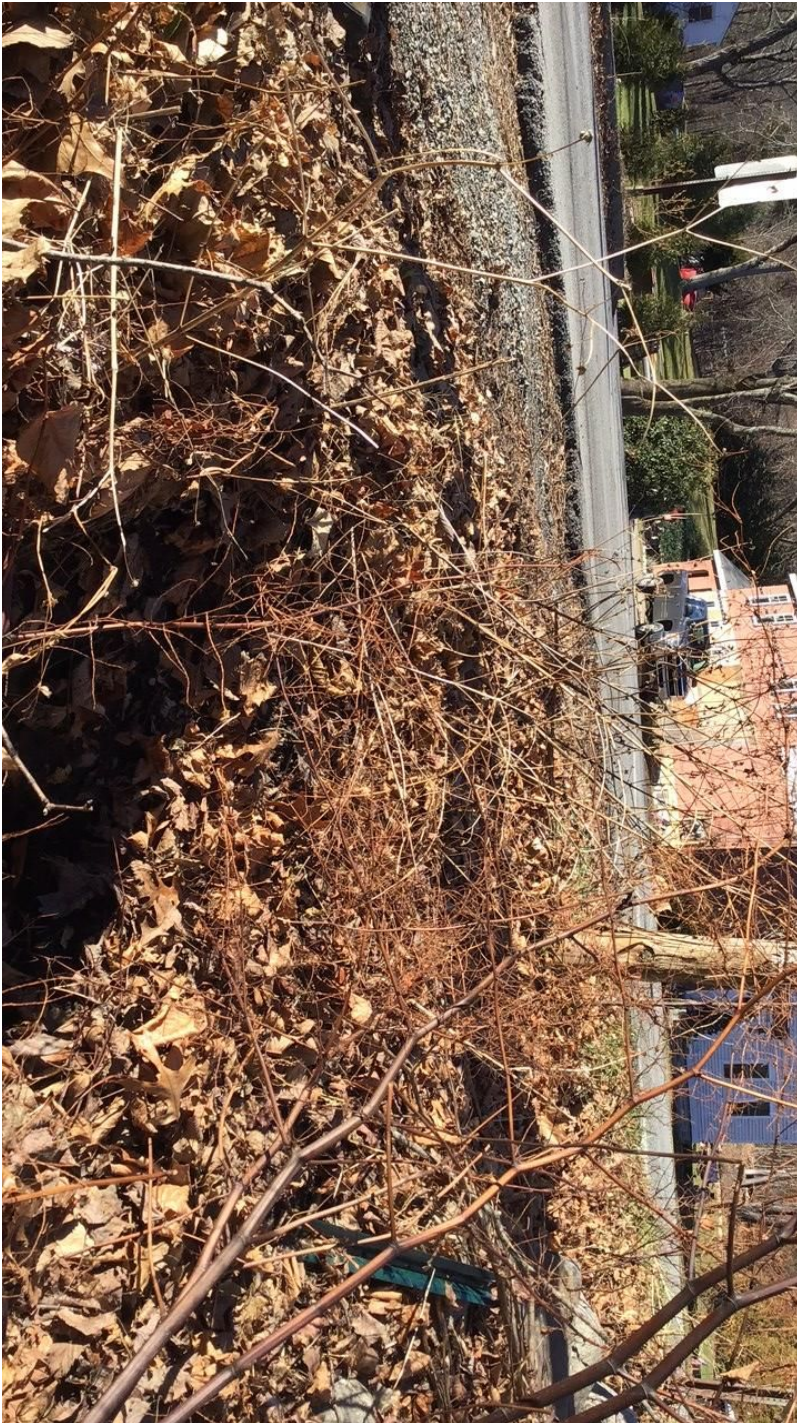
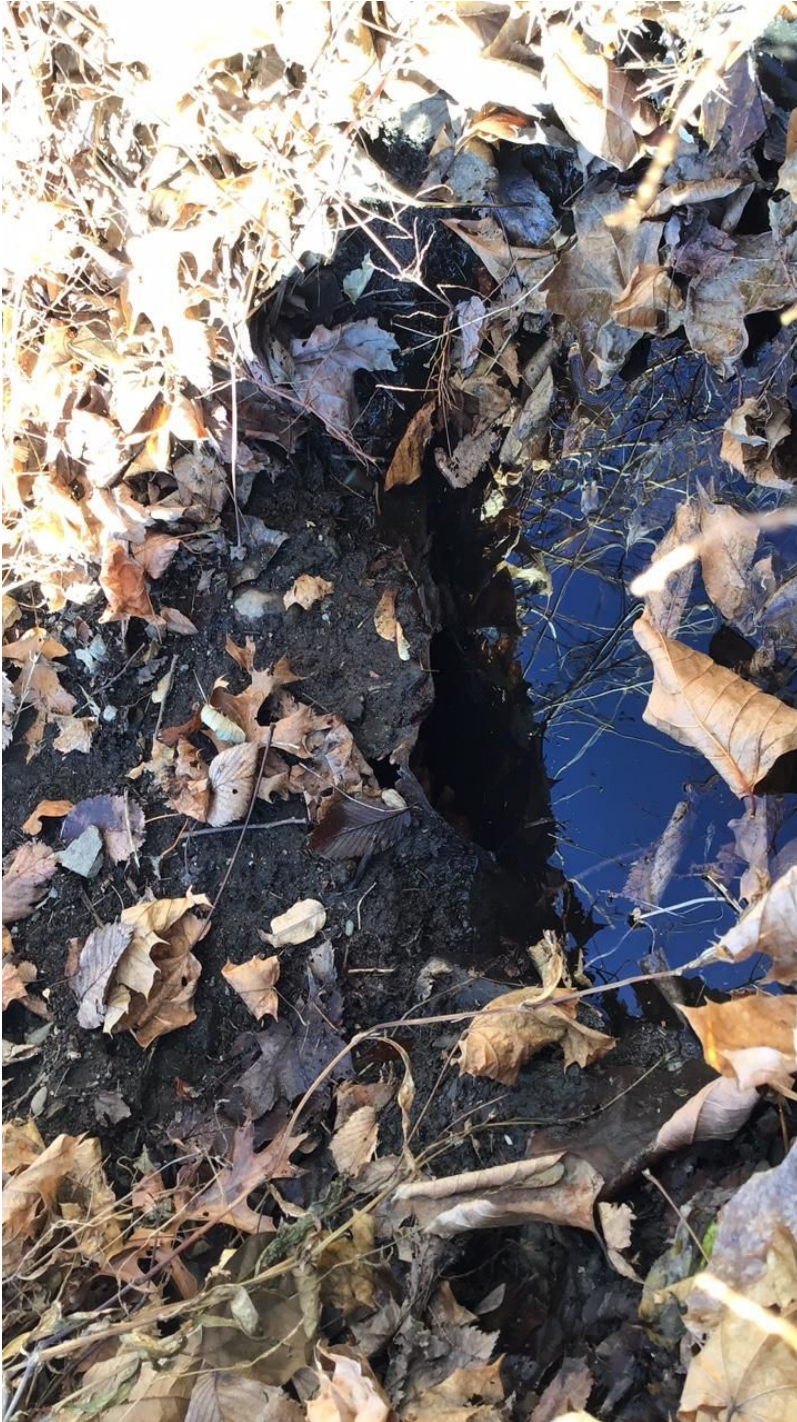
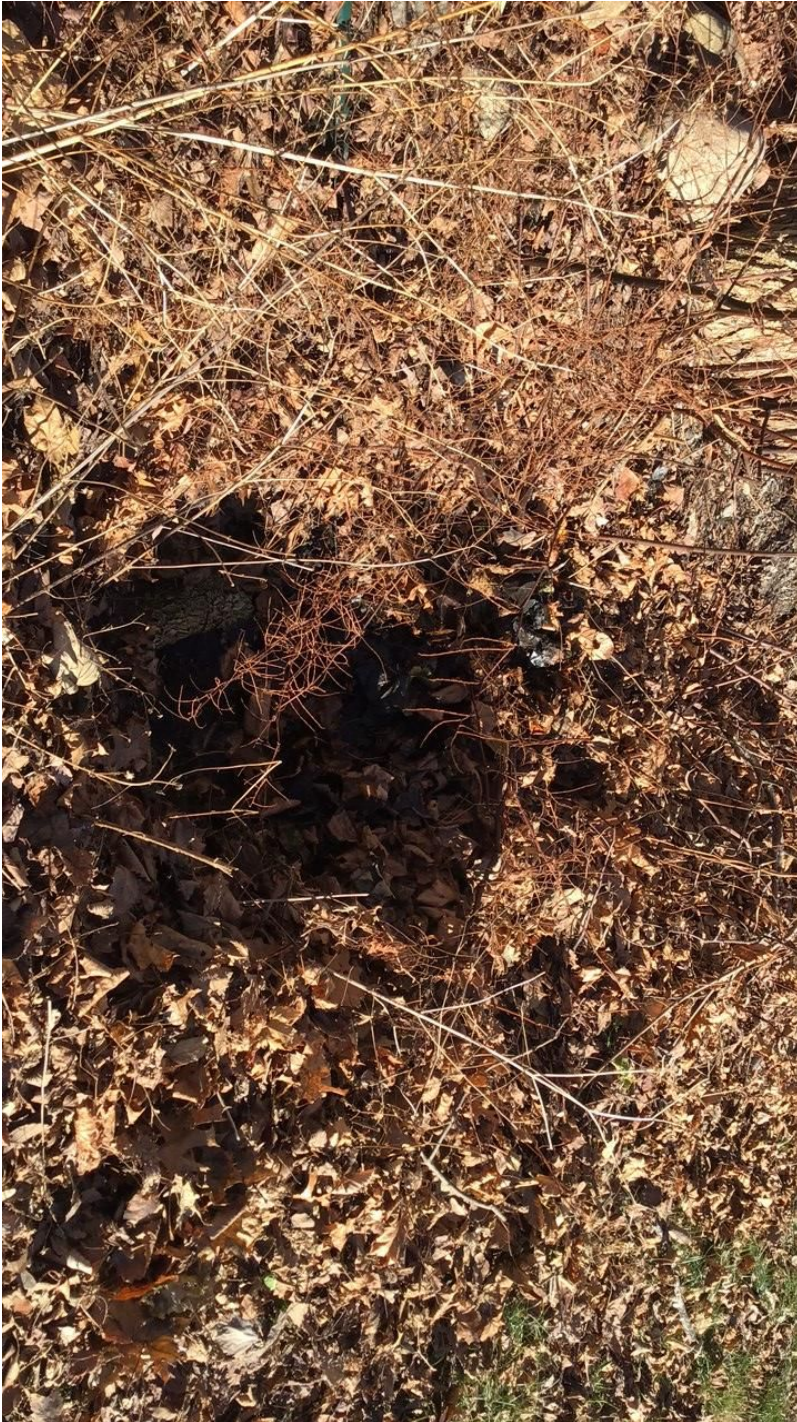
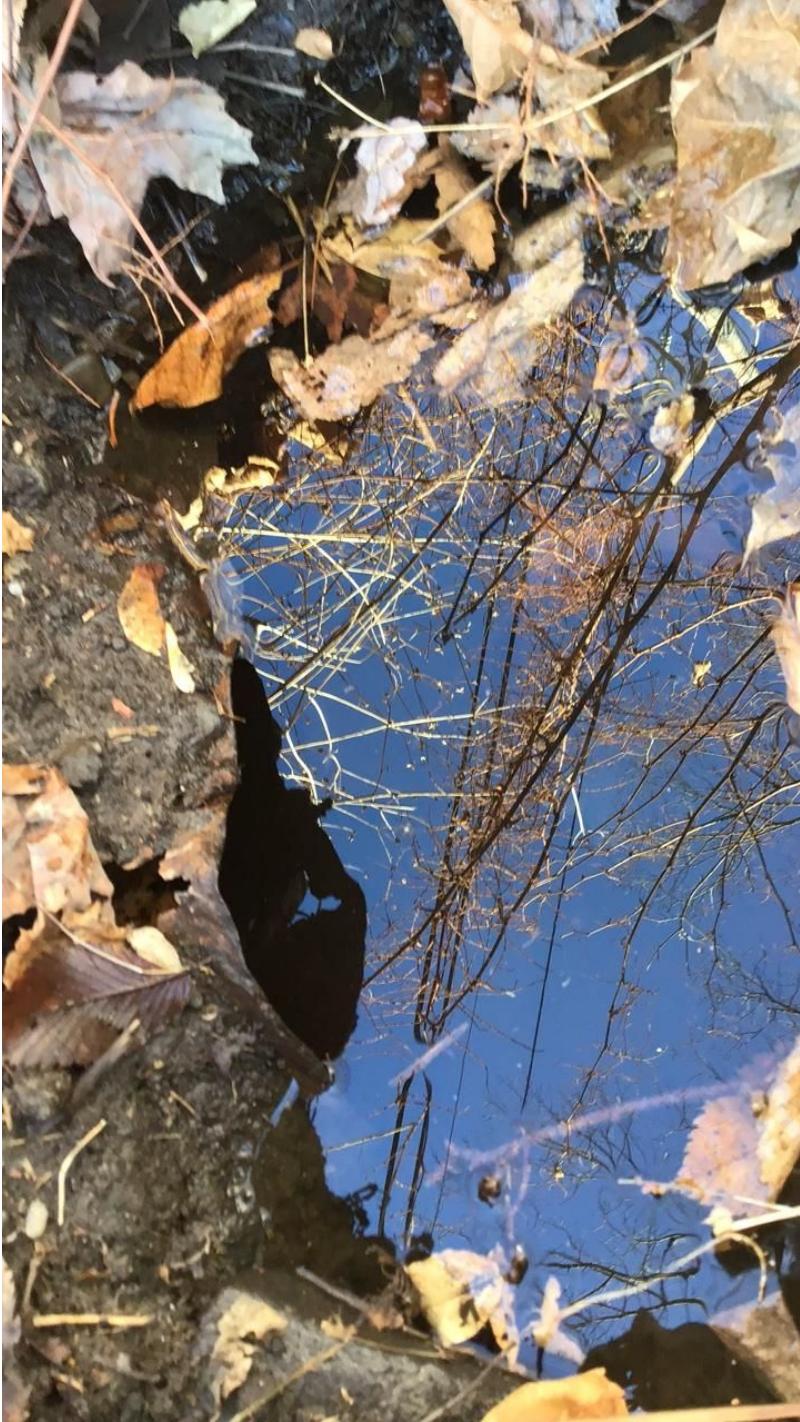
<b>Ownership</b>	Public
<b>Outfall Type</b>	Pipe End
<b>Other Outfall Type</b>	
<b>Material</b>	CMP
<b>Shape</b>	Circular
<b>Diameter/Dimension (in)</b>	10
<b>Condition</b>	Poor
<b>Sediment</b>	1/4
<b>Erosion/Scouring</b>	No
<b>BMP Visible</b>	Other
<b>Other BMP Type</b>	None

<b>Evidence of Pollution (select all that apply)</b>	None
<b>Odor</b>	None
<b>Flow Clarity</b>	N/A (not flowing)
<b>Flow Color</b>	N/A (not flowing)
<b>Flow Color Description</b>	
<b>Evidence of Staining</b>	No
<b>Evidence of Abnormal Vegetation</b>	No
<b>Outfall Damage, Deposits, Growth on Outfall, or Other Indicators of Illicit Discharge</b>	Yes
<b>If yes, please describe:</b>	Corroded metal pipe, compressed, clogged outflow area from natural debris, chipped pipe rim from corrosion.
<b>Potential Sources/Actions Taken</b>	
<b>Needs follow up?</b>	No
<b>Reason for follow up:</b>	
<b>General Comments</b>	Outfall partially submerged, pipe in poor condition.
