FIVE OPTIONS

Stow Town Hall Renovation
375 Great Road / Stow MA

MILLS WHITAKER ARCHITECTS LLC

01 August 2022

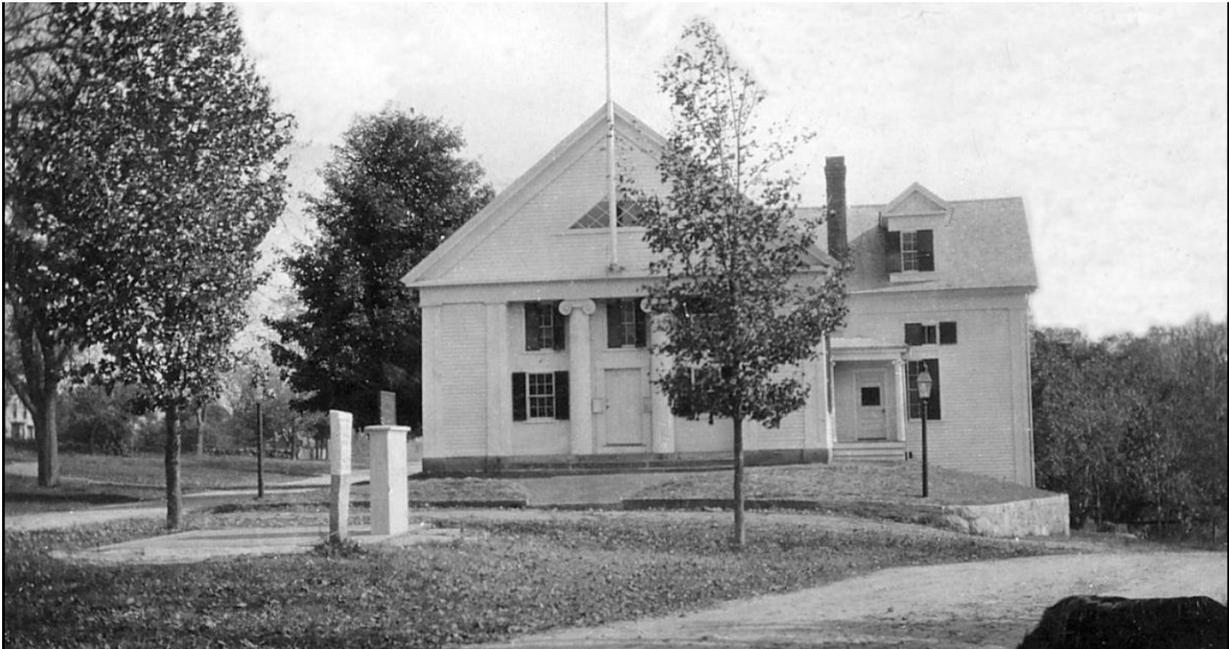
Photo of 1848 Building with 1895 Addition to Right; Fairbanks Hay Scale in Foreground at Left

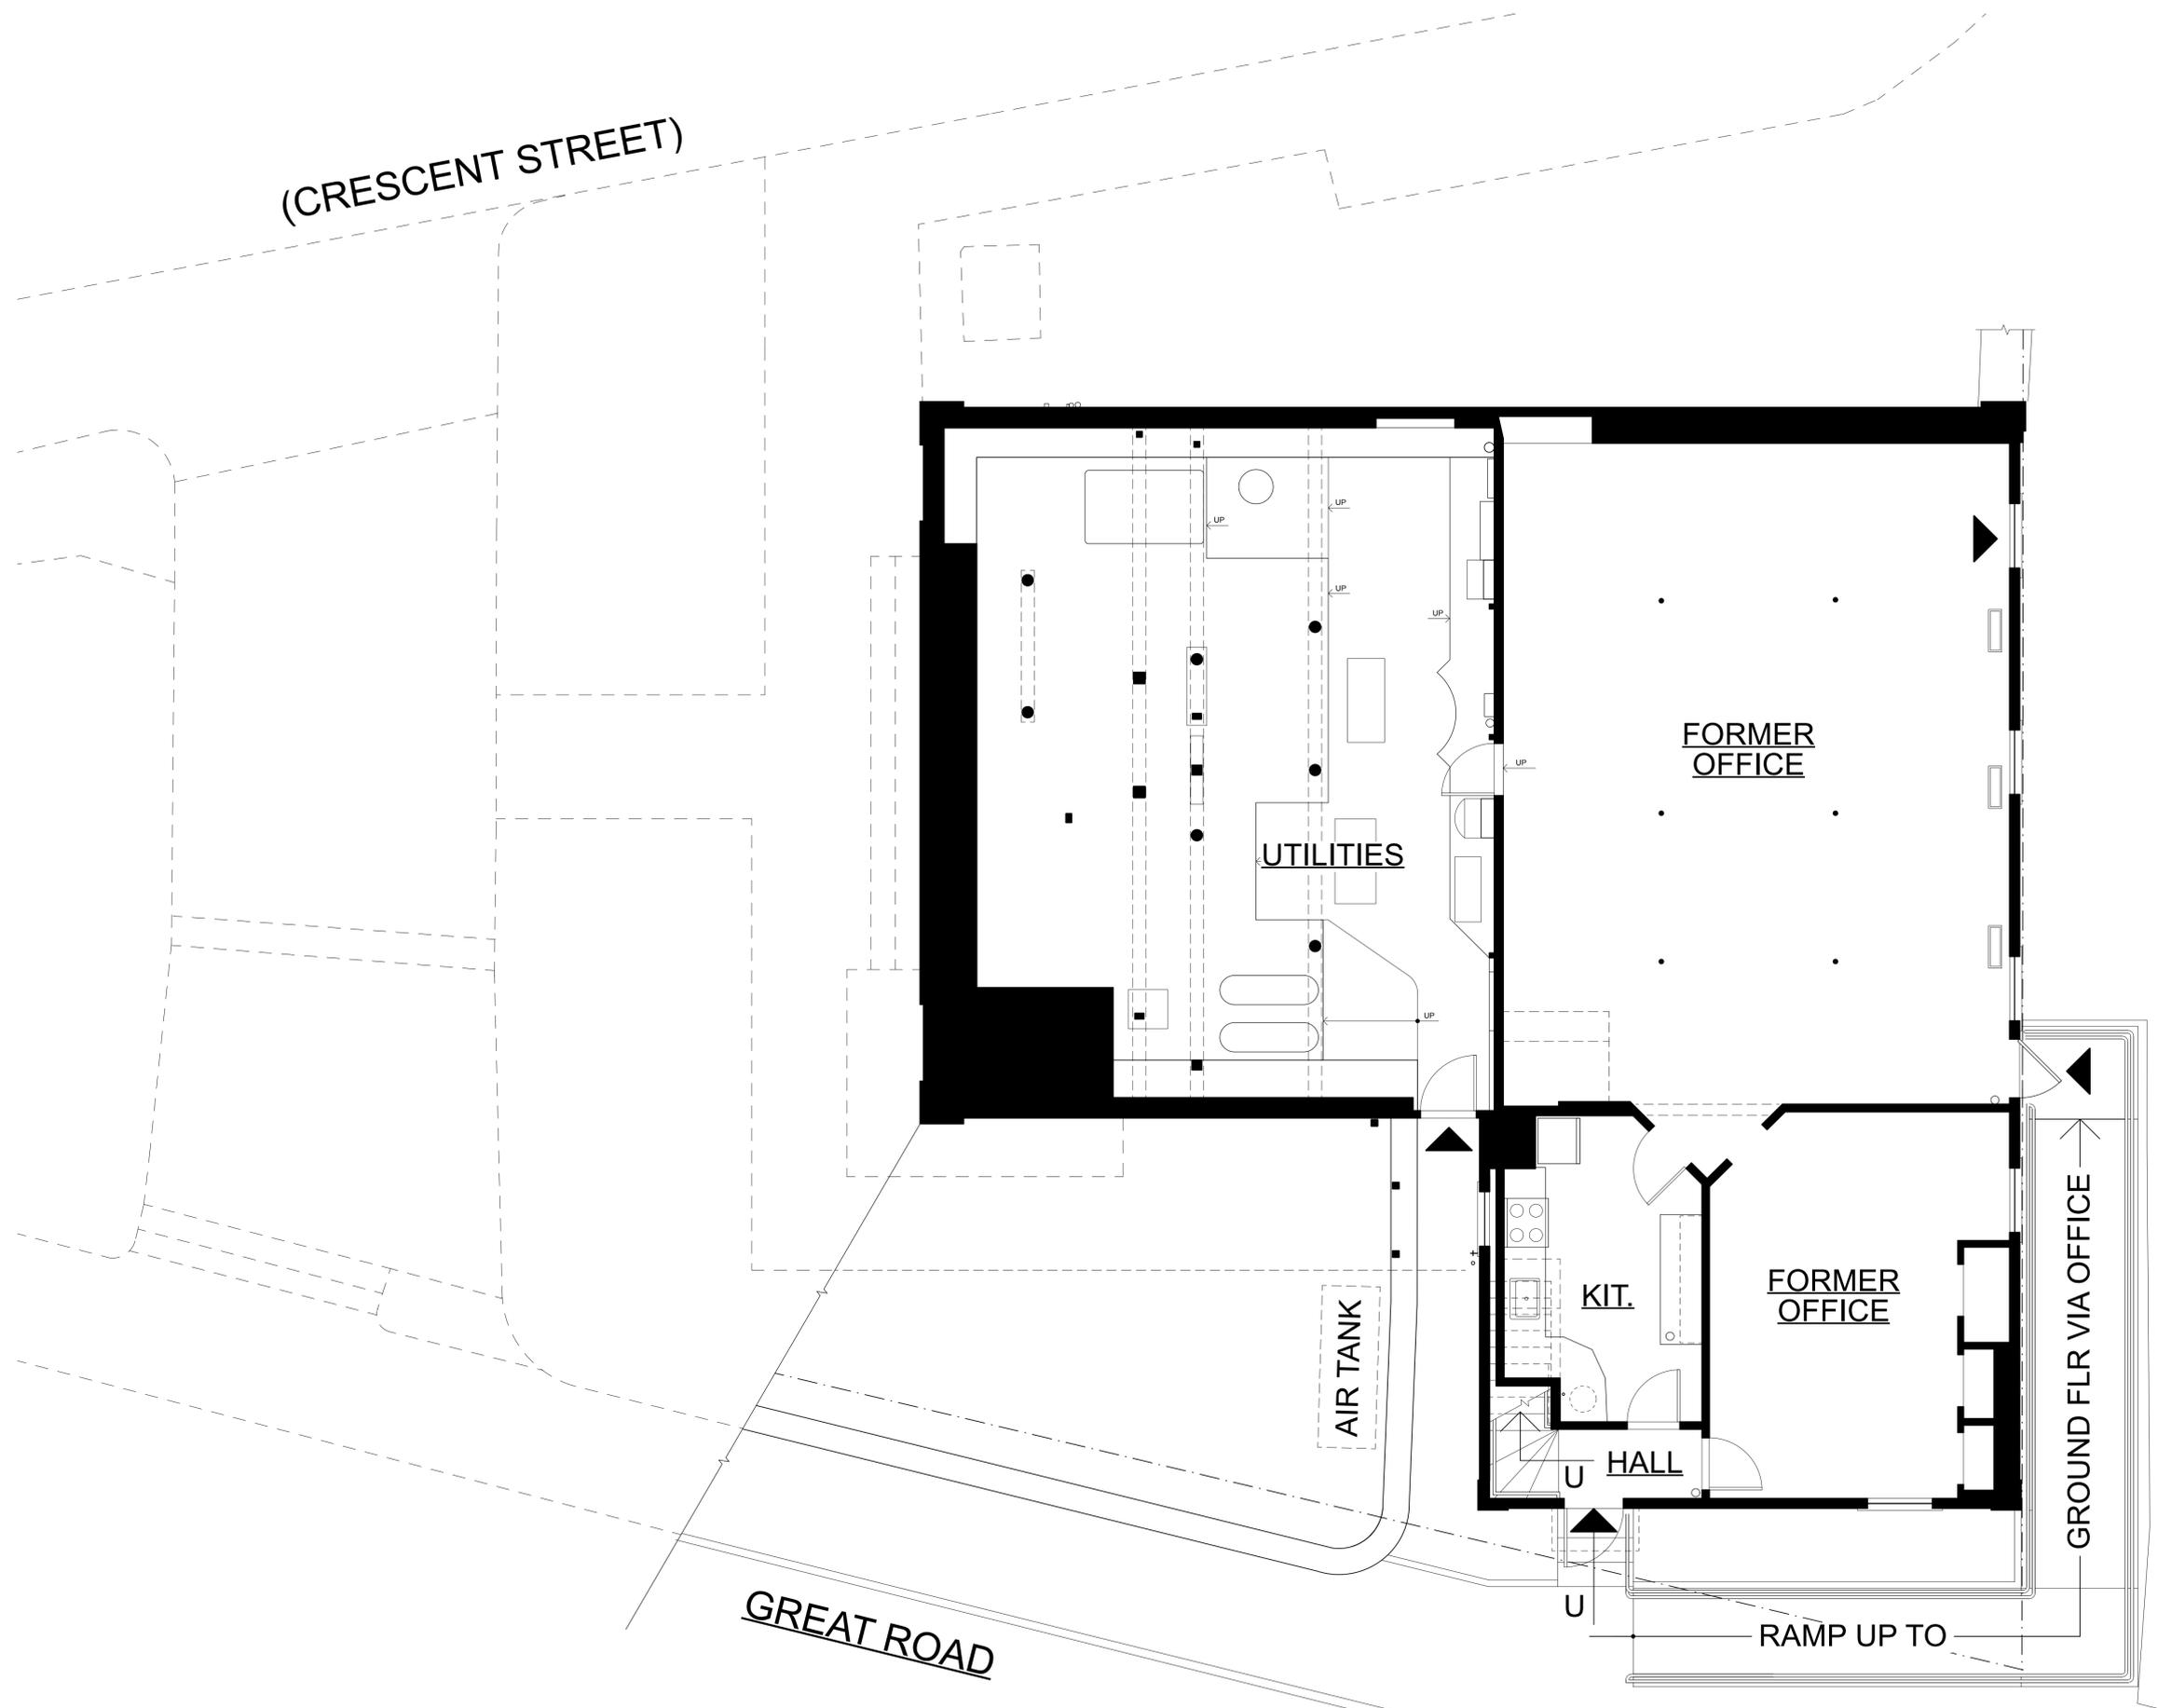
OPTION ONE: GROUND FLOOR PLAN

Refer to the floor plans and building sections of Option One, which illustrate the existing facility.

The existing mechanical and electrical systems will not be upgraded. The current oil-fired hot air furnace heating system will remain, and no air conditioning will be provided. The existing 100-amp single-phase electrical service will not be upgraded. It is assumed that the work will be classified as “ordinary repairs” and will therefore not require issuance of building permits.

The ground floor kitchen will remain inoperable due to its existing conditions, and the ground floor will remain unoccupied. An interim dehumidification system is recommended for the lower level to control moisture accumulation and reduce mold growth. The fire escape stair will be inspected, repairs will be made, and this egress will be certified for life safety since that is required by law every five years. The fire escape door will be repaired so that it can be safely opened from the interior as an emergency exit.

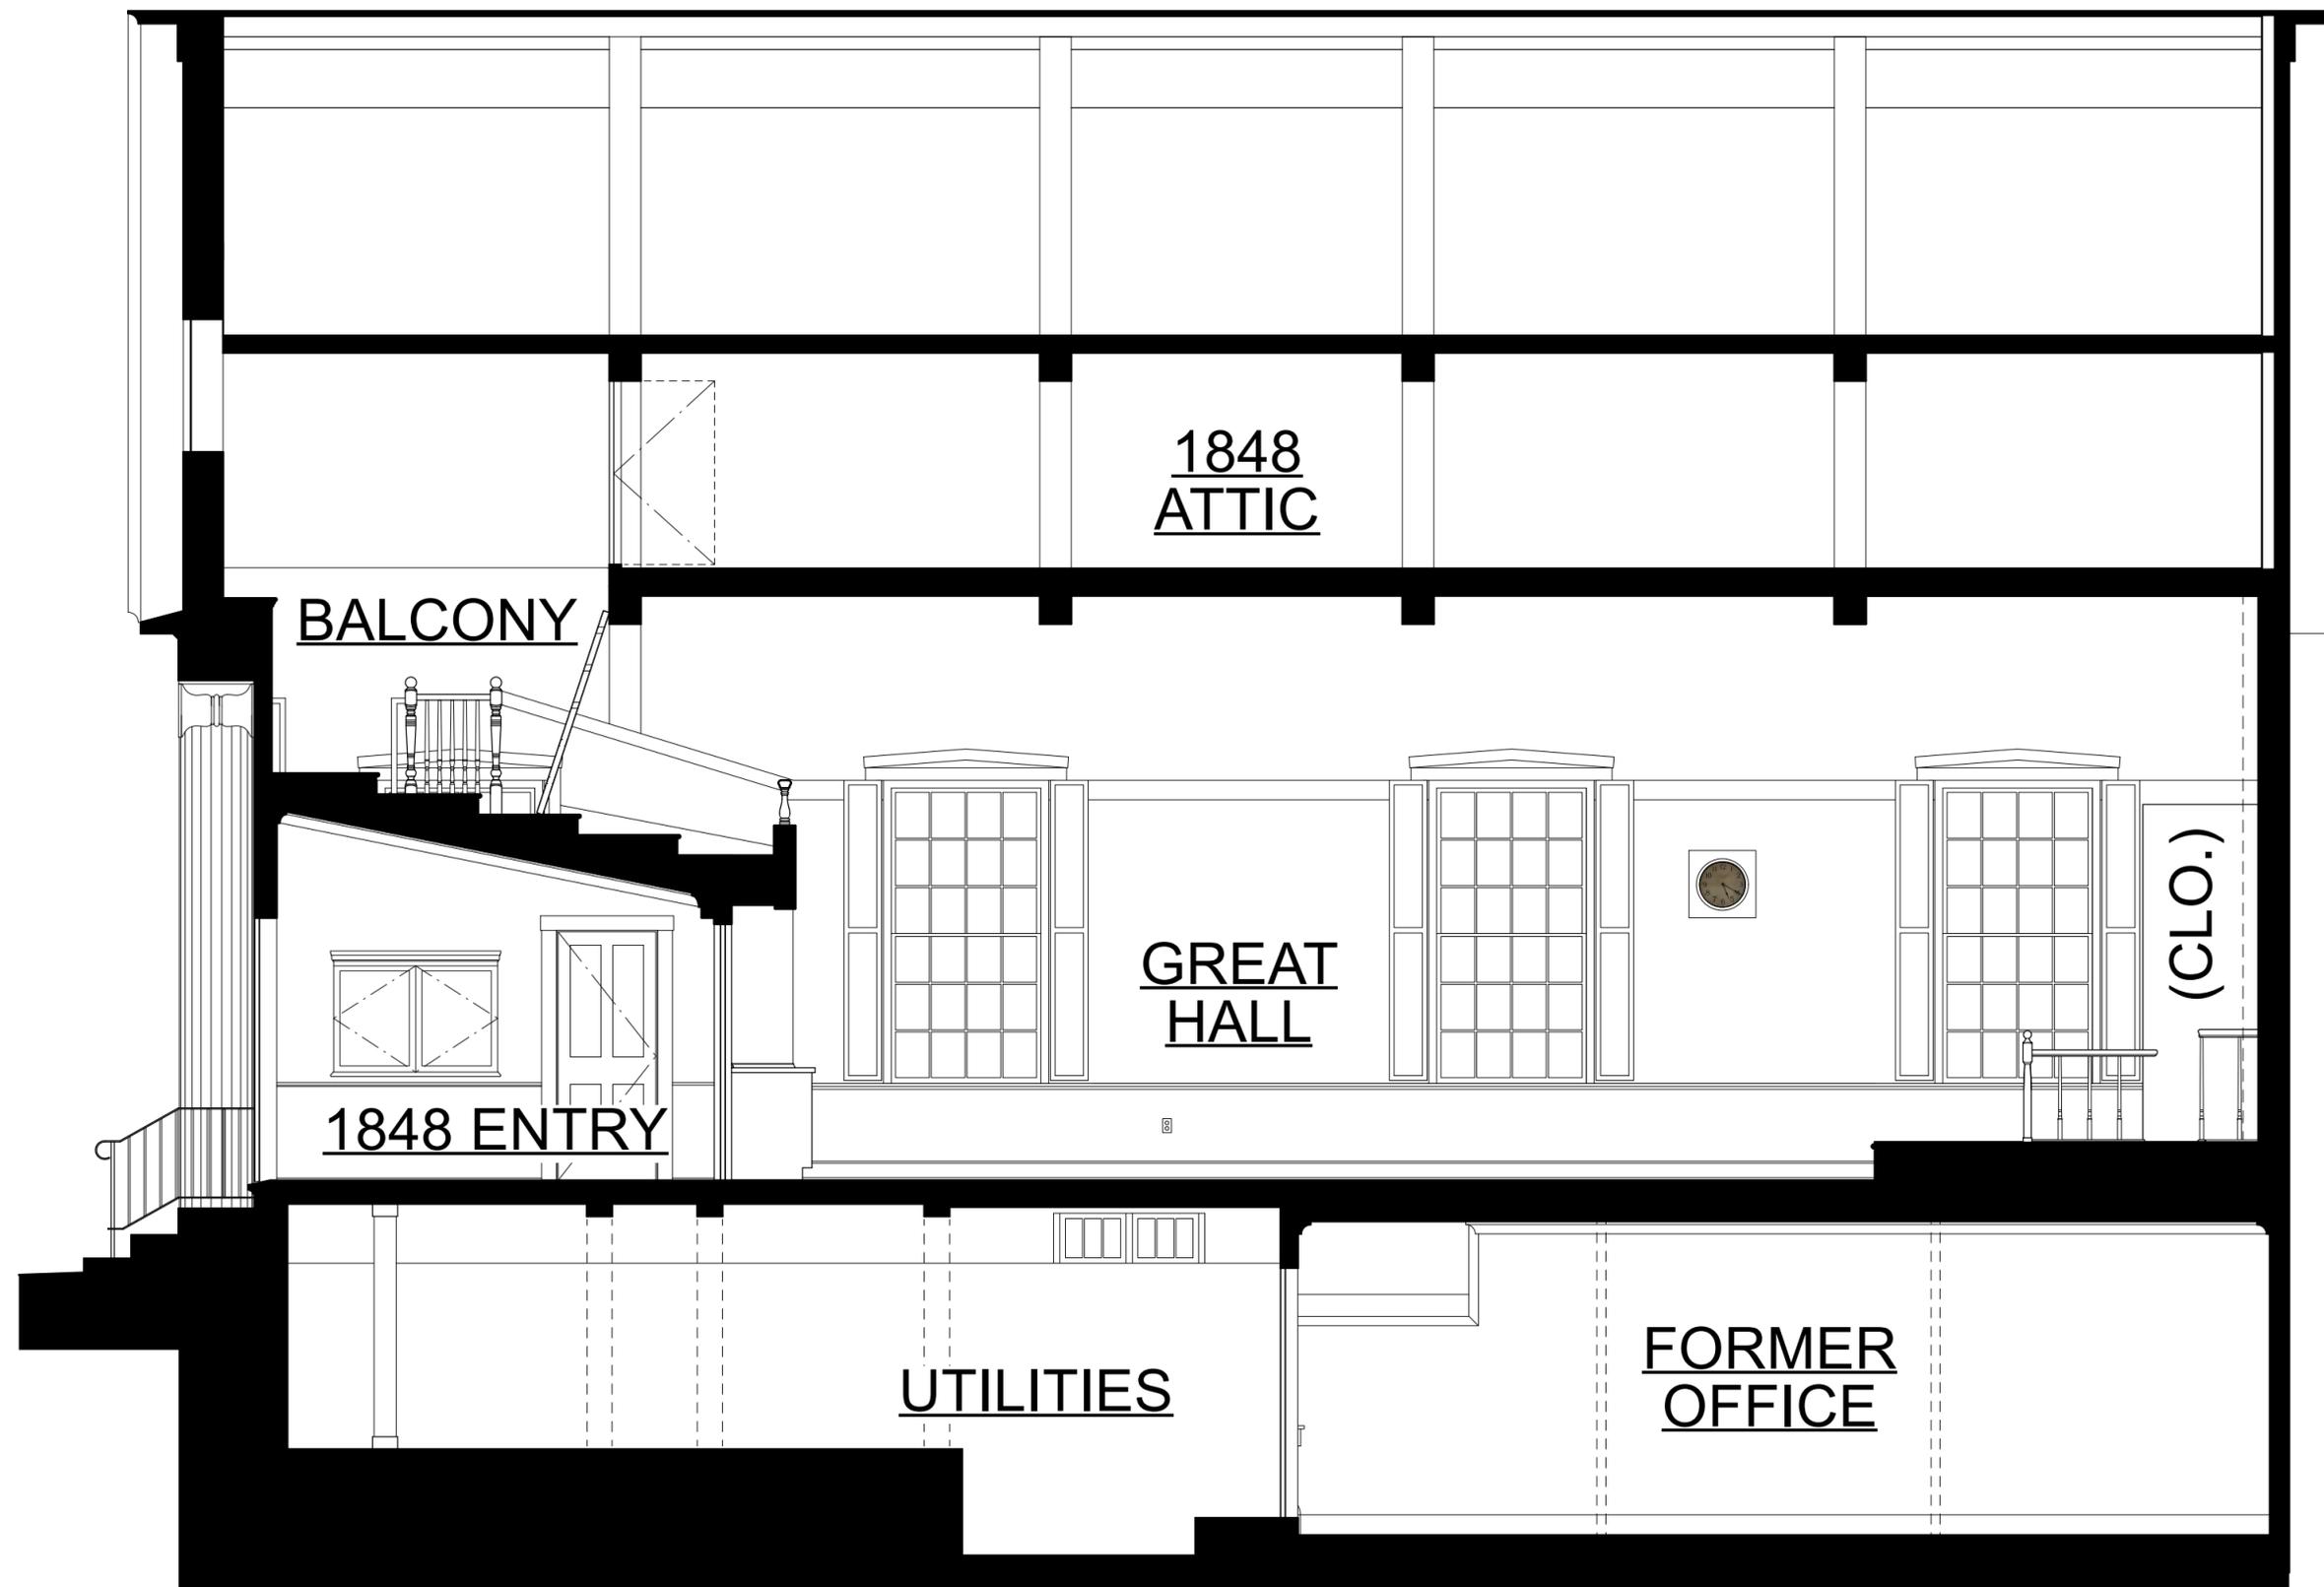
OPTION ONE: LONGITUDINAL SECTION LOOKING NORTH

NO RENOVATION WORK - ROUTINE MAINTENANCE ONLY

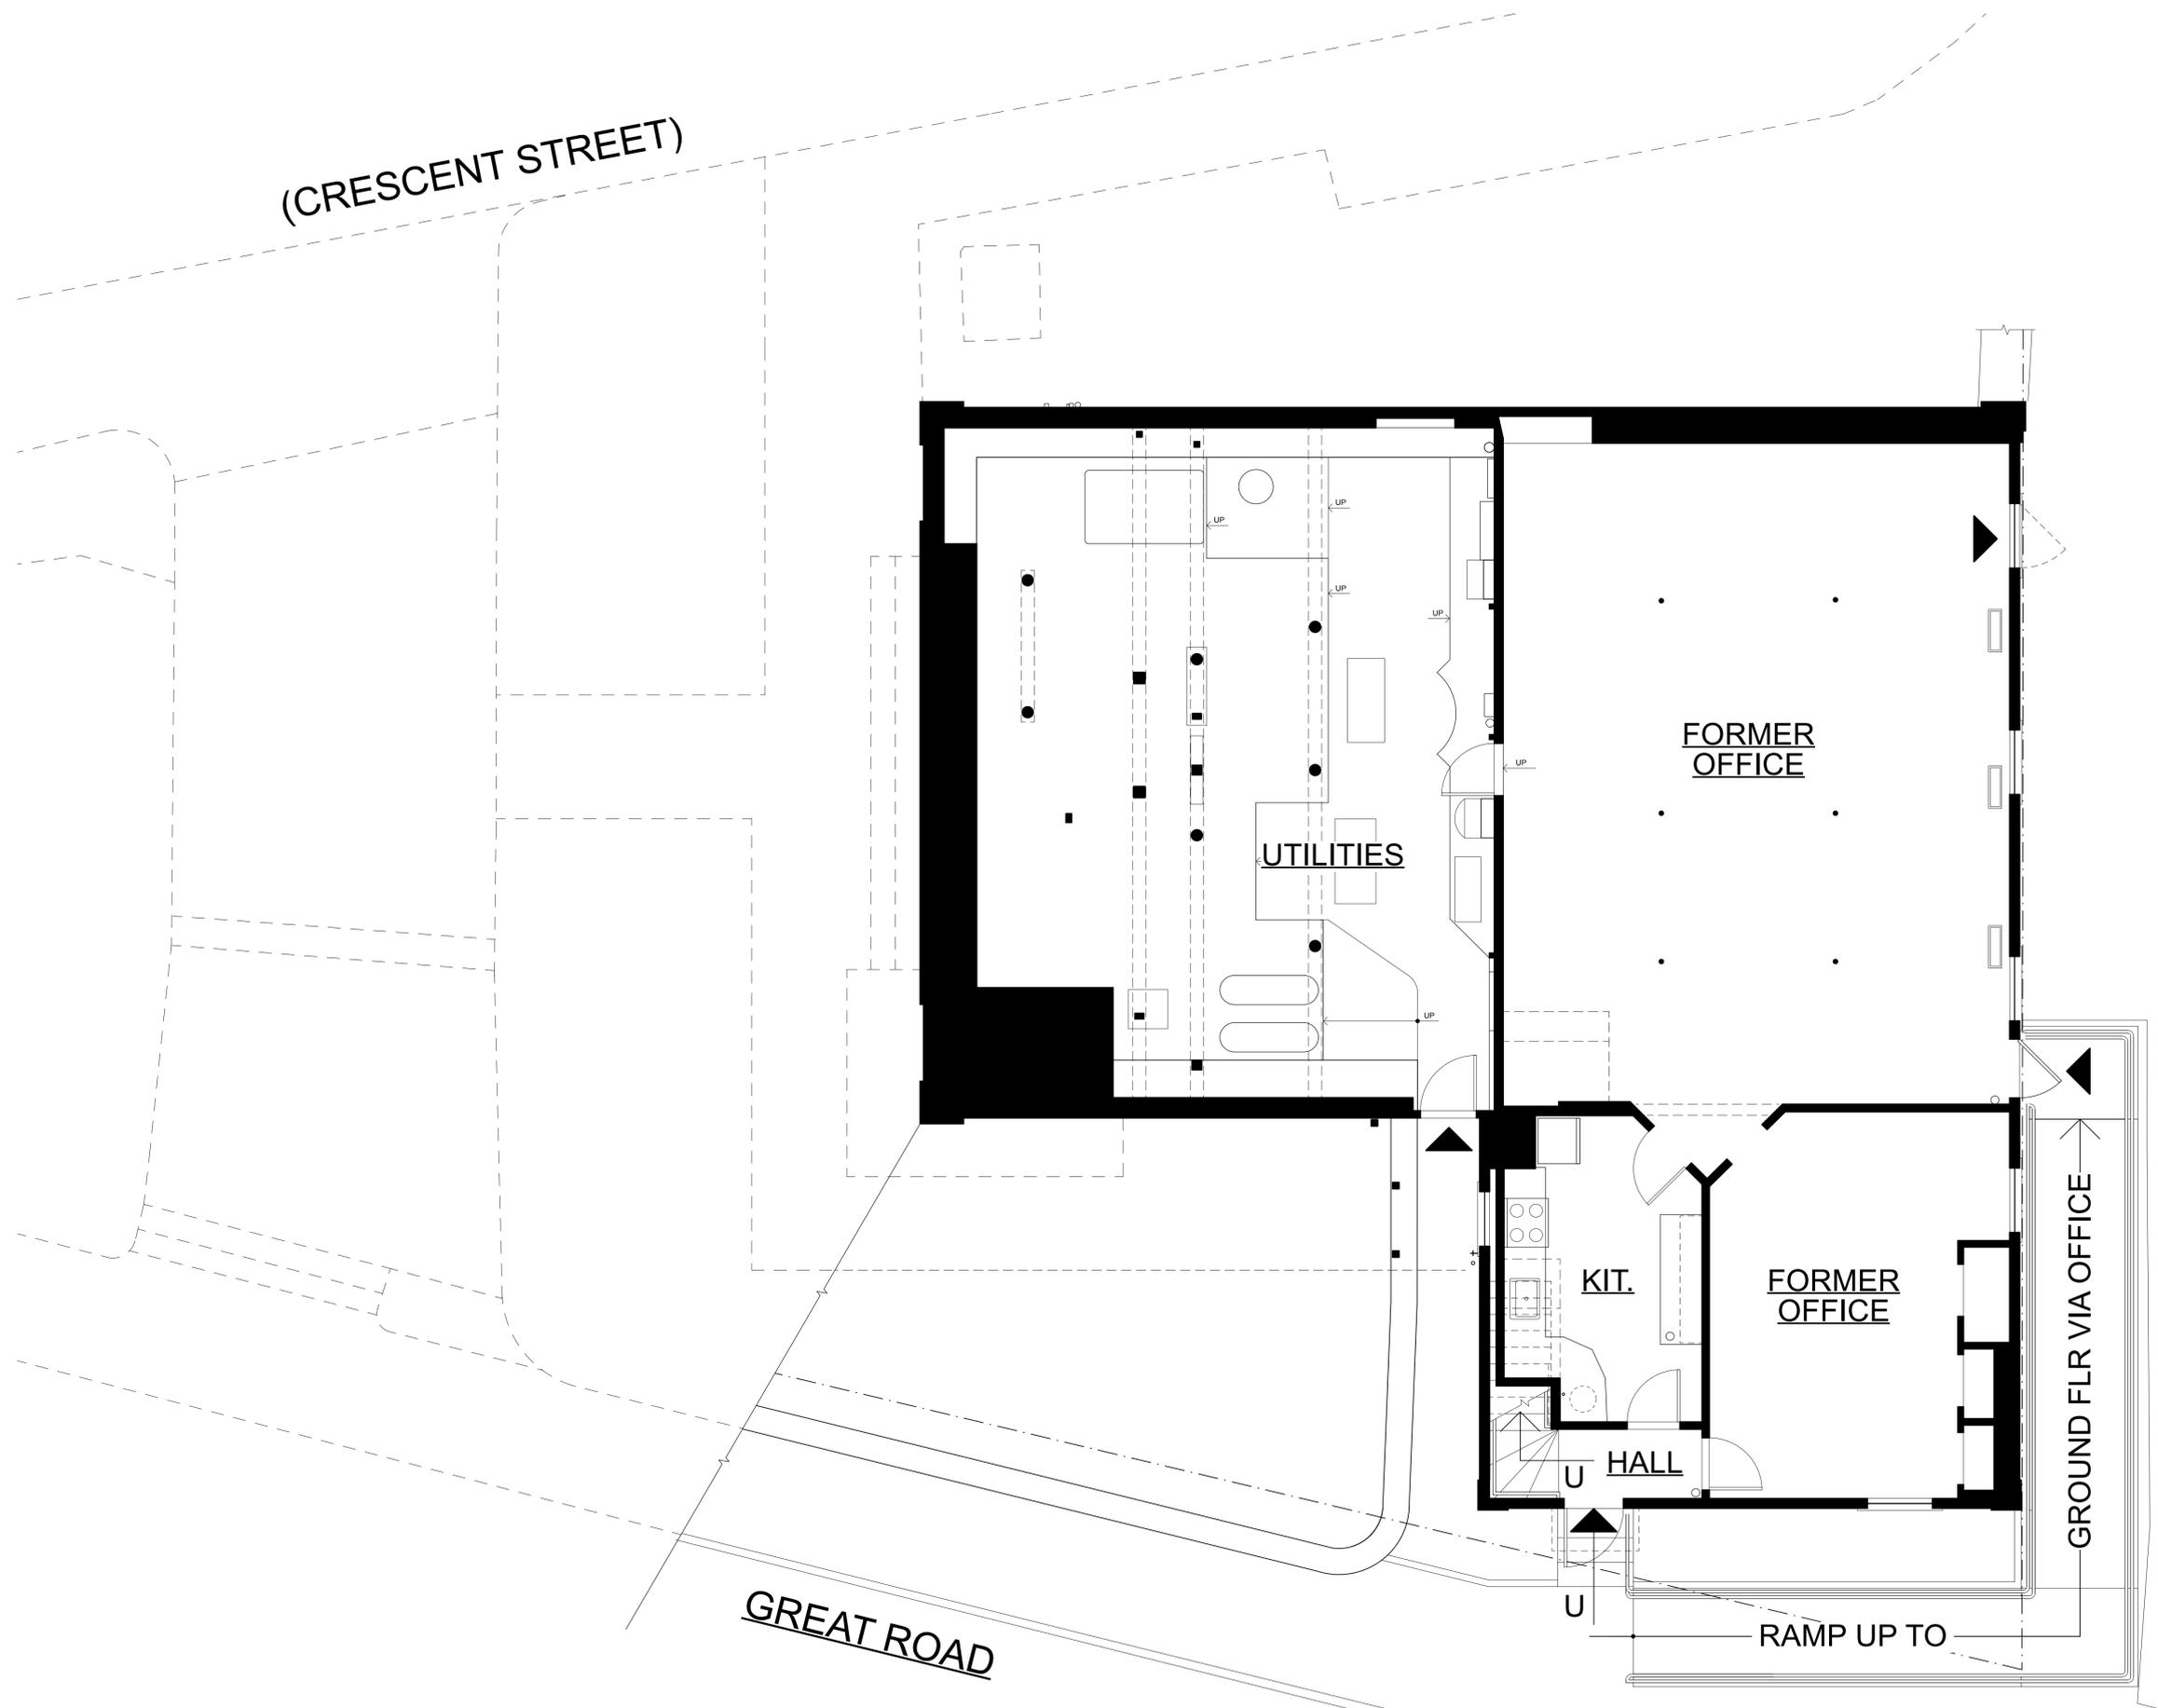
OPTION TWO: GROUND FLOOR PLAN

Refer to the floor plans and building sections of Option Two, showing a lobby on the first floor of the ell and provision of air conditioning in the Great Hall.

As in Option One, the fire escape will be repaired, the ground floor level and kitchen will remain unused, and an interim dehumidification system will be added to the basement. On the first floor of the ell, the former office will be removed to provide a lobby and display area adjacent to the accessible entrance. The existing restrooms will remain in place, and the occupancy load of the facility will be reduced to a maximum of 100 persons to conform with plumbing code fixture limitations for an assembly occupancy.

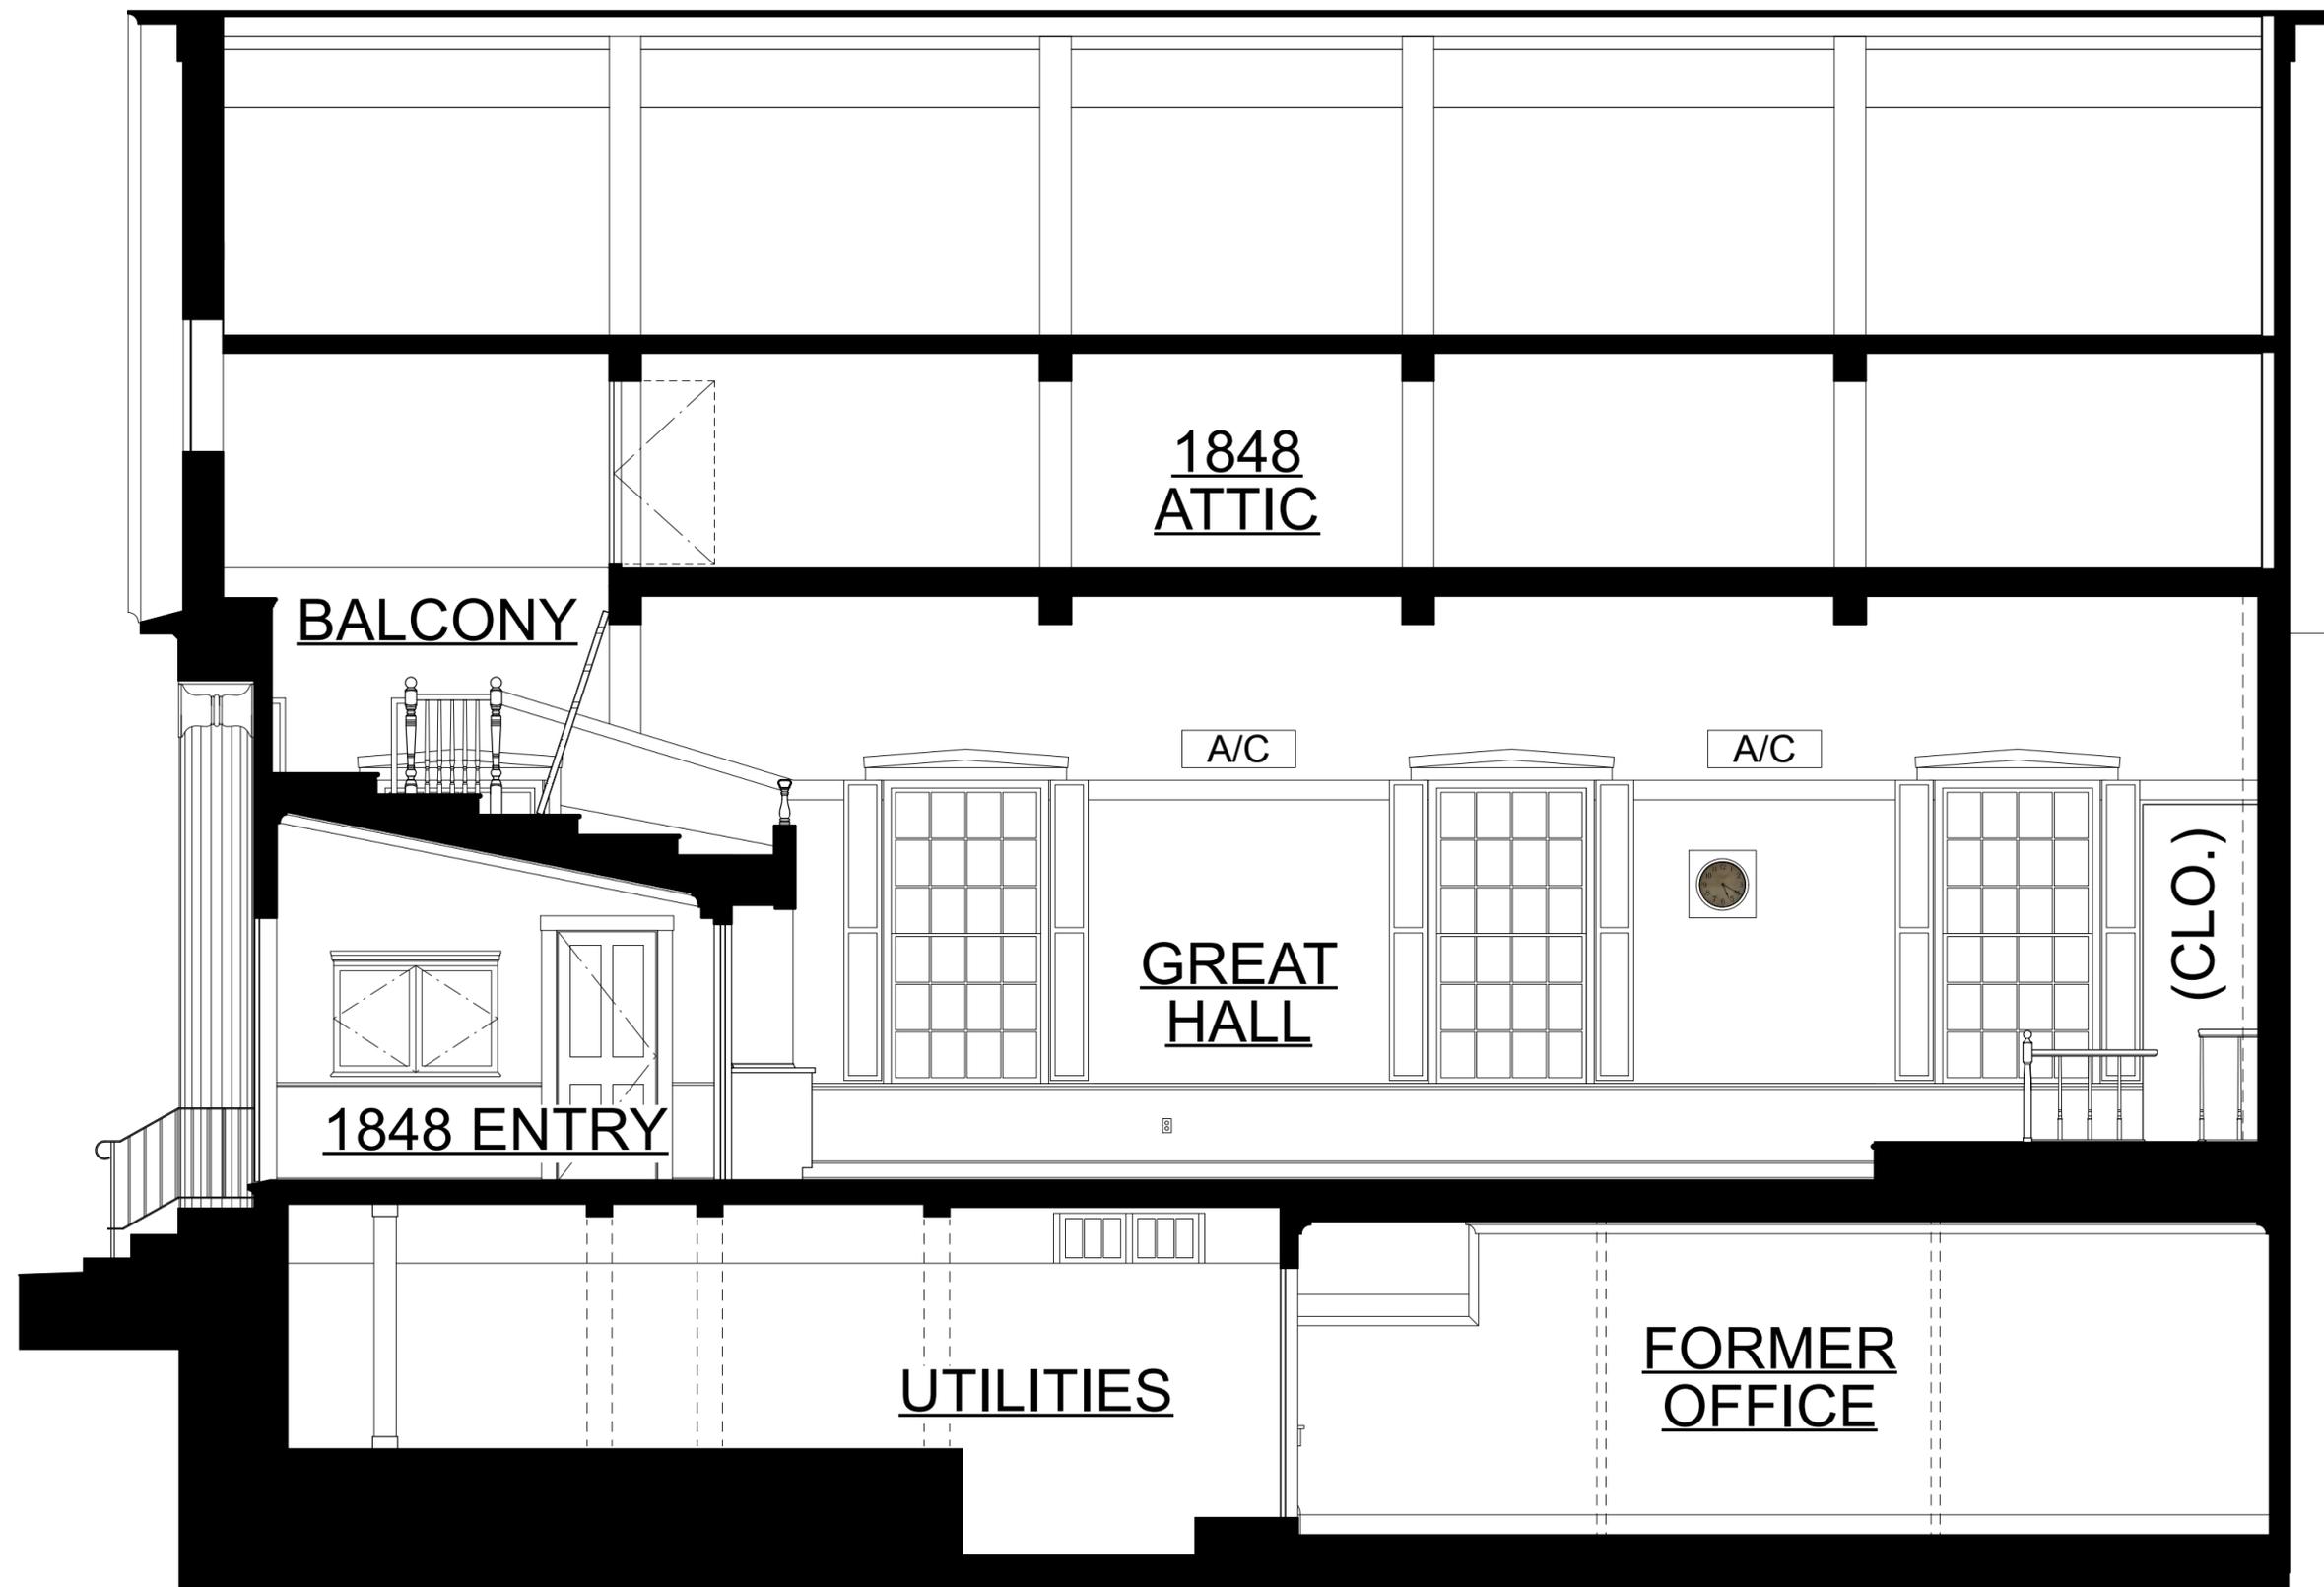
OPTION TWO: LONGITUDINAL SECTION LOOKING NORTH

LIMITED RENOVATIONS - NO ACCESSIBILITY IMPROVEMENTS - NO BASEMENT OCCUPANCY

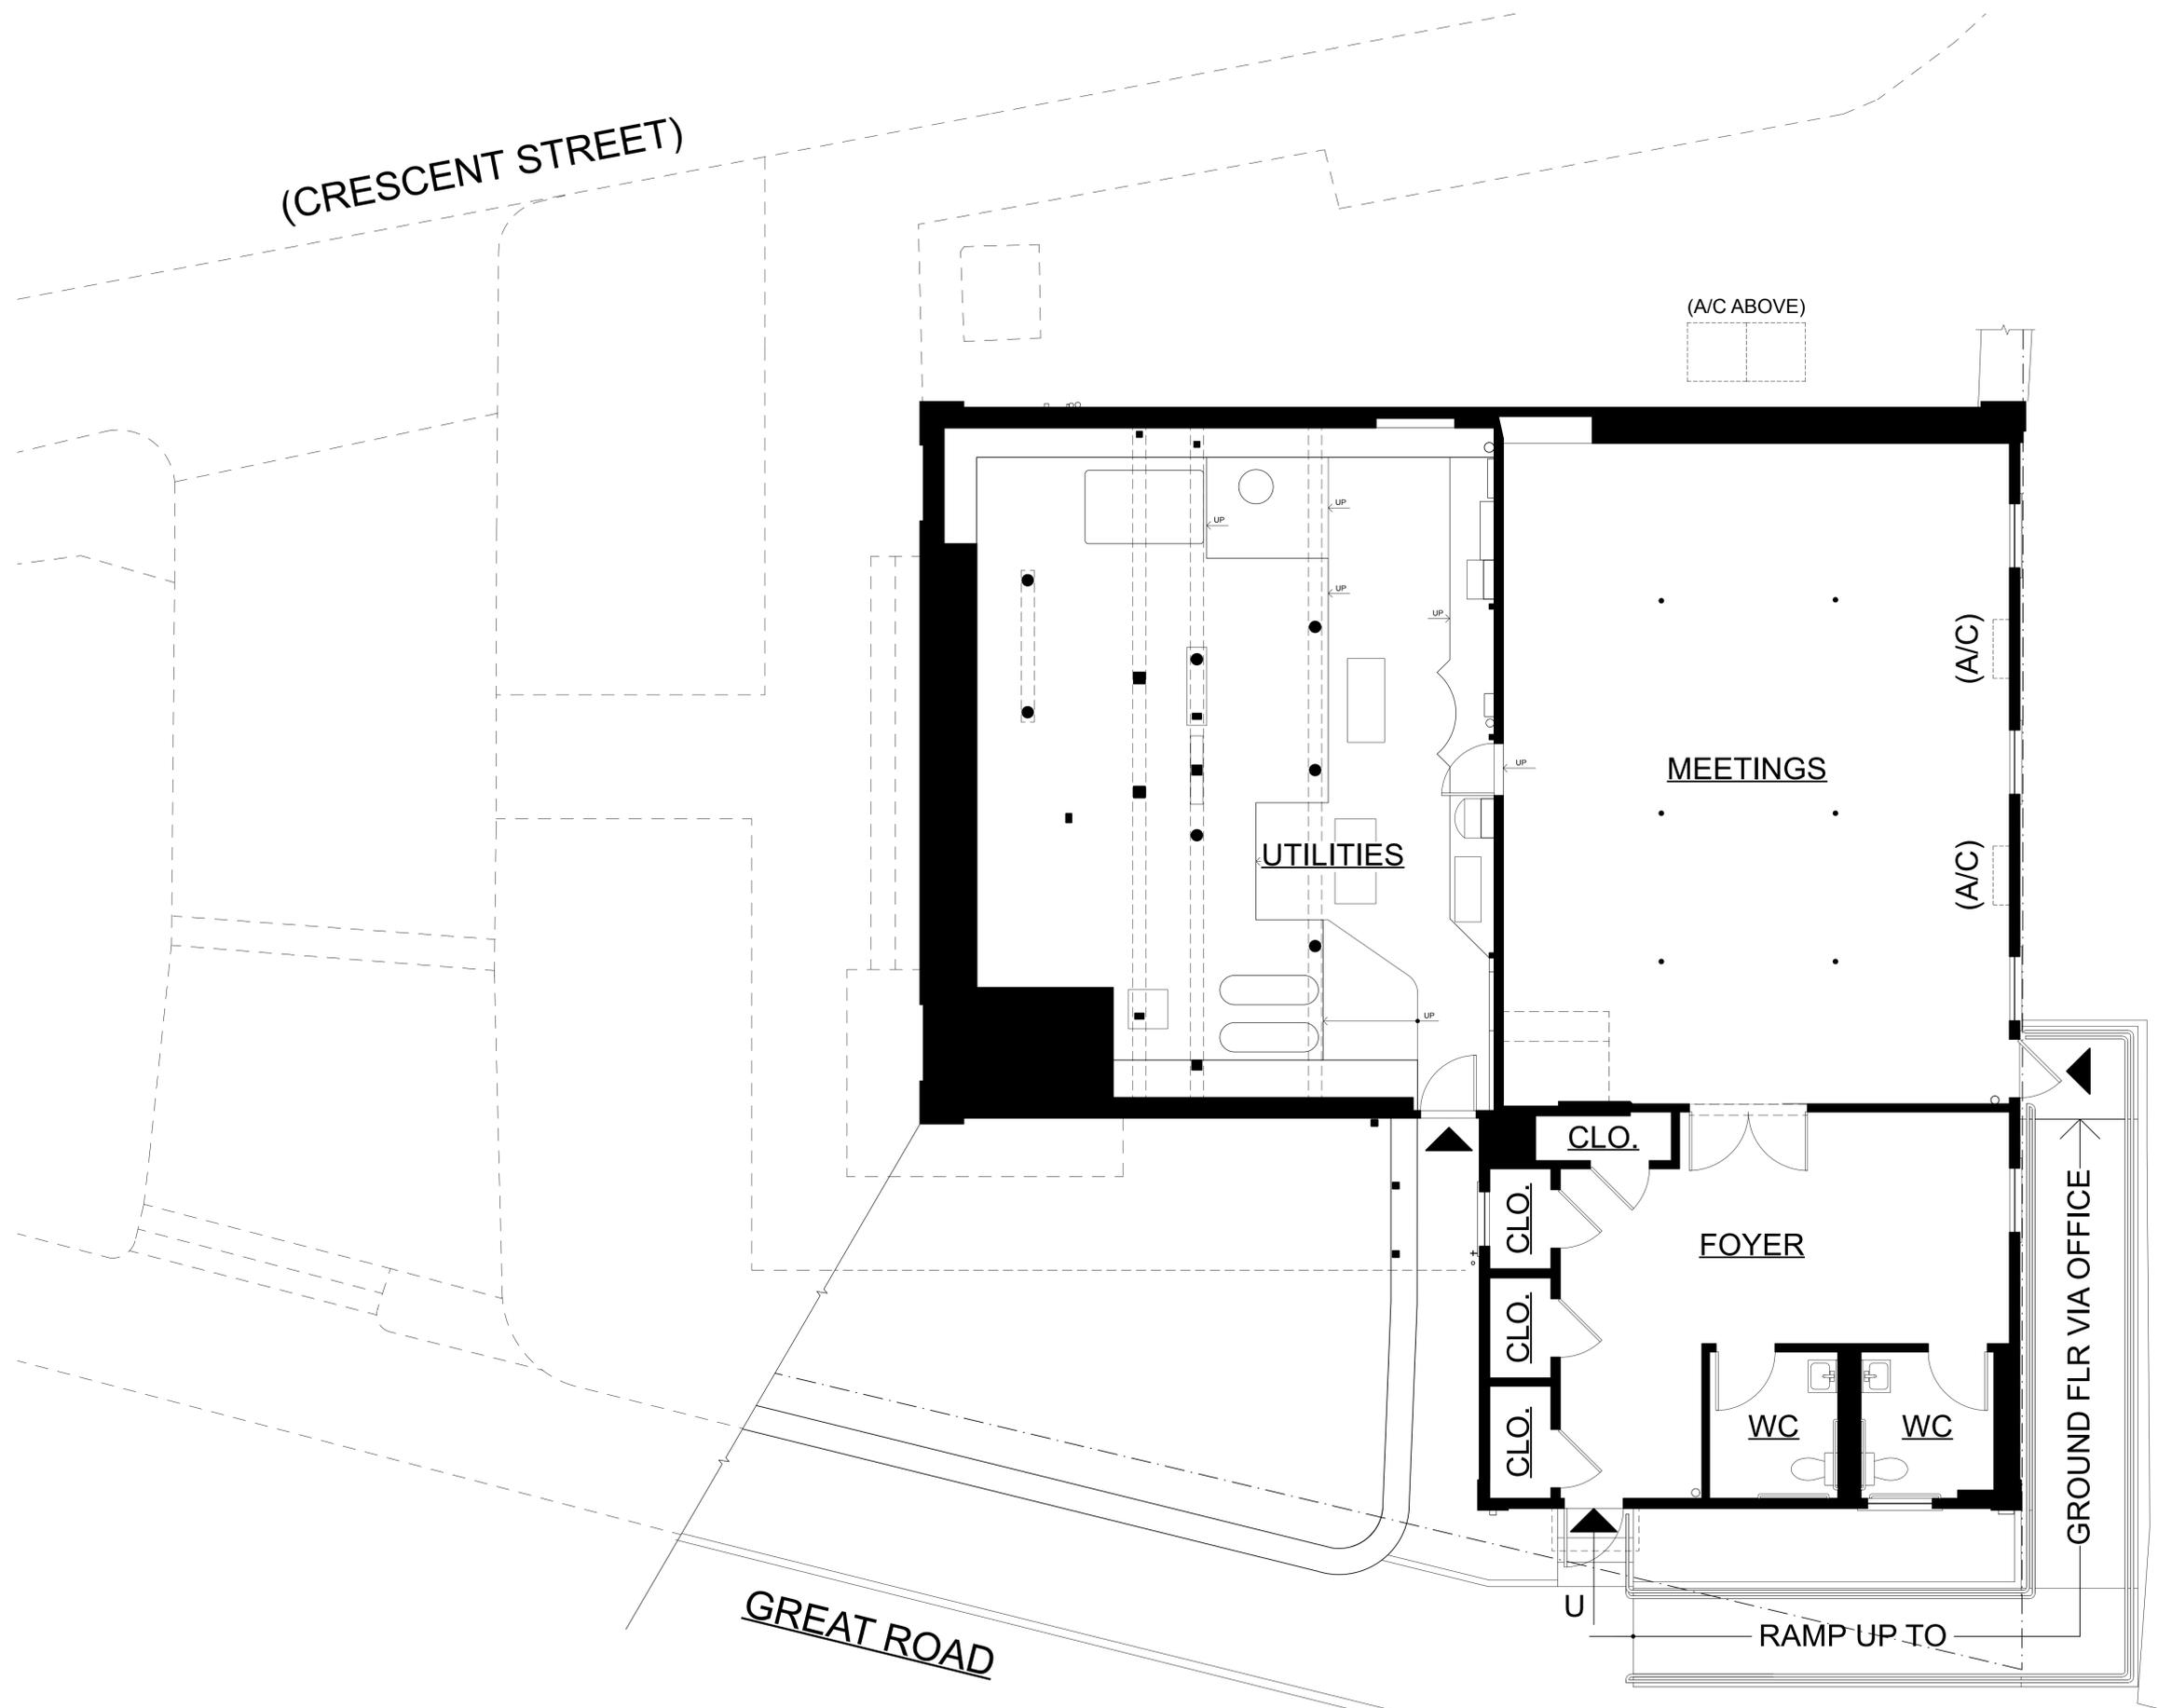
OPTION THREE: GROUND FLOOR PLAN

Refer to the floor plans and building sections of Option Three, showing modifications to the ground floor for a separate use and the absence of stairs from that level up to the first floor. Stairs from the first floor to the attic of the ell would remain in place for this option.

As in Option One and Two, the fire escape will be repaired, existing restrooms on the first floor will remain, and the first floor occupancy load will be limited to 100 persons maximum. The lobby on the first floor of the ell as introduced in Option Two will be provided. A pair of accessible restrooms will be provided on the ground floor level to serve that separate use. The kitchenette will be removed from the ground floor and a foyer with storage closets to support the municipal function room will be provided.
