FIVE OPTIONS

Stow Town Hall Renovation
375 Great Road / Stow MA

MILLS WHITAKER ARCHITECTS LLC

01 August 2022

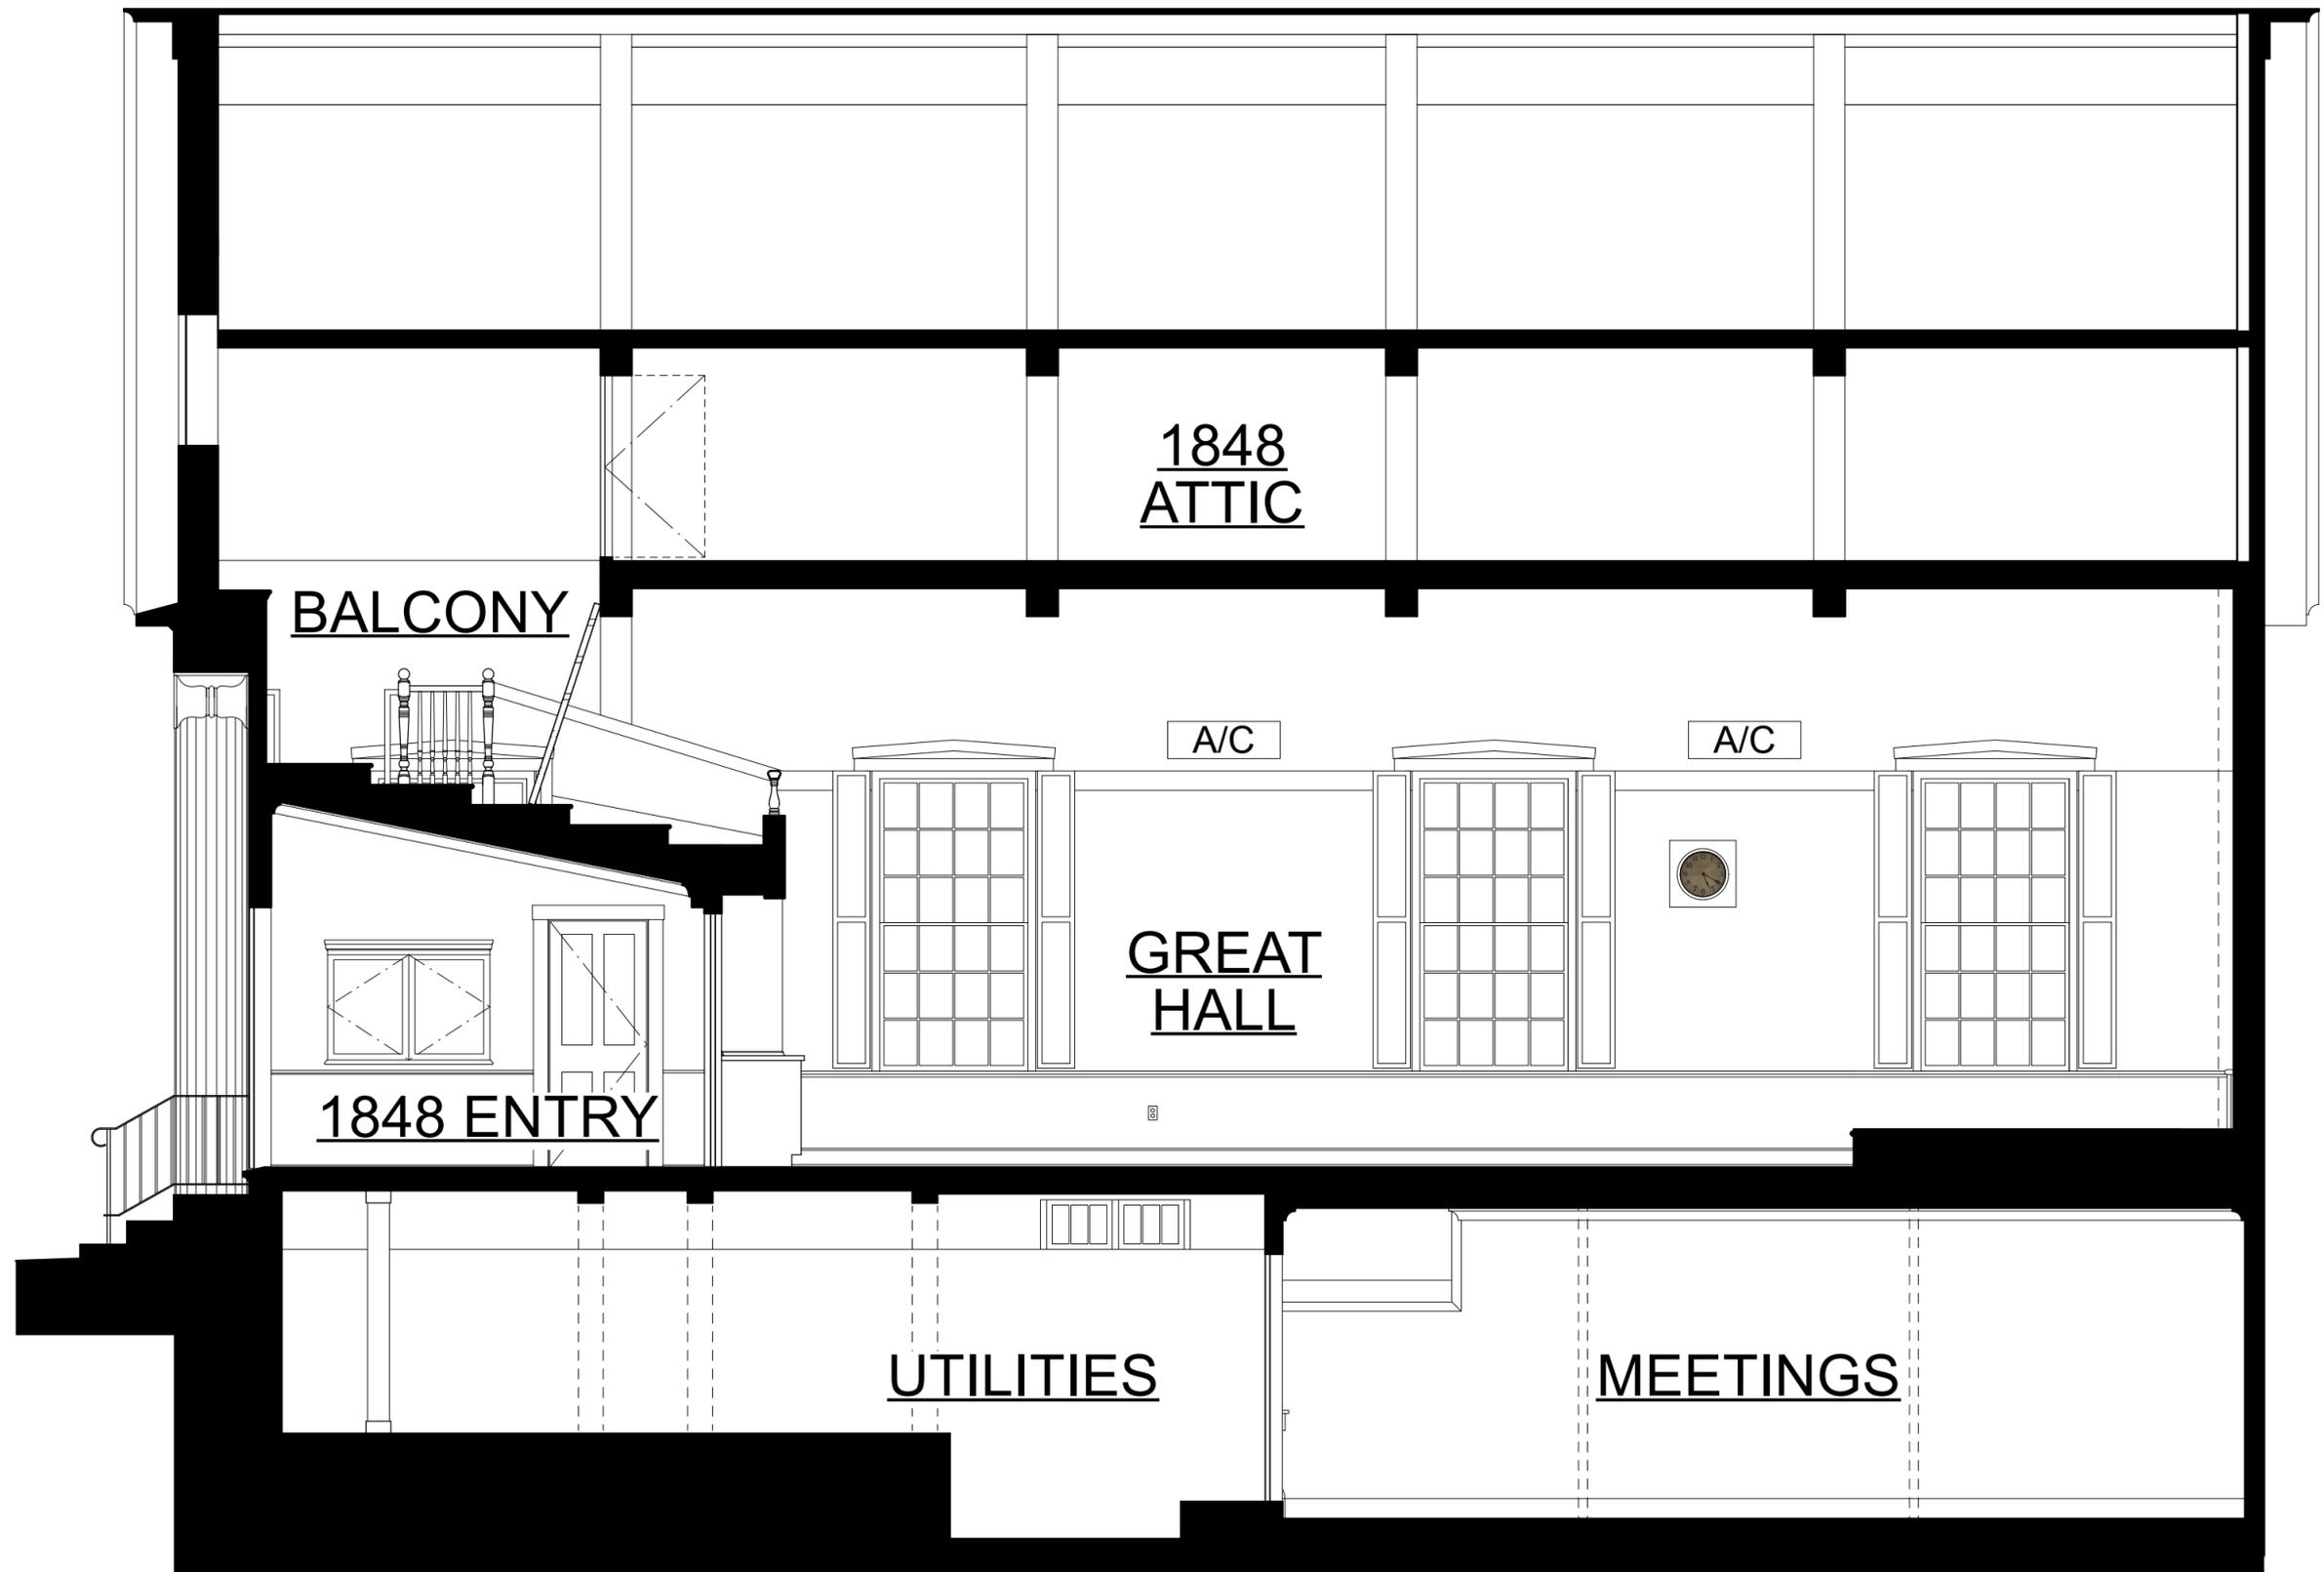
OPTION THREE: LONGITUDINAL SECTION LOOKING NORTH

LIMITED RENOVATION OF EACH FLOOR - NO ACCESS BETWEEN FLOORS (SEPARATE USES)

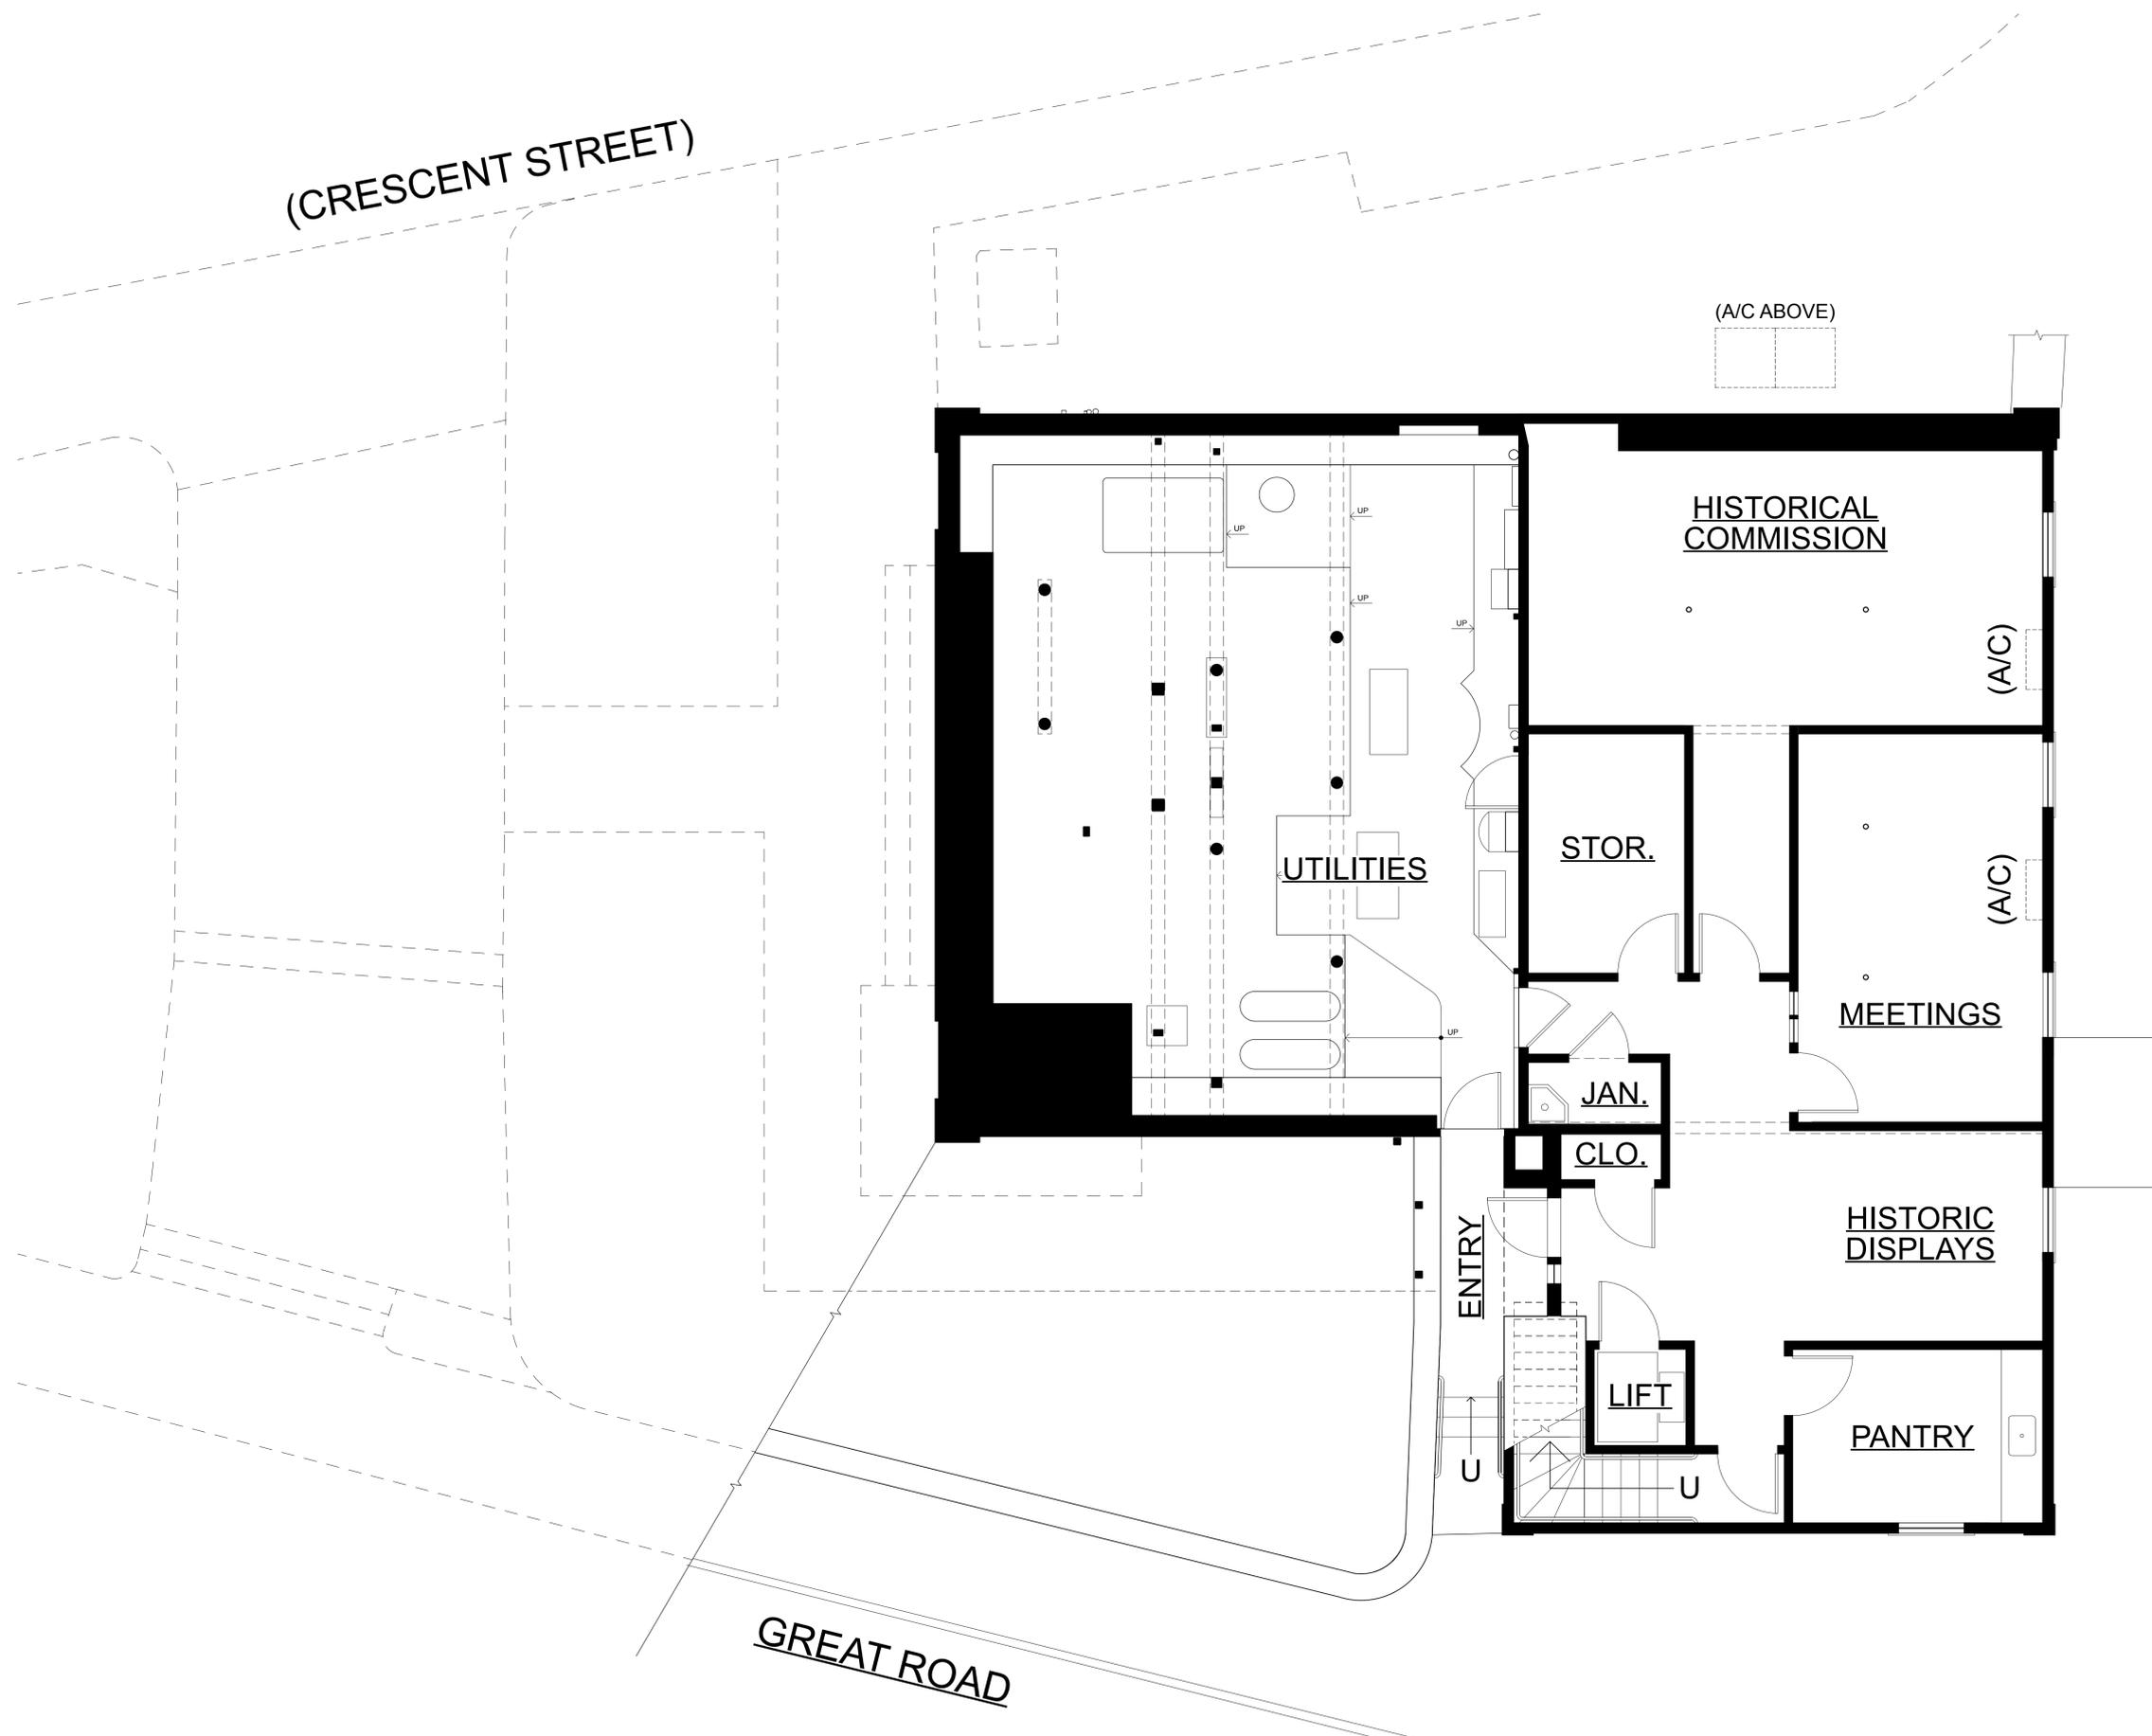
OPTION FOUR: GROUND FLOOR PLAN

Refer to the floor plans and building sections of Option Four, showing modifications to the ground floor and first floor including vertical access between floors.

As in the previous options, the fire escape will be repaired and certified. Restrooms to support the full occupant load of the facility will be provided on the first floor, and a catering pantry for event support will be provided on the ground floor.

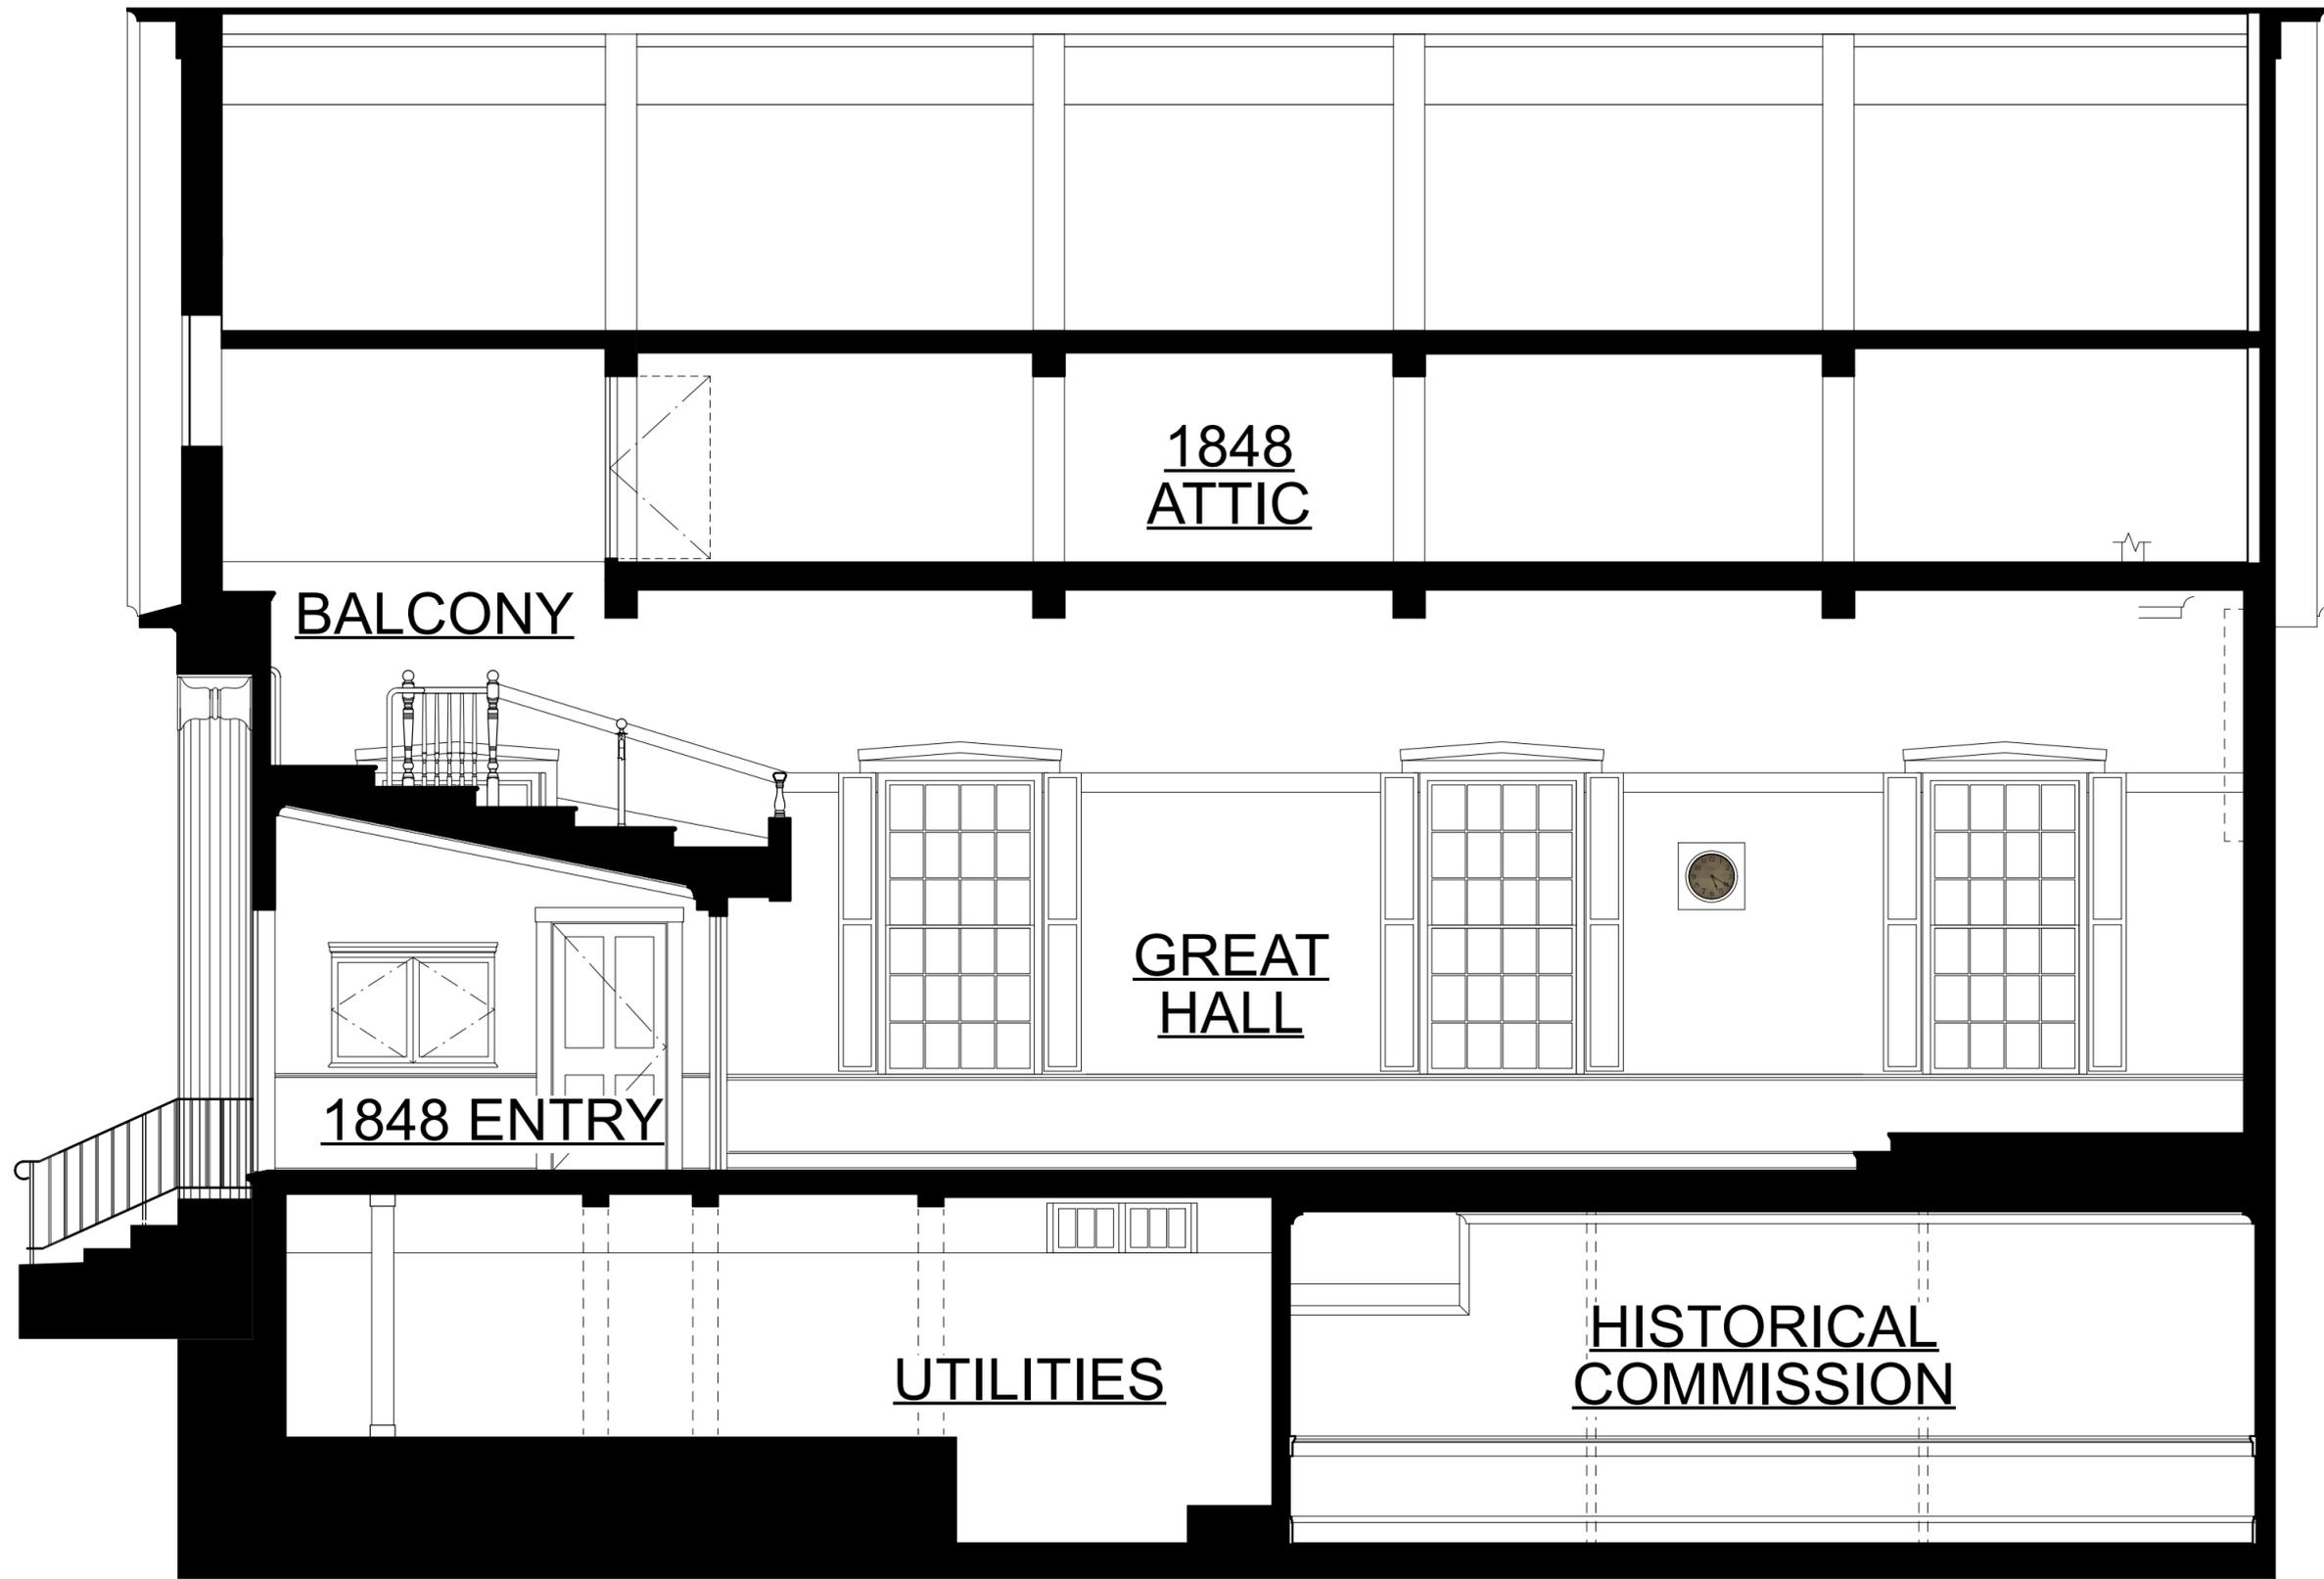
OPTION FIVE: LONGITUDINAL SECTION LOOKING NORTH

RENOVATION SCOPE AS PROPOSED BY TOWN HALL RESTORATION COMMITTEE

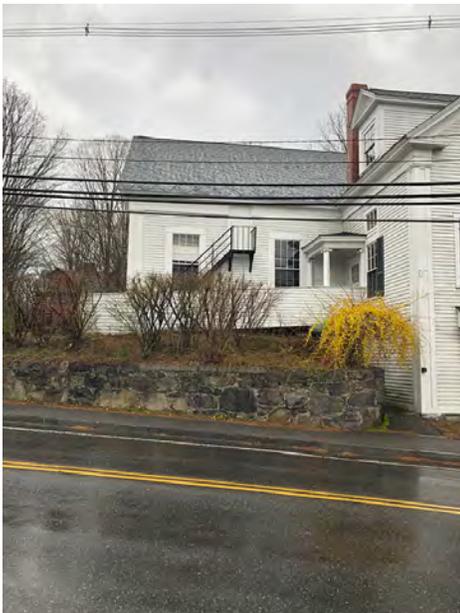
200421-IMG_6476.JPG

South Facade of 1848 Portion with 1895 Addition at Right; Low Clapboard Wall is Guardrail for Accessible Ramp; Fire Escape Stair Exit from Great Hall Balcony

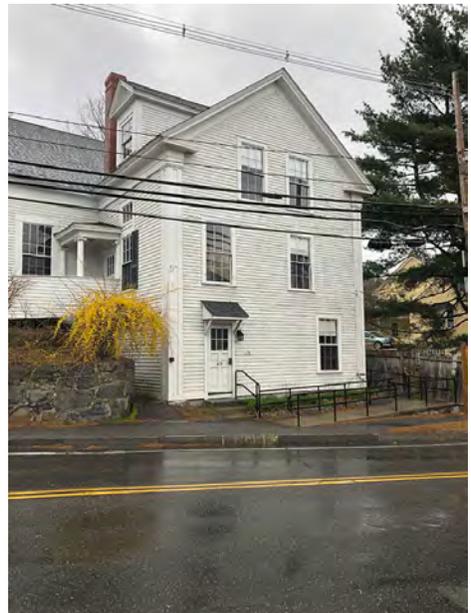
200421-IMG_6475.JPG

1895 Ell Addition at South Side of 1848 Building; Accessible Ramp to Ground Floor Wraps SE Corner

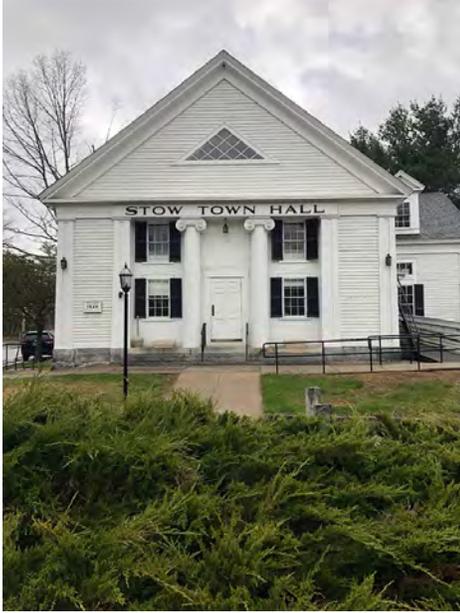
200421-IMG_6471.JPG

West Facade and Historic 1848 Entrance; 1895 Ell Addition at Right Adjacent to Great Road via Accessible Ramp; Crescent Street at Left

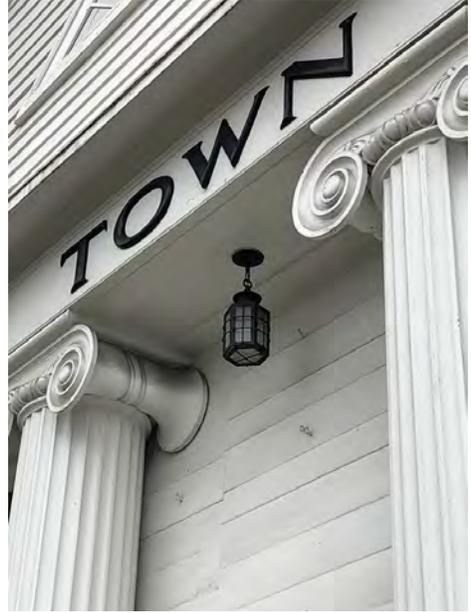
200421-IMG_6494.JPG

*Ionic Volute Capitals on Fluted Columns of Pediment;
Sign Band on Added Wood Board Across Pediment*

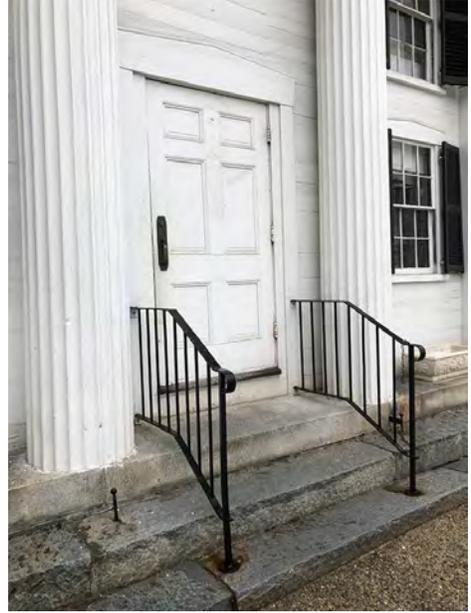
200421-IMG_6461.JPG

*1848 Granite Steps to Entrance Stoop with Pair of Railings;
Each Riser Varies in Height to Granite Plinth and to
Final Step at Wooden Door Threshold to Foyer*

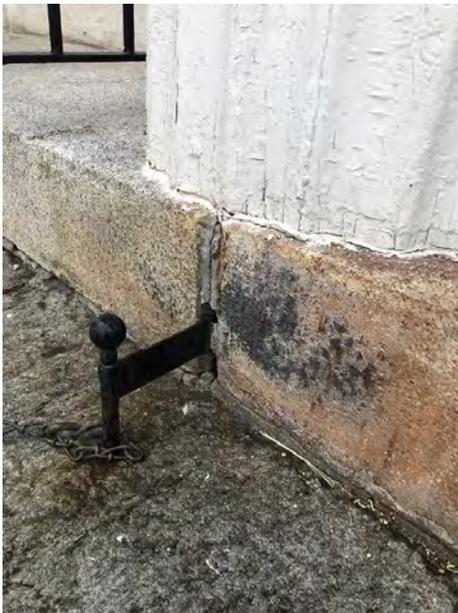
200421-IMG_6469.JPG

*Intact Boot Scraper at South Side of 1848 Entrance;
Base of Painted Fluted Column on Granite Plinth*

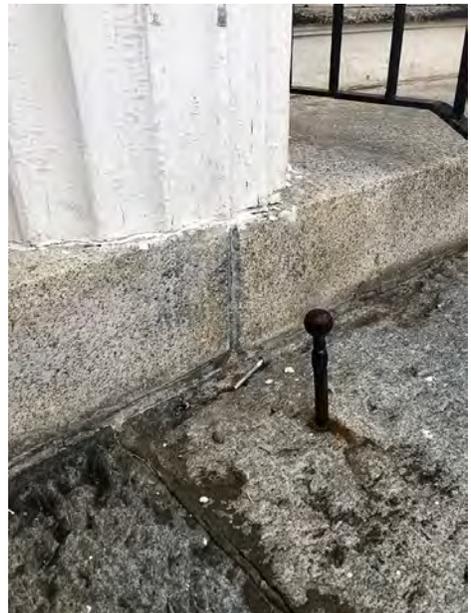
200421-IMG_6470.JPG

North Side Boot Scraper Missing Horizontal Component

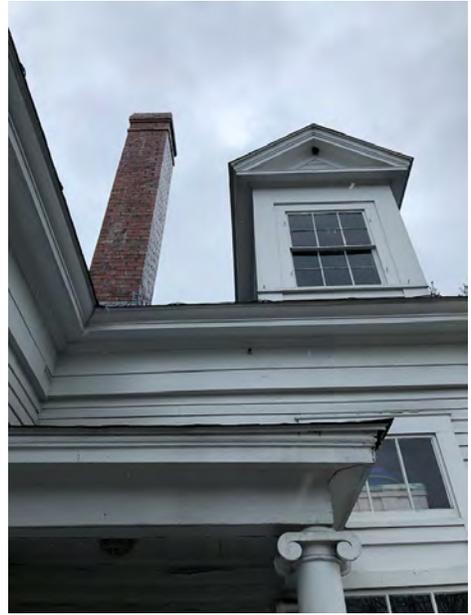
200421-IMG_6464.JPG

Side Door Canopy, Chimney and Dormer at 1895 Ell Addition Adjacent to South Facade at Left

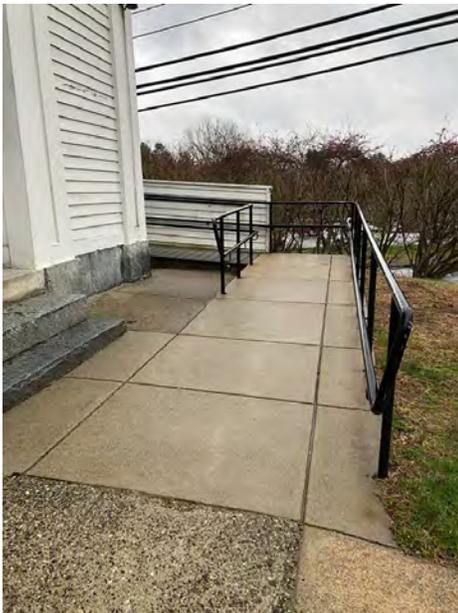
200421-IMG_6462.JPG

Accessible Ramp at Front Facade Heading South and East to Side Entrance at 1895 Ell Addition

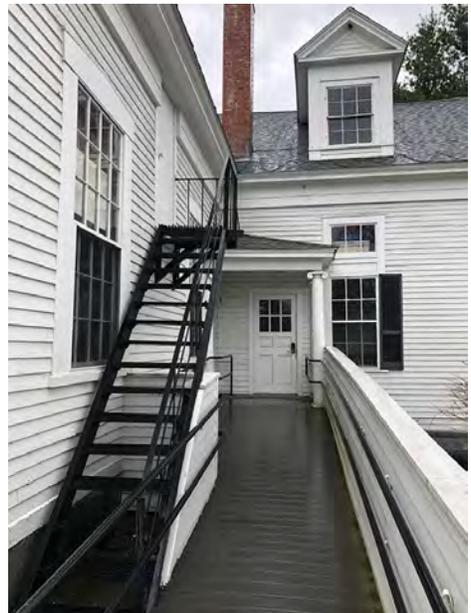
200421-IMG_6463.JPG

Accessible Ramp Heading East to Ell Entrance; Fire Escape Serving Balcony of Great Hall at Left; Dormer in 1895 Attic; Chimney Flue for Furnaces

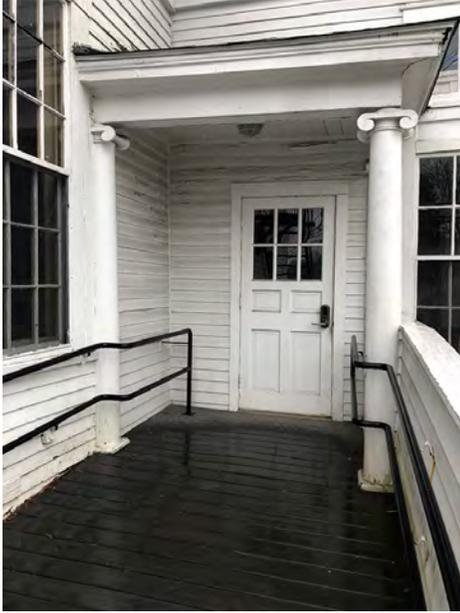
200421-IMG_6466.JPG

*1895 Ell Entrance to Stair Hall at Accessible Ramp;
Inadequate Strike Side Clearance at Pull (18" Required);
Chimney at Interior Restricts Clearance on Hinge Side*

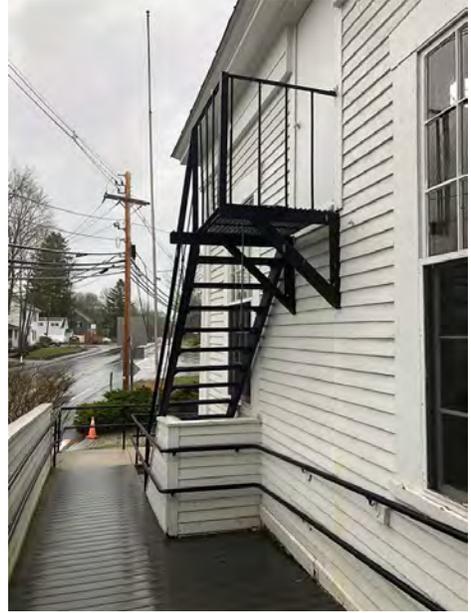
200421-IMG_6467.JPG

*Looking West From Ell Entrance Down Ramp;
Fire Escape Exit Stairs from Balcony of Great Hall*

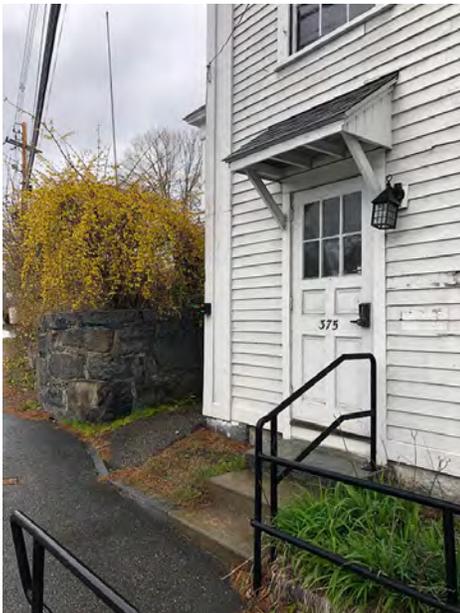
200421-IMG_6479.JPG

*South Door into 1895 Ell Addition Adjacent to
Great Road Sidewalk Leads into Stair Hall;
Accessible Ramp at Lower Left in Foreground;
Service Alley Adjacent to Stone Retaining Wall Beyond*

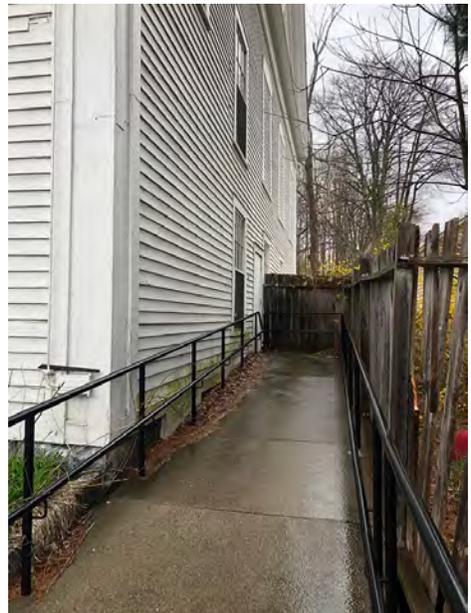
200421-IMG_6478.JPG

*Accessible Ramp at East Side of 1895 Ell to
Ground Floor Enters at Former Office Area;
Ramp is on Abutter's Property with Permission;
Upper Landing Area & Door Clearances Inadequate*

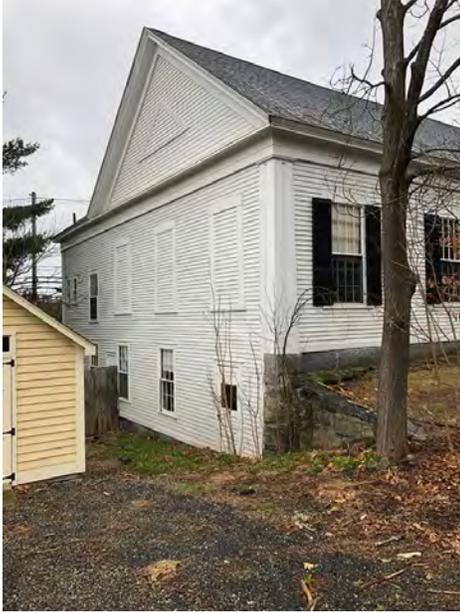
200421-IMG_6452.JPG

*View from Crescent Street at NE Corner of Building;
East Facade with Cased Faux Windows
at First Floor and Attic Levels*

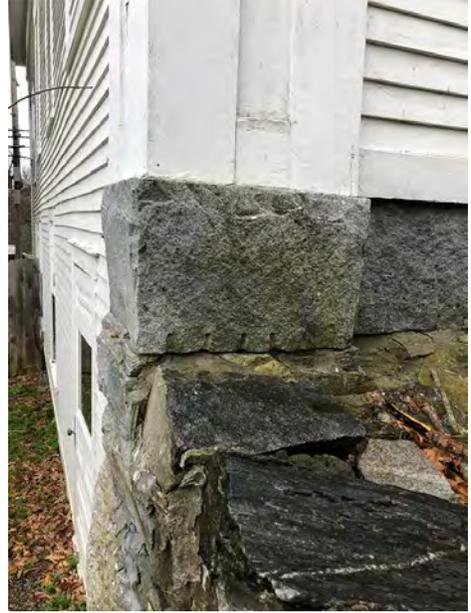
200421-IMG_6453.JPG

*Tooling Marks in Granite at Base of NE Cornerstone;
Retaining Wall in Foreground Toward Crescent Street*

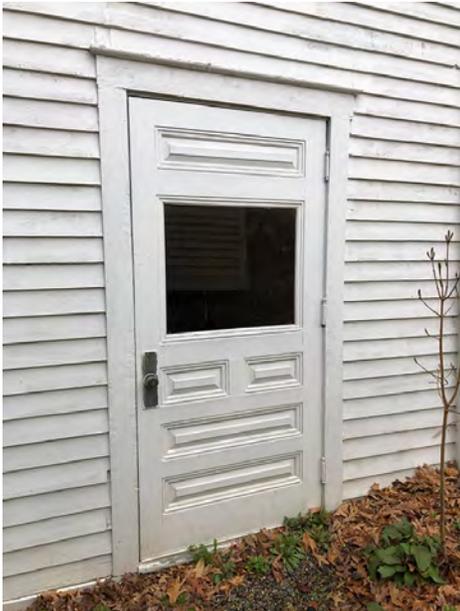
200421-IMG_6454.JPG

*Inoperable Door from Ground Floor in East Facade
Blocked by Elevated Height of Finished Grade*

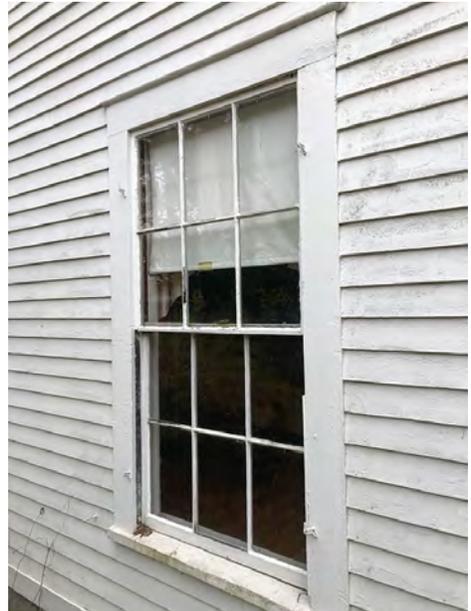
200421-IMG_6455.JPG

*6-over-6 Wood Window Sash in East Facade of Ground
Floor at 1895 Ell Addition; Painted Wood Clapboards*

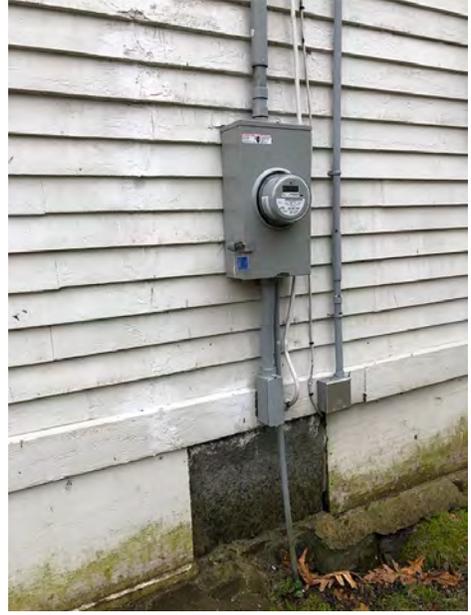
200421-IMG_6456.JPG

Electrical Meter at North Facade Near NW Corner; Existing Service is 100-Amp, Single-Phase, 120/240-Volt

The existing mechanical and electrical systems will not be upgraded. The current oil-fired hot air furnace heating system will remain, and no air conditioning will be provided. The existing 100-amp single-phase electrical service will not be upgraded. It is assumed that the work will be classified as “ordinary repairs” and will therefore not require issuance of building permits.

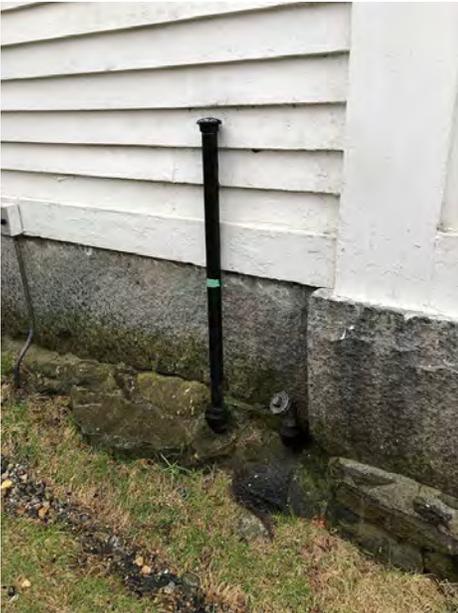
200421-IMG_6458.JPG

Fuel Oil Fill & Vent at North Facade Adjacent to NW Corner

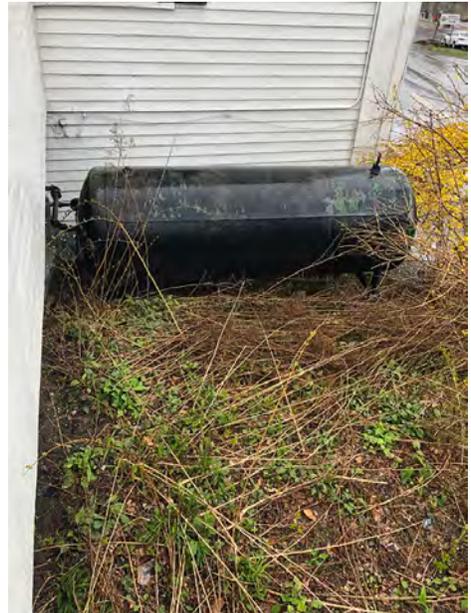
200421-IMG_6465.JPG

Pneumatic Tank in South Yard for Former Fire Horn; Abandoned Horn Penetrated Roof for Town Notifications

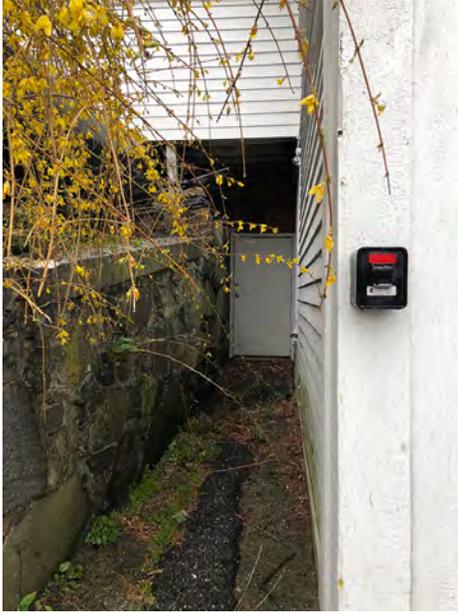
200421-IMG_6480.JPG

Service Alley to Cellar Entrance Adjacent to 1895 Addition; Bulging Rubble Stone Retaining Wall at Left Side of Alley; Knox Box for Fire Department Keys at SW Corner of Ell

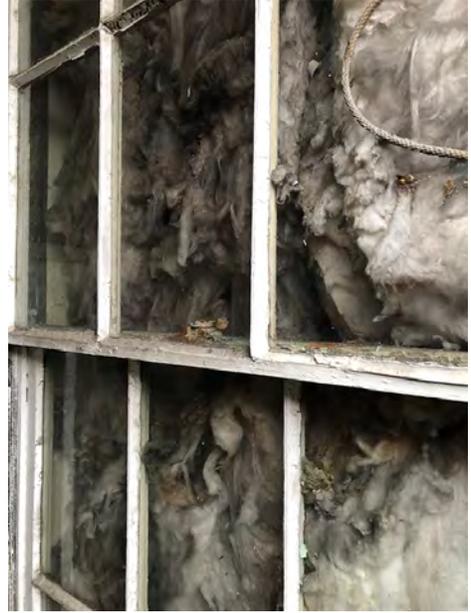
200421-IMG_6482.JPG

Insulation in Blocked Window Opening of Kitchen in West Wall of 1895 Ell Adjacent to Service Entrance; Window Not Visible from Interior of Kitchen

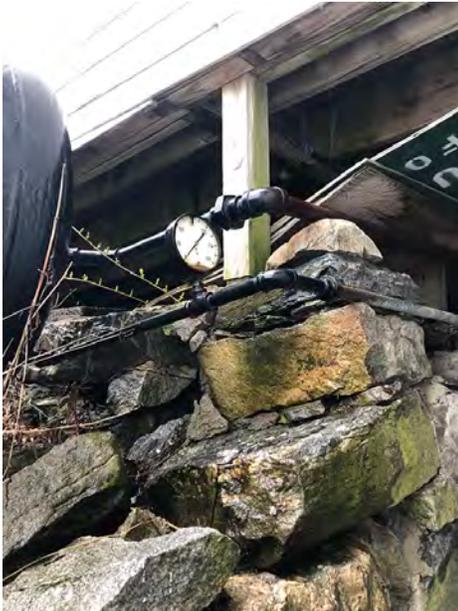
200421-IMG_6481.JPG

Wooden Post Bearing on Rubble Masonry at Ramp Structure to Side Entrance Adjacent to Abandoned Pneumatic Tank Serving Former Fire Alarm Notification System for Town

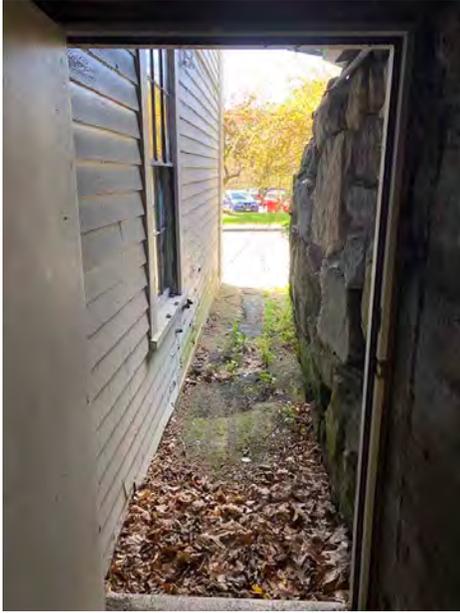
200505-IMG_6764.JPG

*Looking South Thru Service Alley
Toward Great Road from Cellar Door;
Bulging Stone Retaining Wall at Right;
Blocked Kitchen Window at Left*

View from Utility Room at Service Alley; Stone Wall is Bulging and Requires Repair; Area to be Reconfigured for Accessible Entrance

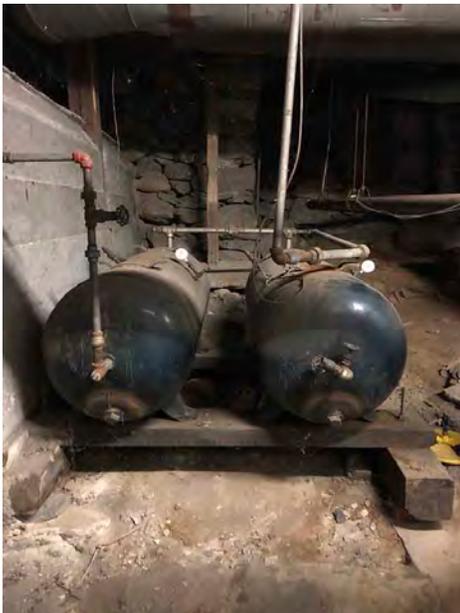
200505-IMG_6762.JPG

*Abandoned Interior Air Tanks for Former Fire Horn
System Adjacent to South Foundation Wall;
Concrete Buttress Added to South Stone Wall*

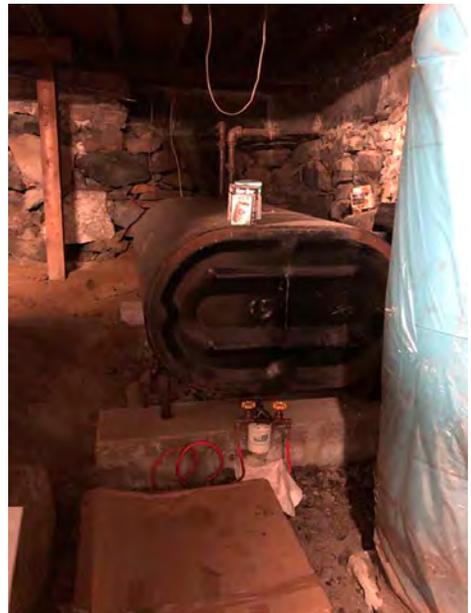
200505-IMG_6753.JPG

*Active Fuel Oil Tank Adjacent to North Foundation Wall
Serves Pair of Hot-Air Furnaces for Heating System*

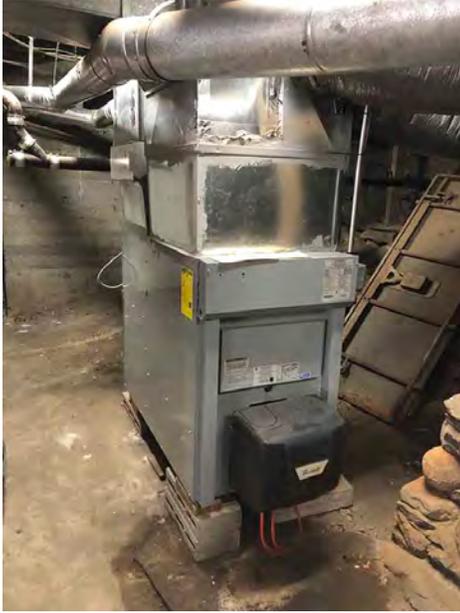
200505-IMG_6759.JPG

One of Two Oil-Fired Hot-Air Furnaces in Cellar

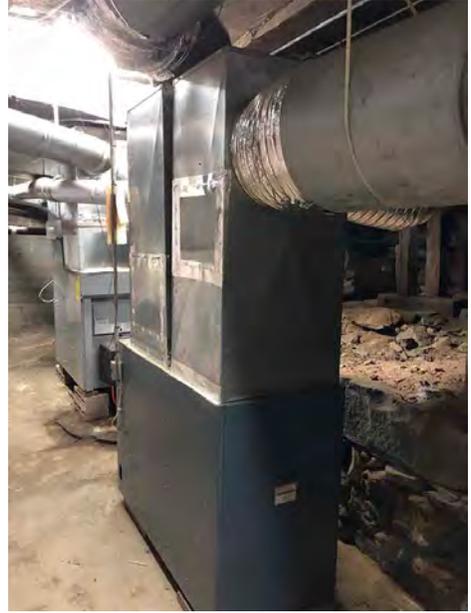
200505-IMG_6756.JPG

Pair of Oil-Fired Hot Air Furnaces in Cellar Mechanical Room; Existing Heating System

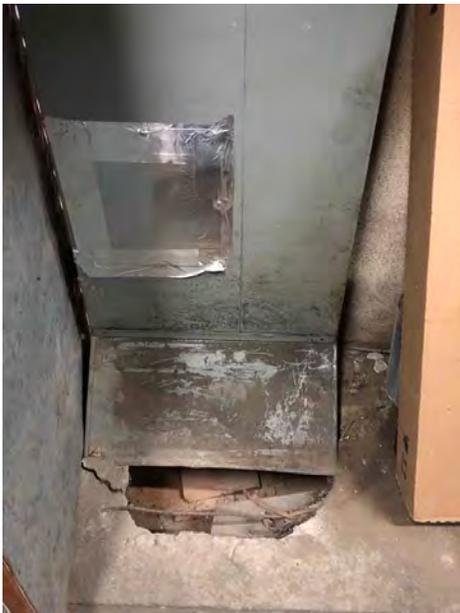
200505-IMG_6766.JPG

Combustion Air Opening in Cellar Slab at Base of Duct Along East Wall Adjacent to Furnaces

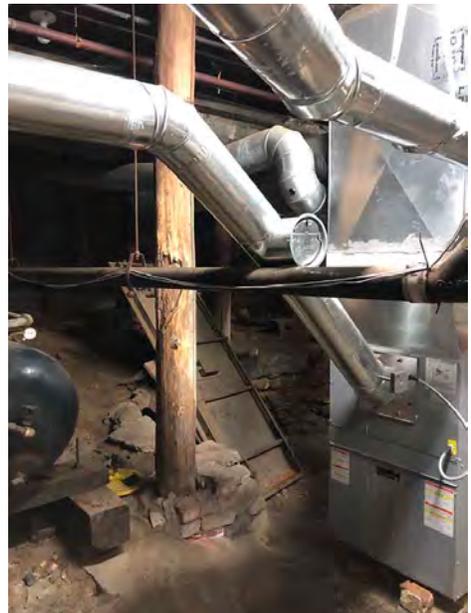
200505-IMG_6763.JPG

Hewn Timber Log Post Adjacent to Oil-Fired Hot Air Furnace

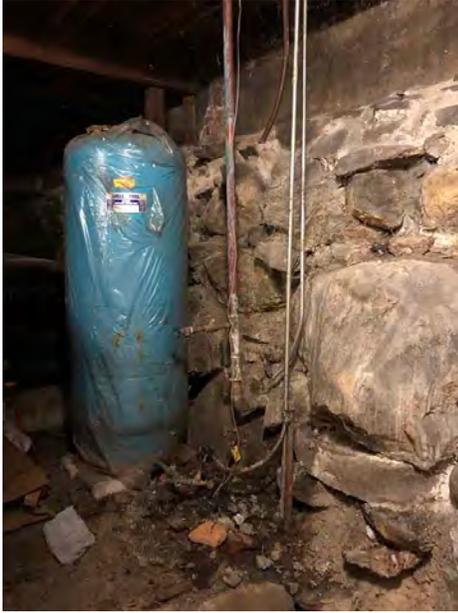
200505-IMG_6752.JPG

Pressurized Well Tank Adjacent to Electrically Grounded Water Service at North Rubble Foundation Wall

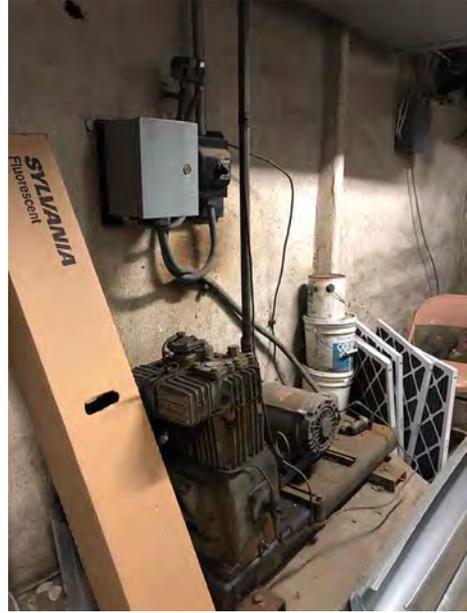
200505-IMG_6760.JPG

Abandoned Compressor in Mechanical Room for Former Air Horn Fire Alarm Notification System

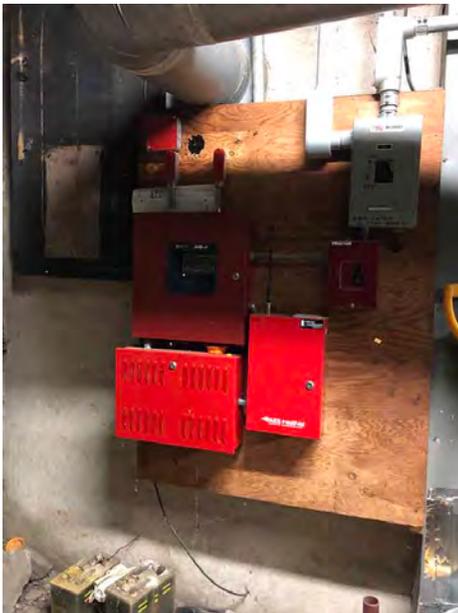
200505-IMG_6754.JPG

Fire Alarm Control Panel Components in East Wall of Mechanical Room

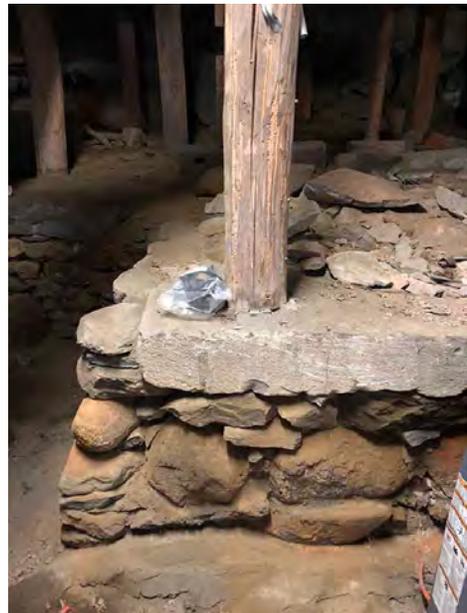
200505-IMG_6761.JPG

Timber Post on Concrete Pad over Rubble Masonry

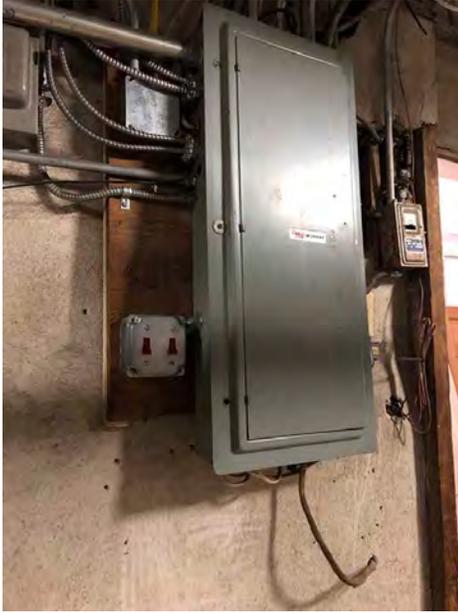
200505-IMG_6758.JPG

Electrical Service Panel at East Wall of Mechanical Room in Cellar
