FIVE OPTIONS

Stow Town Hall Renovation
375 Great Road / Stow MA

MILLS WHITAKER ARCHITECTS LLC

01 August 2022

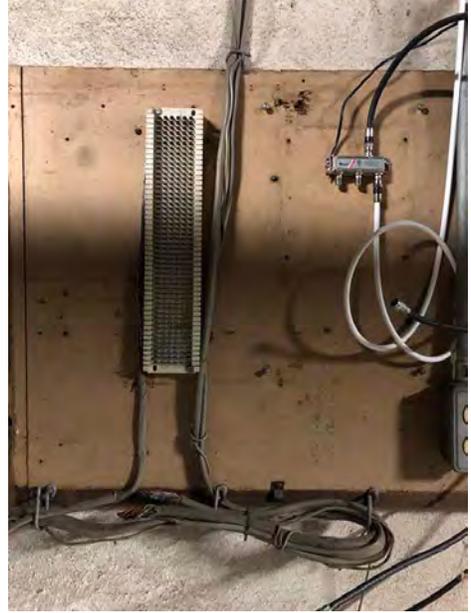
200505-IMG_6757.JPG

Patch Panel for Telephone and Cable Service at East Wall of Mechanical Room in Cellar

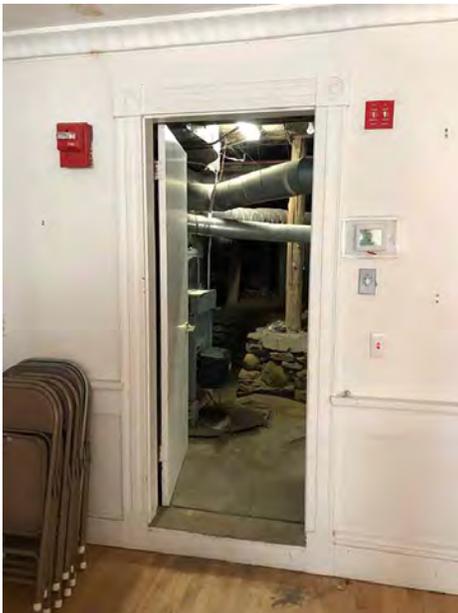
200505-IMG_6751.JPG

Raised Threshold at Door from Ground Floor Former Office Area to Mechanical Room in Cellar

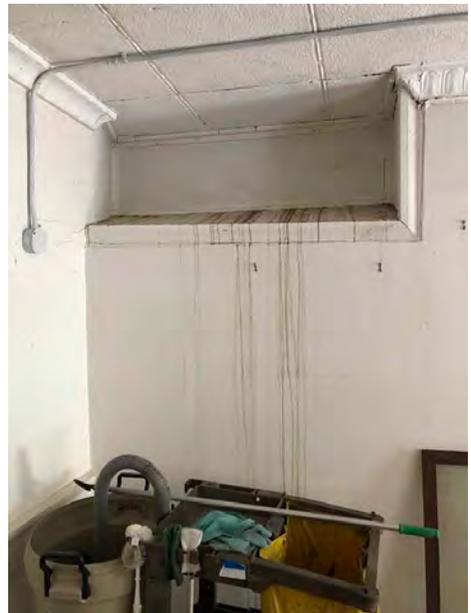
200505-IMG_6768.JPG

Evidence of Water Infiltration at Blocked Cellar Sash in NW Corner of Former Ground Floor Office; Plaster Finishes Conceal Rubble Stone Foundation Wall at North Side

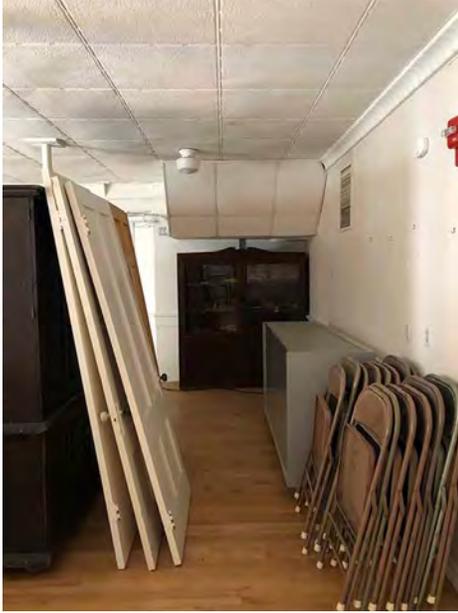
200505-IMG_6769.JPG

Painted Tin Ceiling and Wood Flooring at Ground Floor; Soffits at Furnace Flues in SW Corner of Former Office; Mechanical Room at Right

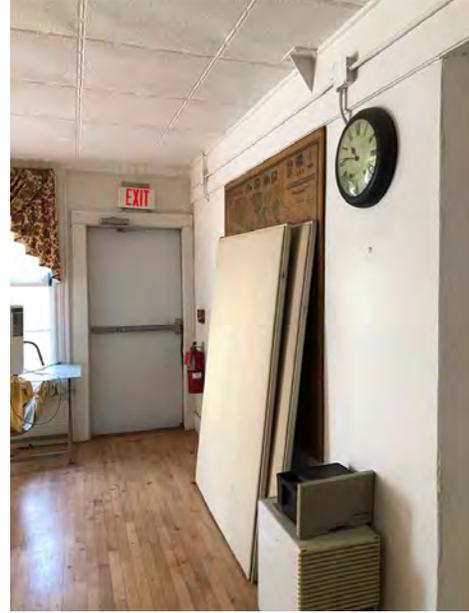
200505-IMG_6770.JPG

Exit Door to Exterior Ramp at SE Corner of Former Ground Floor Office Area; Strike Side Push Clearance at Door Inadequate on Interior Side of Exit; Pull Side Clearance at Exterior also Inadequate

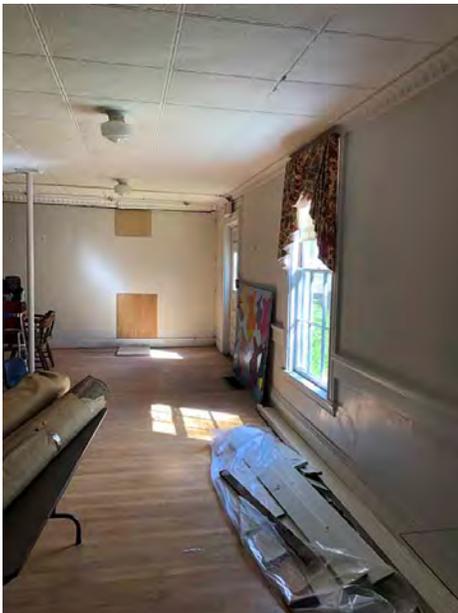
200505-IMG_6750.JPG

Looking North to NE Corner in Ground Floor; Painted Tin Ceiling, Wood Flooring, Plaster Walls; 6-over-6 Window; Blocked Exit Door Beyond

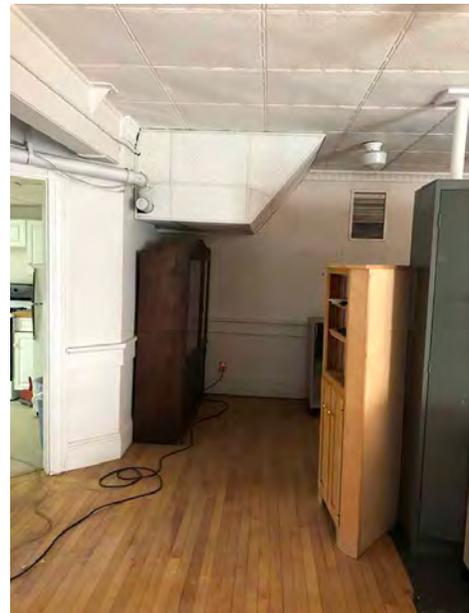
200505-IMG_6749.JPG

SW Corner of Former Office Area Adjacent to Kitchen; Acoustical Tile Ceiling Soffit Conceals Oil-Fired Furnace Flues to Brick Chimney at Left

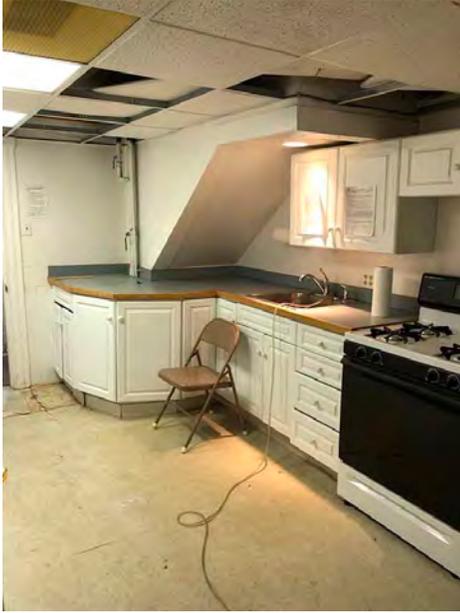
200505-IMG_6771.JPG

SW Corner of Ground Floor Kitchen with Ceiling Soffit Below Stairs to First Floor; Gas Range at Right (Gas Service Disconnected)

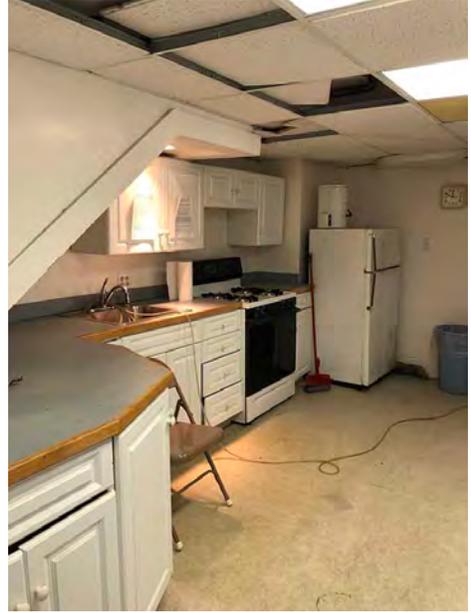
200505-IMG_6746.JPG

Ground Floor Kitchen View to NW Corner; Brick Chimney Enclosure Behind Refrigerator; Gas Stove without Gas Service or Exhaust Hood; Water Heater & Drain Ejector Pump Under Counter

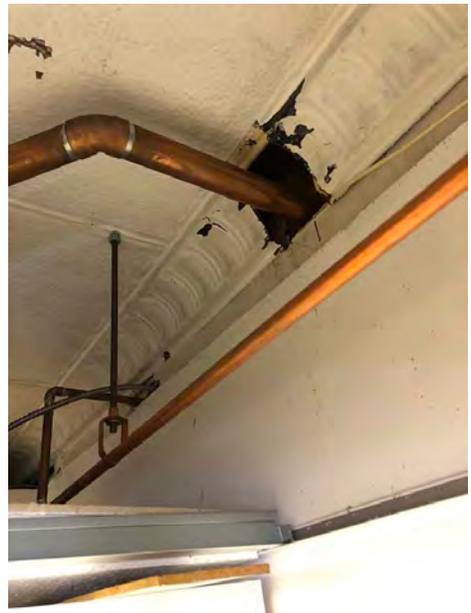
200505-IMG_6773.JPG

Copper Piping Penetrating Tin Crown Above Kitchen Ceiling

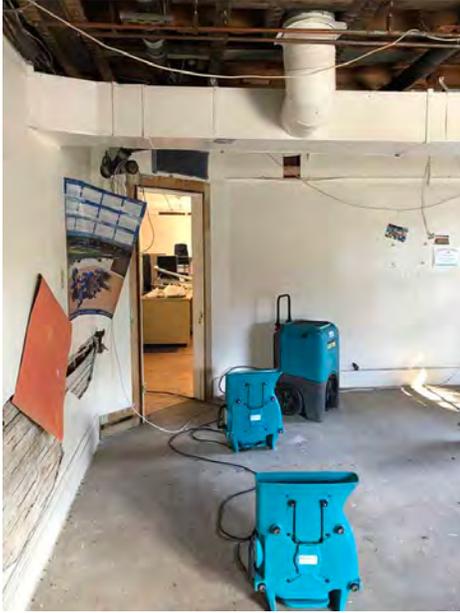
200505-IMG_6748.JPG

Painted Heating Ducts at Ceiling Serve Restrooms Above; Ceiling Removed Due to Recent Water Leak; Temporary Dehumidifiers (Blue) at Floor Level

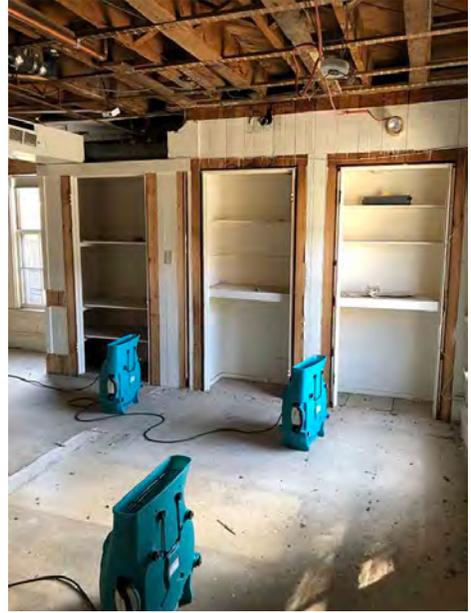
200505-IMG_6747.JPG

Dehumidifiers in Former Office Below Restrooms Following Recently Repaired Water Leak; Former Ceiling Removed to Expose Wood Framing

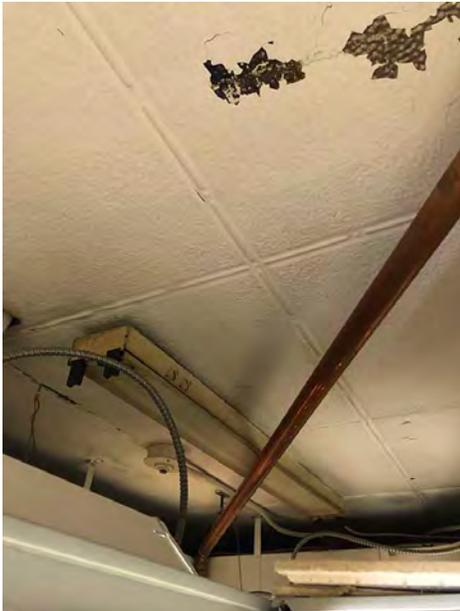
200505-IMG_6774.JPG

Copper Piping, Abandoned Light Fixture and Painted Tin Above Kitchen Acoustical Ceiling

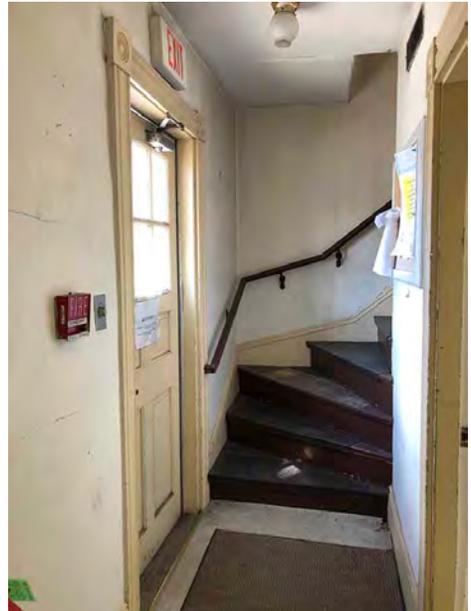
200505-IMG_6775.JPG

Winder Stairs to First Floor in SW Corner of 1895 Addition; Exterior Door to Sidewalk in South Facade at Left

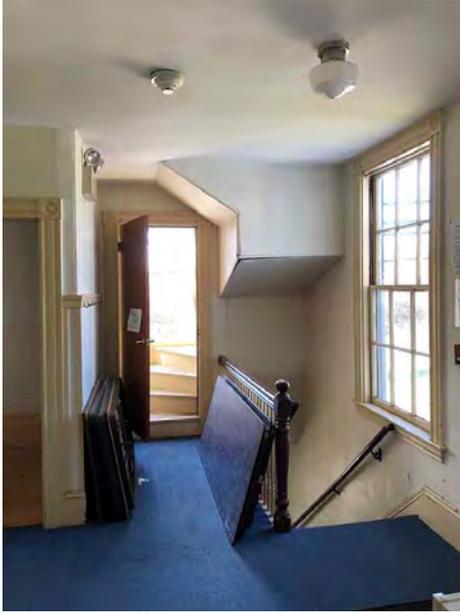
200505-IMG_6724.JPG

*Looking South in 1895 Stair Hall at First Floor;
Stairs Down to Ground Floor at Right;
Stairs Up to Attic at Left*

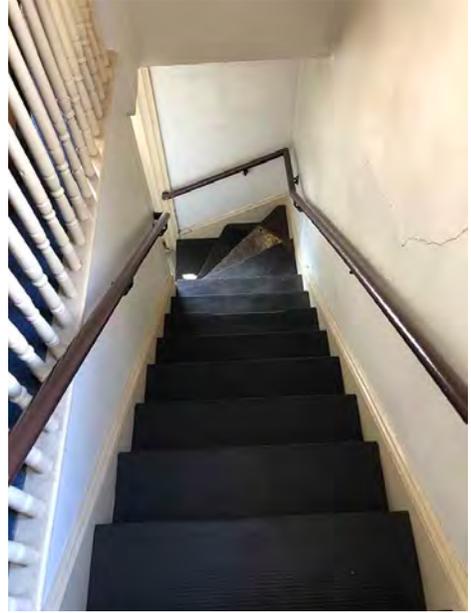
200505-IMG_6744.JPG

*Looking Down Winder Stairs in 1895 Ell from
First Floor to Ground Floor Level*

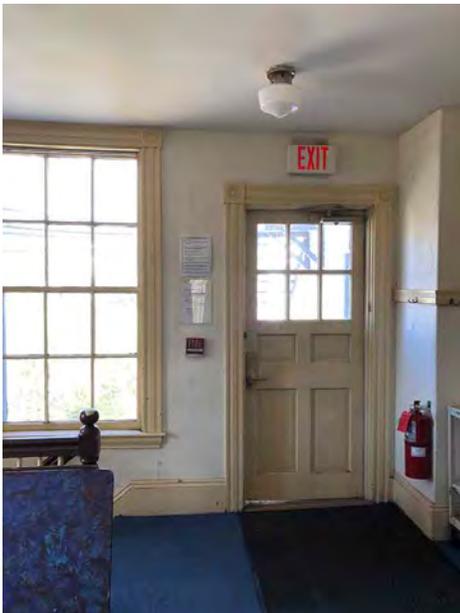
200505-IMG_6730.JPG

*Side Entrance from Exterior Ramp into 1895 Addition at
First Floor Stair Hall; Chimney Enclosure at Right;
Stairs Down to Ground Floor at Left*

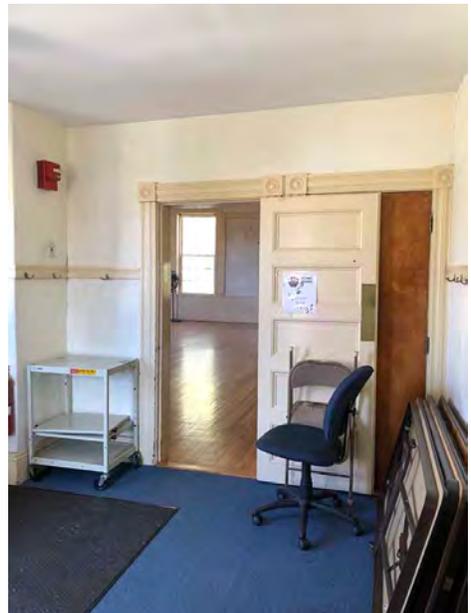
200505-IMG_6729.JPG

*One of Two Doors from Ell Addition into Great Hall;
Each Door is 32" Wide and not Handicap Accessible*

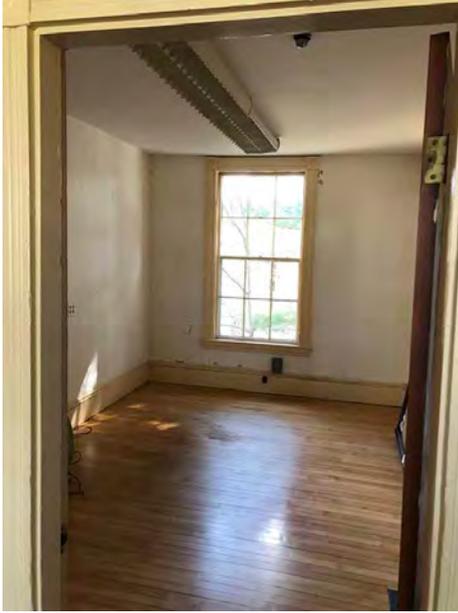
200505-IMG_6725.JPG

*Former Office at First Floor of 1895 Ell
Adjacent to Stair Hall; Window in East Wall;
Louvered Strip Fluorescent Light Fixture;
32" Wide Door not Handicap Accessible*

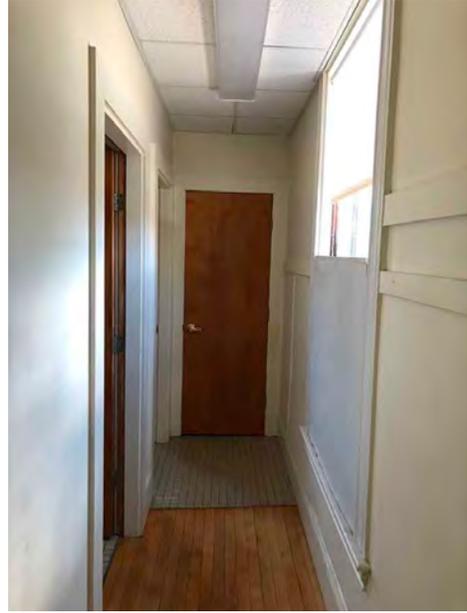
200505-IMG_6726.JPG

*Passage at South Side of Building to Public Restrooms;
Wrap Around Acrylic Light Fixture & Acoustical Tile;
Door to Custodial Closet at End of Hall*

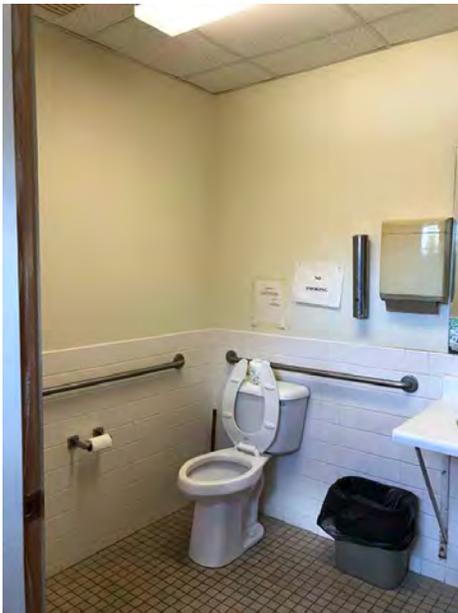
200505-IMG_6728.JPG

*First of Two Public Accessible Restrooms at
First Floor of 1895 Ell Addition*

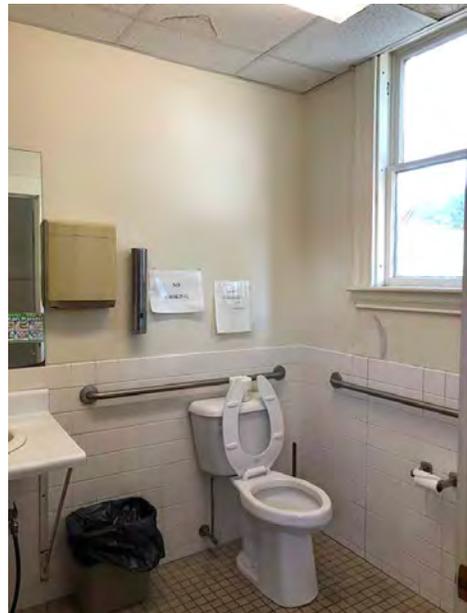
200505-IMG_6727.JPG

*Second of Two Public Accessible Restrooms at
First Floor in SE Corner of 1895 Ell*

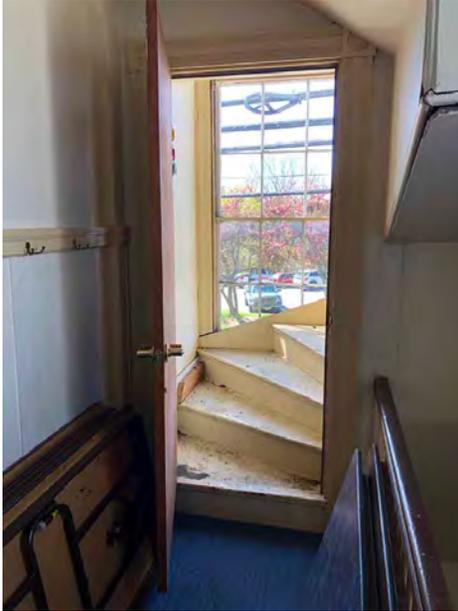
200505-IMG_6732.JPG

*Winder Stairs from First Floor of 1895 Ell to Attic;
No Handrails at Stair*

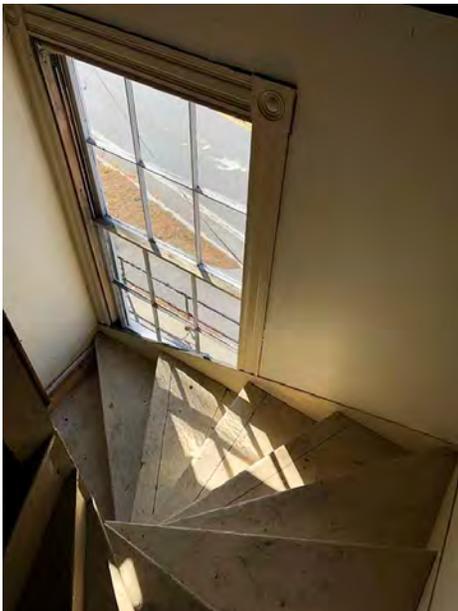
200505-IMG_6743.JPG

*Looking Down 1895 Ell Attic Winder Stairs;
No Handrails; South Wall Window at Great Road*

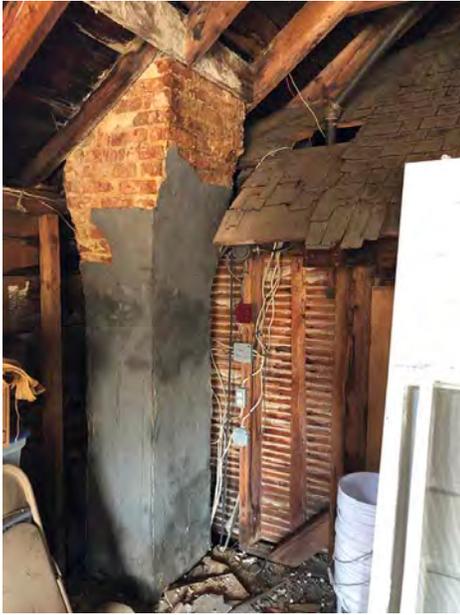
200505-IMG_6734.JPG

*Parged Brick Furnace Chimney in NW Corner of 1895 Attic
Adjacent to Former Exterior Wall of 1848 Town Hall;
Original Clapboards of South Wall Removed*

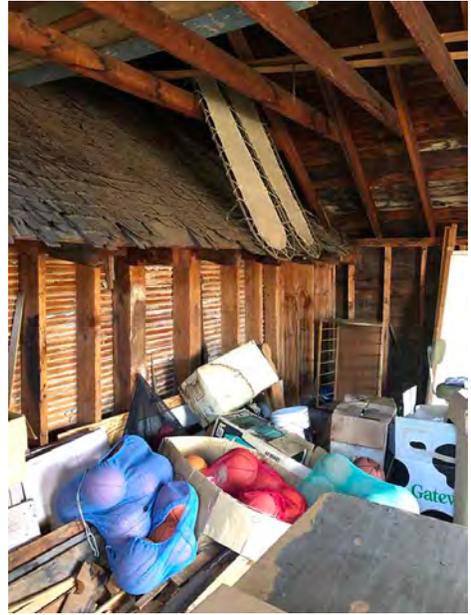
200505-IMG_6735.JPG

*Siding Removed Revealing Lath & Plaster of 1848 Wall;
Wood Shingles Remaining at South Slope of 1848 Roof*

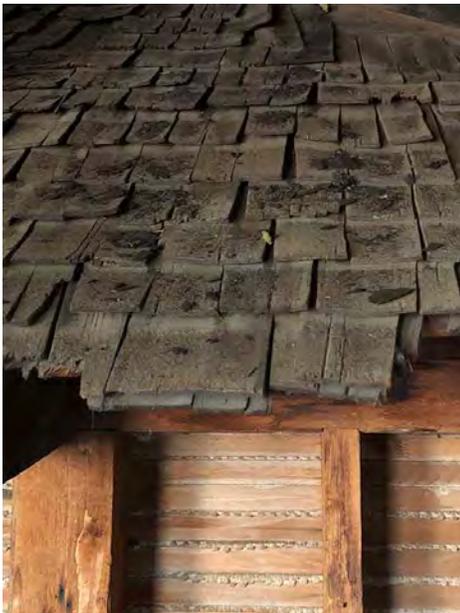
200505-IMG_6738.JPG

*Detail of Wood Shingles at 1848 Roof Surface;
Wood Lath and Plaster Keys in Great Hall Wall Where
Plaster was Replaced in 1895 when Ell was Added*

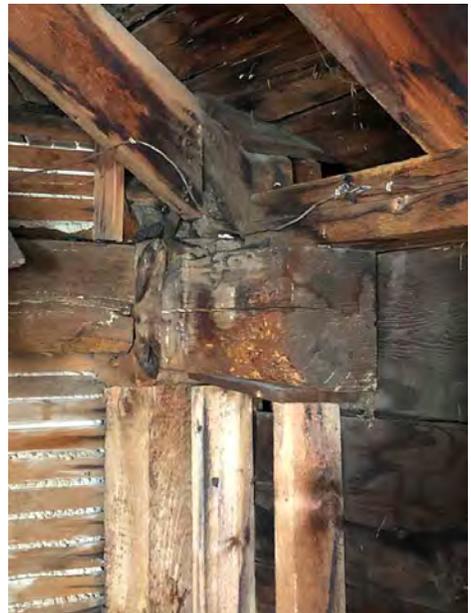
200505-IMG_6737.JPG

*Exposed Timber Beam End at NE Corner of 1895 Attic
Adjacent to SE Corner of Original 1848 Wall*

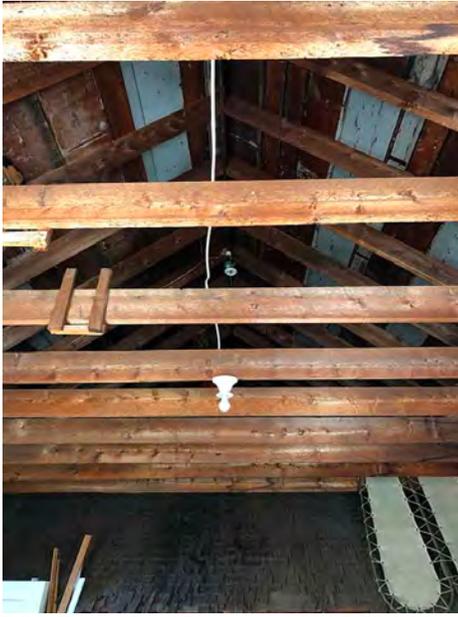
200505-IMG_6741.JPG

Collar Ties in Roof Framing of 1895 Ell Addition

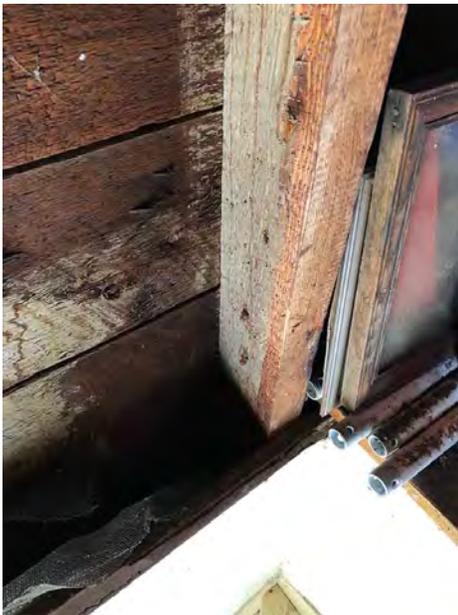
200505-IMG_6742.JPG

*Exposed Wood Stud and Board Sheathing at
NW Corner of 1895 Ell Attic Stair;
Plaster Finish Stops at Attic Floor Level*

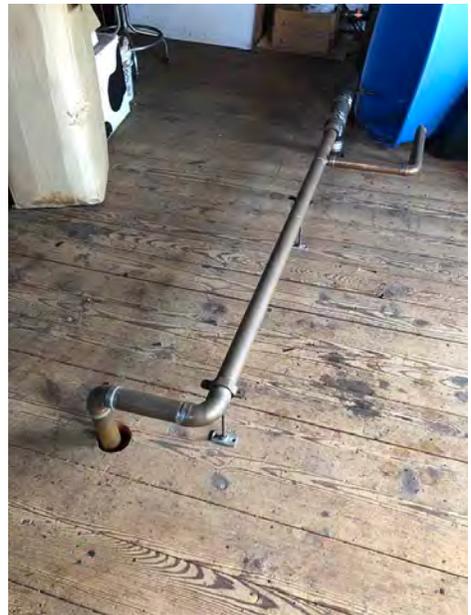
200505-IMG_6736.JPG

*Plumbing Vent from Restrooms at First Floor and
Kitchen at Ground Floor Installed Exposed
Above Floor Level of 1895 Ell Attic*

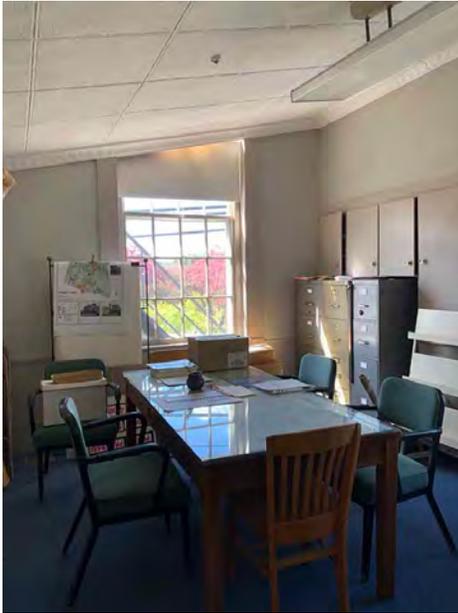
200505-IMG_6808.JPG

*Former Office Area in SW Corner of Building;
Sloping Embossed Tin Ceiling Below Balcony Framing*

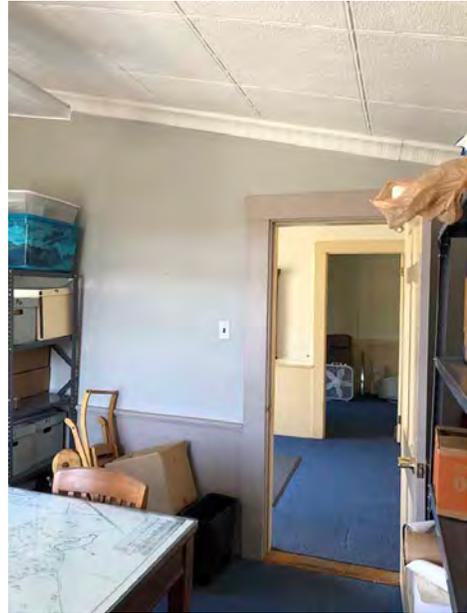
200505-IMG_6809.JPG

*Looking North in Former Office Adjacent to 1848 Entrance
Foyer Beyond; Sloping Tin Ceiling of Balcony Above;
32" Wide Door not Handicap Accessible*

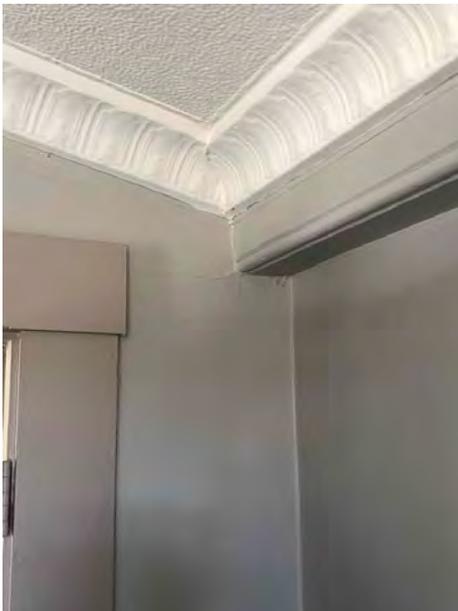
200505-IMG_6810.JPG

*Detail of Painted Tin Crown Moulding at Ceiling of
Former Office on South Side of 1848 Entrance Foyer*

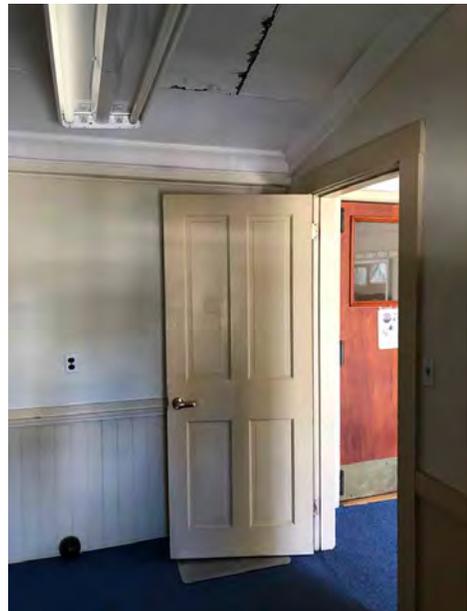
200505-IMG_6812.JPG

*Four-Panel Door Leading from 1848 Entrance Foyer
into Former Office at North Side of Foyer;
32" Wide Door not Handicap Accessible*

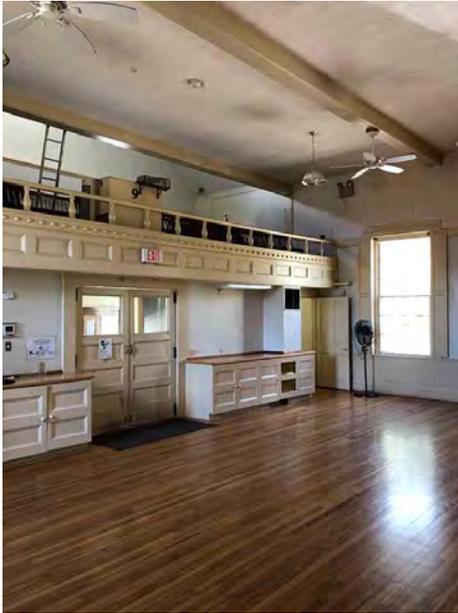
200505-IMG_6807.JPG

*Great Hall and Balcony with Entrance Foyer Beyond;
Built-in Cabinetry Added in 2000 Renovation;
Duct Chases from Oil-Fired Furnaces Below;
Attic Access Ladder Visible at Upper Left*

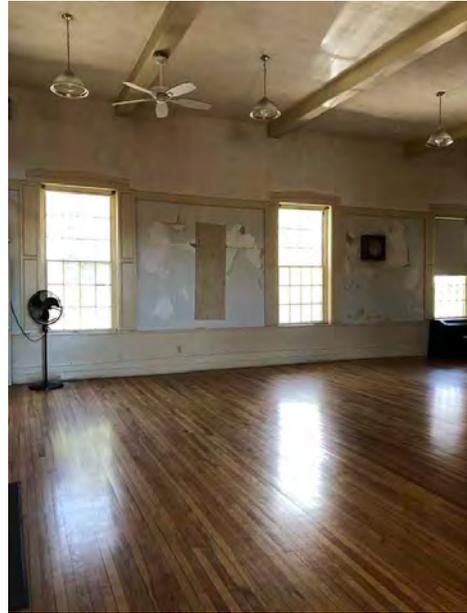
200505-IMG_6813.JPG

*Looking North in Great Hall Across Oak Flooring;
Ceiling Fans and Floor Fan are Existing "Cooling" System*

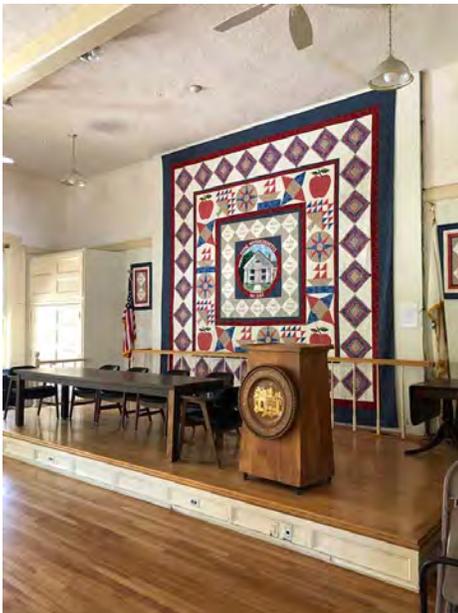
200505-IMG_6777.JPG

*Stage of Great Hall with Podium and Town Quilt;
Storage Closets on Each Side of Stage from 2000*

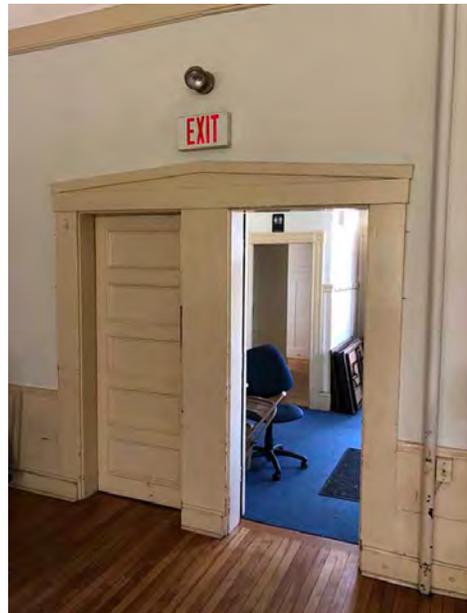
200505-IMG_6806.JPG

*Pair of Doors at Exit from Great Hall to 1895 Ell;
Head Casing Detail Matches Windows of Town Hall;
Doors 32" Wide not Handicap Accessible*

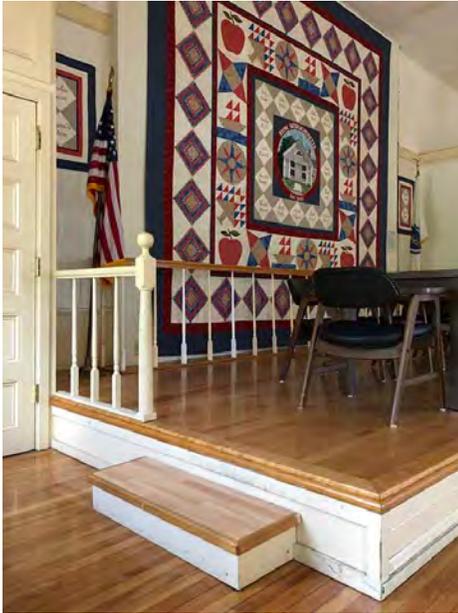
200505-IMG_6817.JPG

One Tread and Two Risers to Great Hall Stage at Each End of Stage; Stage not Wheelchair Accessible

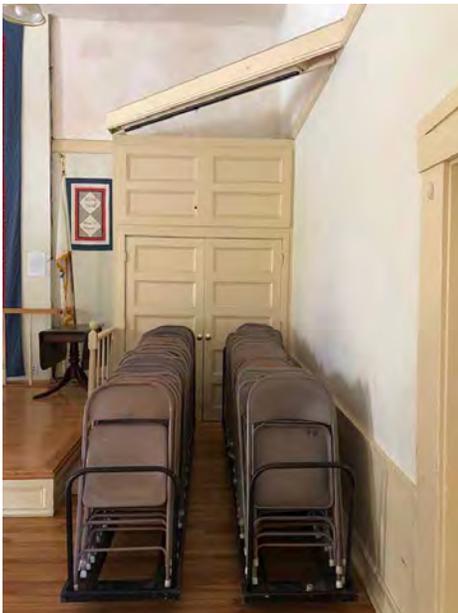
200505-IMG_6776.JPG

Chair Storage Dollies and Closet at SE Corner of Great Hall; Projection Screen Mounted at Angle Above Storage in Cased "Beam" is Manually Operated with Pull String; Video or Slide Projector is Setup on Stand When Used

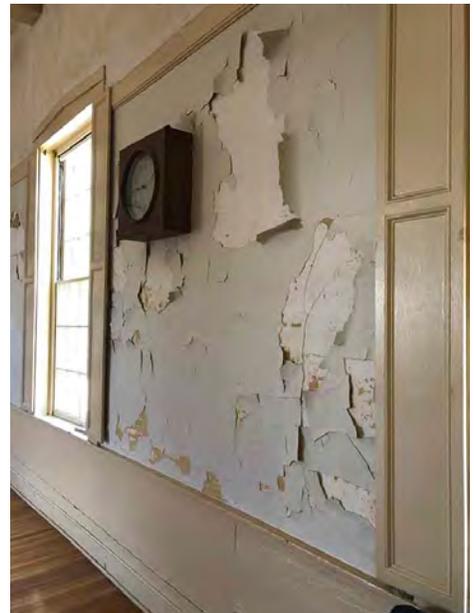
200505-IMG_6780.JPG

Peeling Paint at Plaster of Great Hall; Painted Wainscoting Below Windows and Acoustical Finish Above Windows; Wall-Mounted Clock on North Wall of Great Hall; Exterior Walls are not Insulated

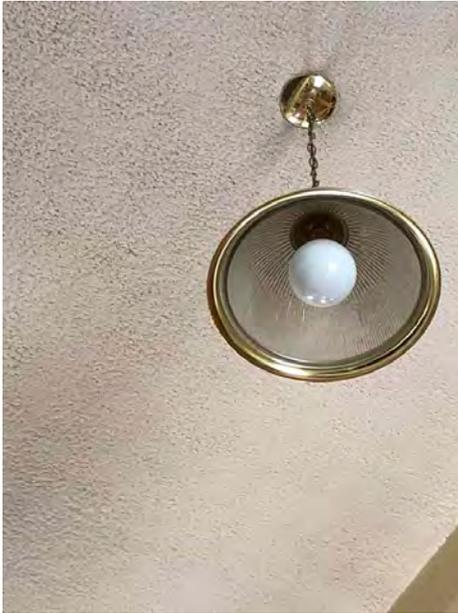
200505-IMG_6814.JPG

*Textured Ceiling Finish Reduced Reverberation in Great Hall;
Acoustical Finish and Light Fixtures Referenced in "Stow-Info"
Historical Society Newsletter of February 2000*

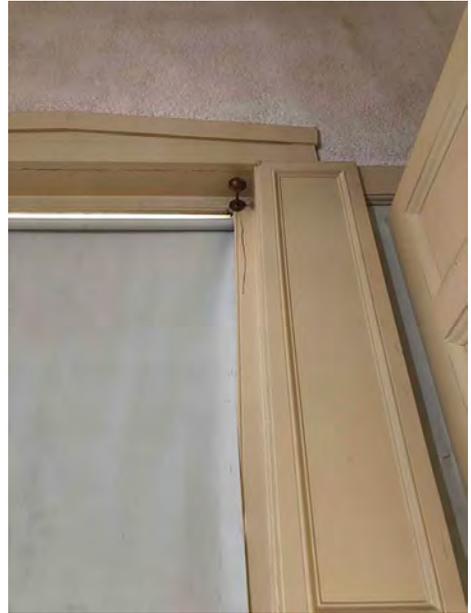
200505-IMG_6782.JPG

*Great Hall Window Head Casing and
Fixed Interior Shutters at Jamb;
Former Drapery Hardware at Head*

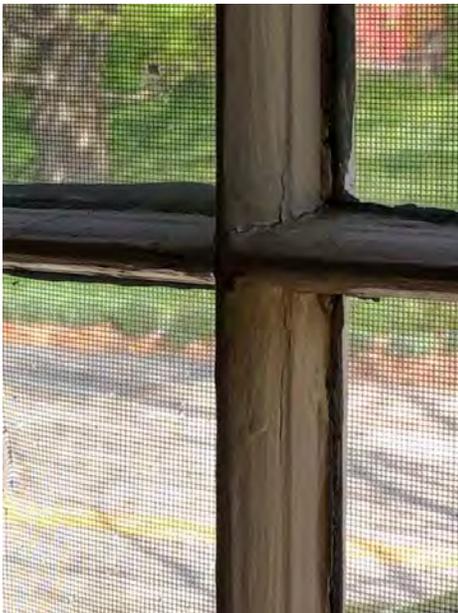
200505-IMG_6783.JPG

*Greek Revival Muntin Profiles in Great Hall Window Sash;
Half Screens Visible at Exterior of Lower Sash*

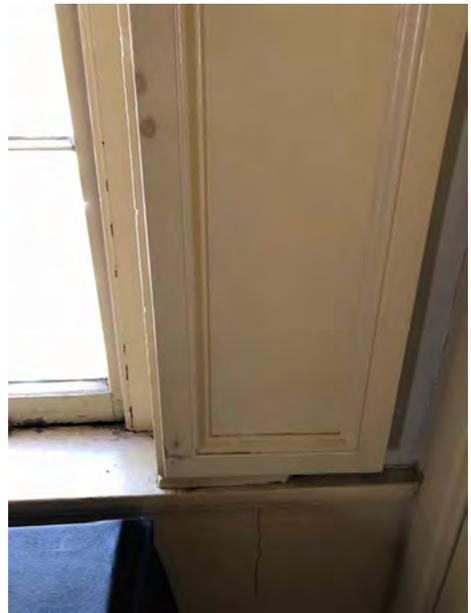
200505-IMG_6781.JPG

*Interior Shutter Fixed in Place at Great Hall Window
Appears to be Solely Decorative - Not
Wide Enough to Cover Half of the Window*

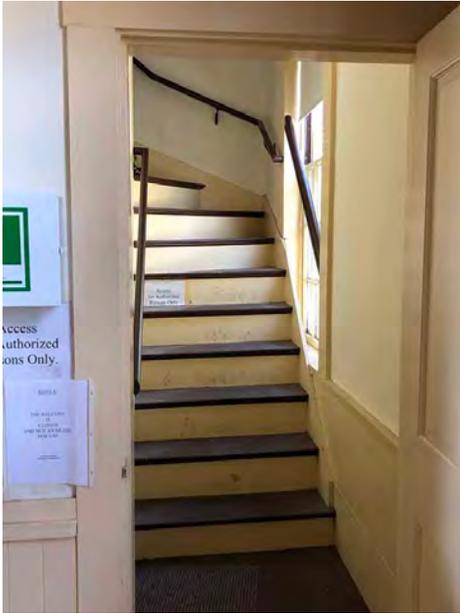
200505-IMG_6786.JPG

*Stair Leading from Main Hall to Balcony in NW Corner;
Discontinuous Handrails on Both Sides of Stairs*

Recommended work in the project includes replacement of the balcony stair handrails per 521 CMR 27.4, reduction of seating capacity (while retaining "authorized only" use limitations), and improvements to the historic guardrail. The Town will post a maximum occupancy load of 49 persons (down from the current 71) in order to remove the emergency exit and exterior fire escape stair since only one means of egress would then be required. The variance from 521 CMR 14.1 requests that the balcony tiered seating gallery remain as-is, along with the 32" door and the winder stairway. If full compliance with 521 CMR 14.1 were required, the following additional work would need to be performed:

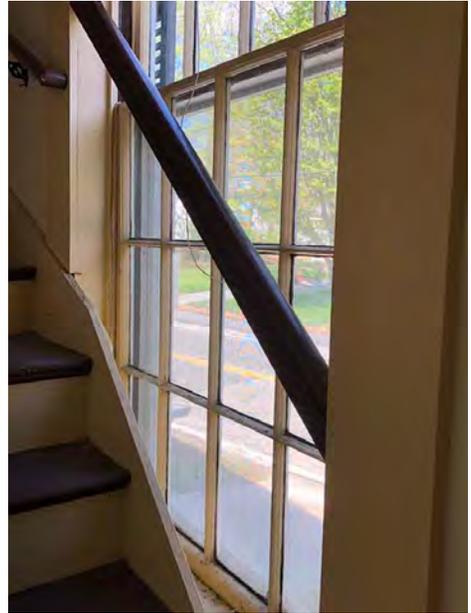
200505-IMG_6787.JPG

Guard Rail Adjacent to Balcony Stair at Window Opening

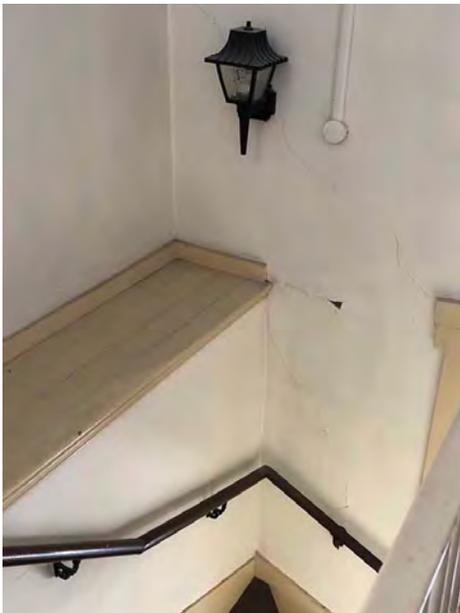
200505-IMG_6803.JPG

*Northwest Corner of Balcony at Stair;
Outdoor Type Fixture Mounted on Wall*

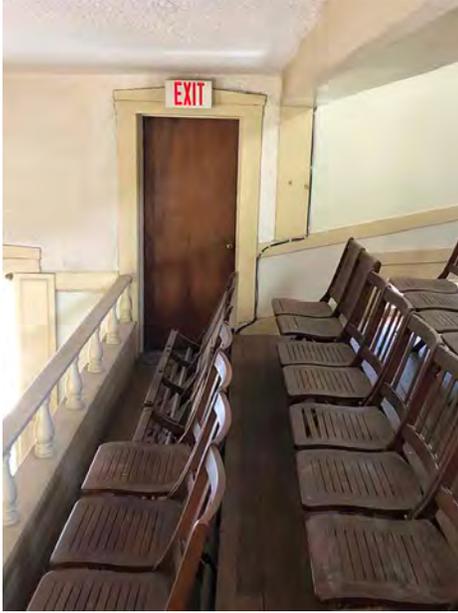
200505-IMG_6800.JPG

*Front Rows of Balcony with South Exit to Fire Escape;
Exit Door Operates with Extreme Difficulty;
Second Exit Required if 50 or More Occupants in Balcony*

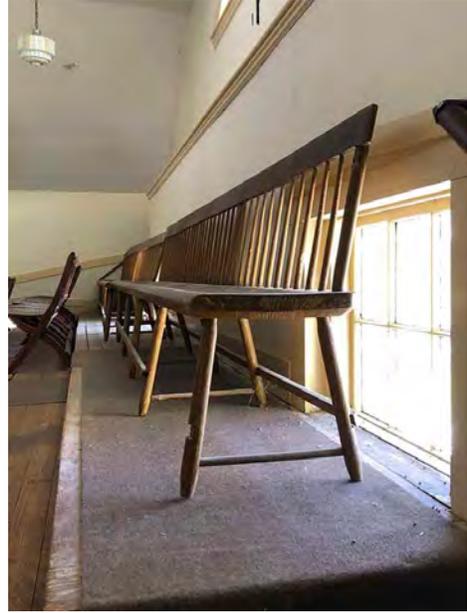
200505-IMG_6788.JPG

*Back Row of Balcony with "Deacon's Bench" Seating;
Differs from Other Folding Seating Sections in Balcony*

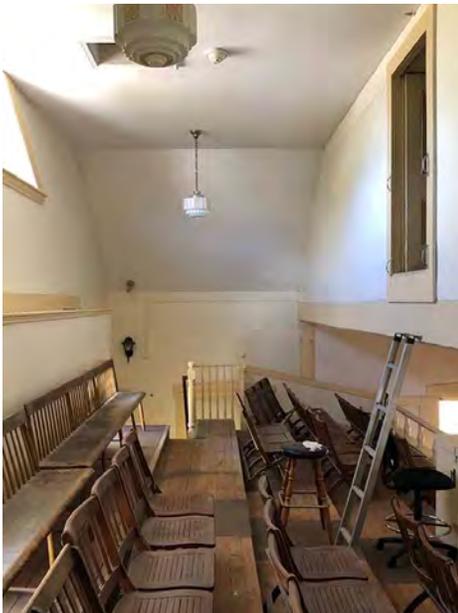
200505-IMG_6790.JPG

*Looking North in Balcony Area Toward Stair;
Attic Access Thru Hatch in Wall at Right via
Aluminum Ladder Hitched in Place & Removable*

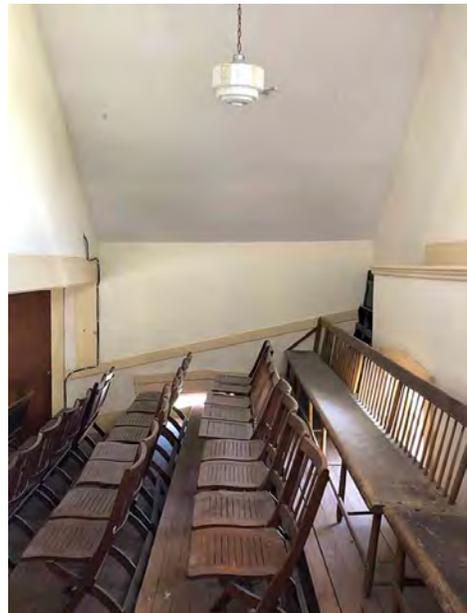
200505-IMG_6789.JPG

*Looking South in Balcony Area;
Total of Five Stepped Tiers in Balcony;
Folding Chairs at Lower Four Tiers and
Deacon's Bench at Upper Fifth Tier*

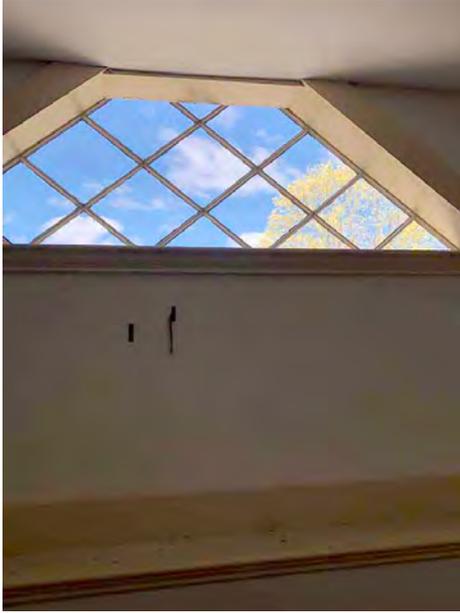
200505-IMG_6792.JPG

*Iconic Window at Gable End of Entrance Facade
Upper Portion Partially Concealed by Balcony Ceiling;
Window Configuration Similar at Town Offices Building*

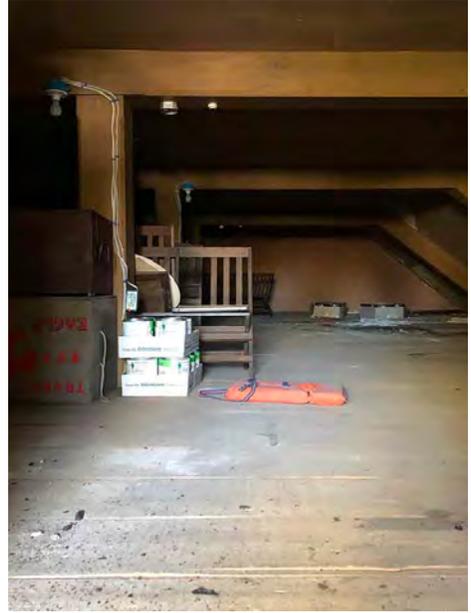
200505-IMG_6791.JPG

*Attic Area Above Main Hall with King Posts of Roof Trusses;
Storage Area not Original from 1848 as Evidenced by
Painted Casings on Timber Trusses and Plaster Ceiling*

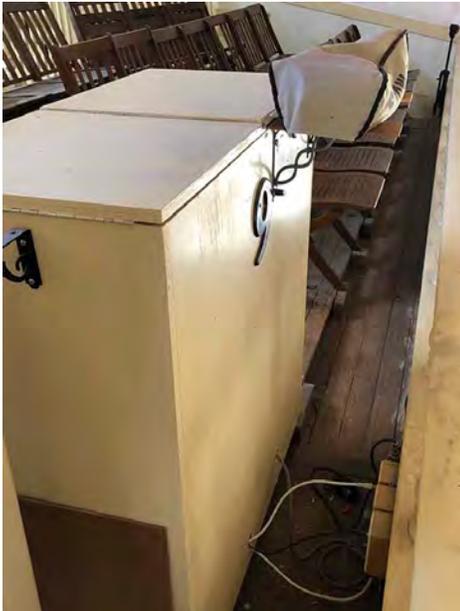
200505-IMG_6793.JPG

*Projection Equipment at Front Row of Balcony;
Storage Cabinet for Audiovisual Equipment;
Local Access TV Channel 9 Identified on Cabinet*

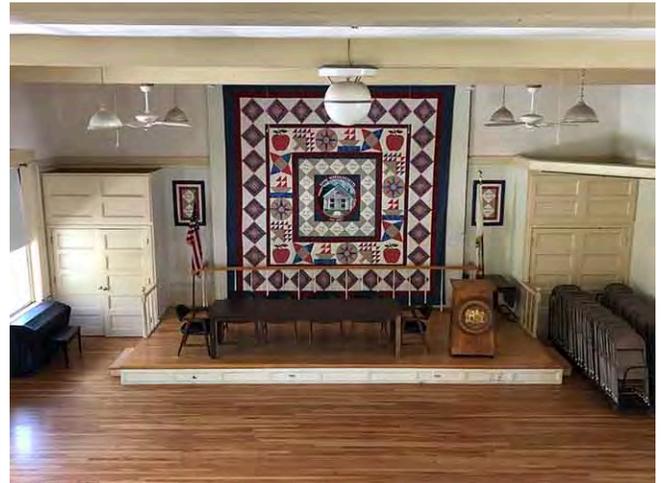
200505-IMG_6794.JPG

*View of Great Hall Stage from Balcony Level;
Storage Cabinets at Each Side of Stage Referenced as
Part of Improvements in Feb 2000 "Stow-Info"*

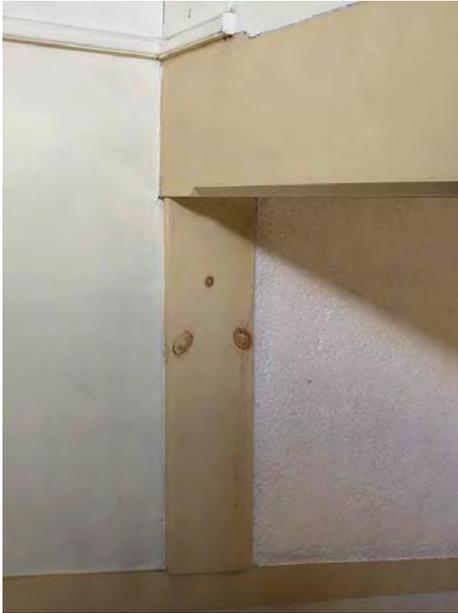
200505-IMG_6801.JPG

Painted Pilaster and Chamfered Beam at Intersection of Attic Framing to North Wall of Balcony at Main Hall; Low Headroom at Beam in Balcony (68" Above Tier 2); Pilaster Added as a Stop for Sprayed Acoustical Finish

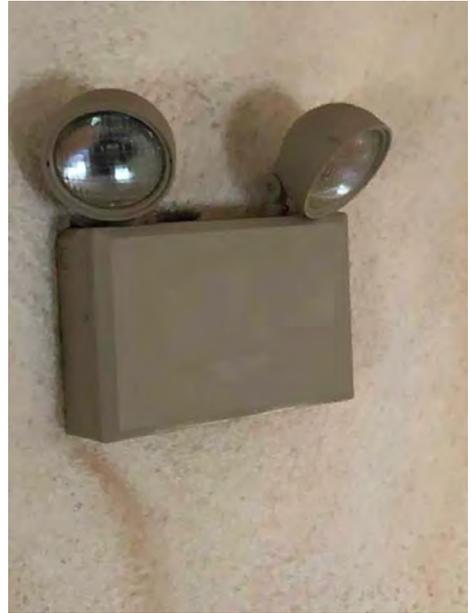
200505-IMG_6798.JPG

Dual Head Battery Pack Emergency Light in Great Hall; Textured Finish at Upper Wall (and Ceiling) is Sprayed Acoustical Finish from 2000 Renovation

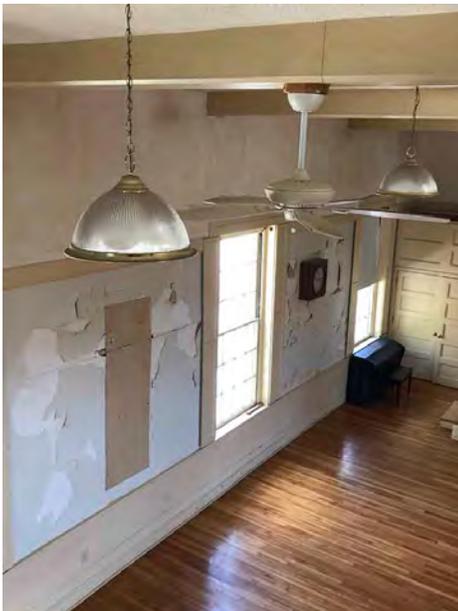
200505-IMG_6796.JPG

Pendant Ceiling Fixtures and Paddle Fans in Great Hall Referenced as Part of Renovations in 2000

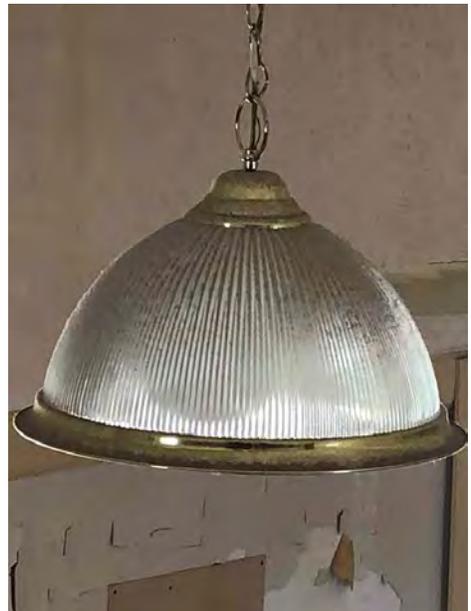
200505-IMG_6797.JPG

Ribbed Glass Shade on Pendant Fixtures in Great Hall from 2000 Renovations

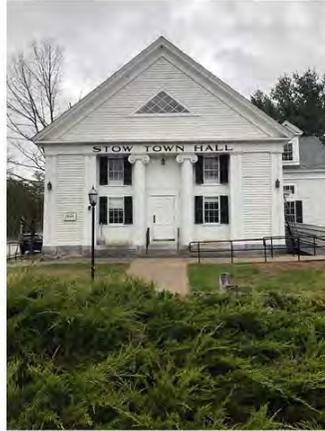
IMG_6471.JPG

*Front Facade of Existing Building;
1848 Greek Revival Structure*

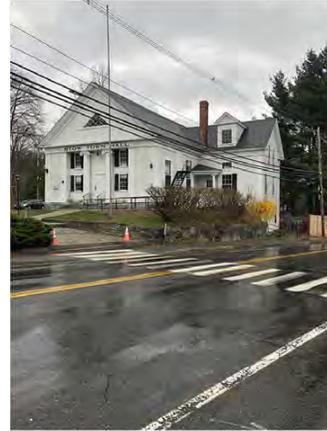
IMG_6473.JPG

*View Across Great Road Showing
1848 Original Building and 1895 Ell Addition*

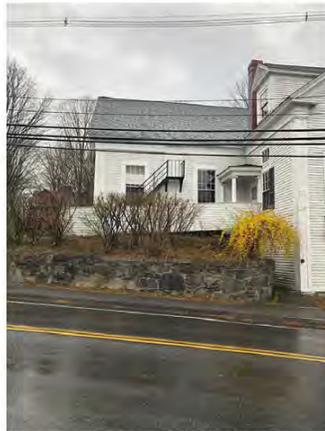
IMG_6476.JPG

*View Across Great Road Showing
South Elevation Fire Escape & Access Ramp*

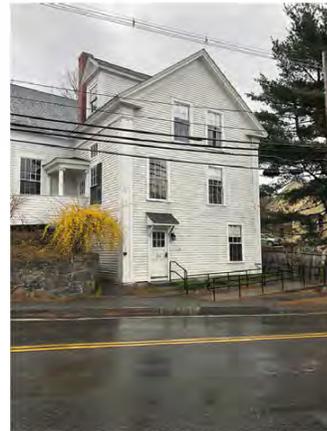
IMG_6475.JPG

*South Facade of 1895 Ell with Multiple
Entrances to Ground Floor Level*

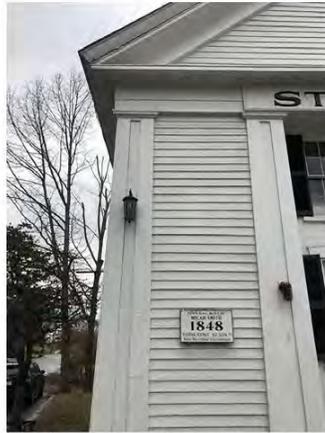
IMG_6490.JPG

Detail at Northwest Corner of Front Facade

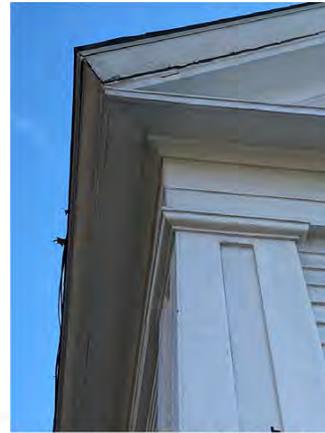
IMG_8233.JPG

*Detail of Corner Pilaster, Frieze, Rake & Clapboards
Typical of Greek Revival Style*

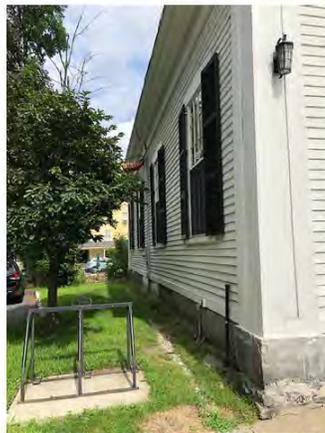
IMG_7782.JPG

*North Facade of Building Facing Crescent Street;
Continuous Granite Plinth Typical of Greek Revival*

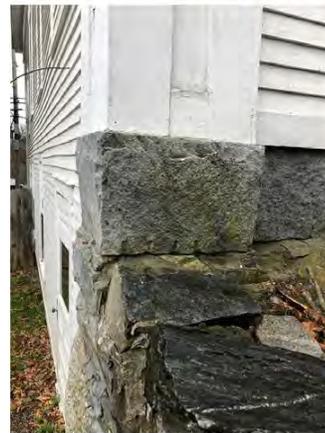
IMG_6453.JPG

*Detail of Granite at Northeast Cornerstone
Showing Tooling Marks from Quarry*

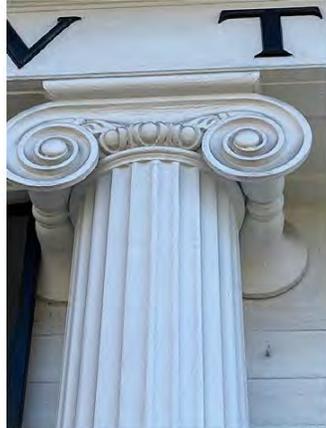
IMG_8236.JPG

One of Two Fluted Wooden Column with Ionic Capitals at Front Facade; Pair Frames Entry & Supports Pediment

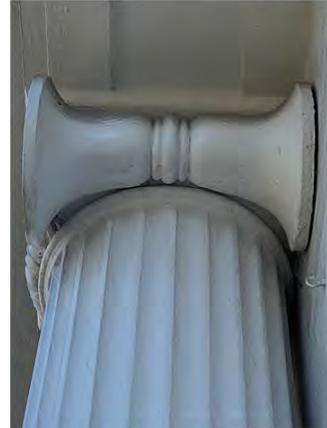
IMG_8237.JPG

Detail of Column and Capital

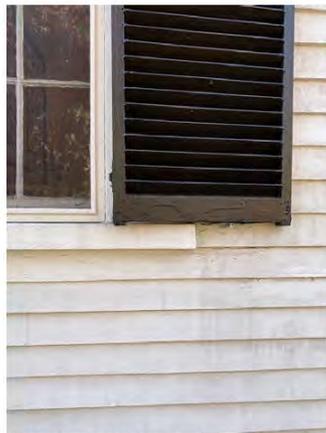
IMG_8186.JPG

Window Sill Detail with Operable Shutter; Typical at North Facade

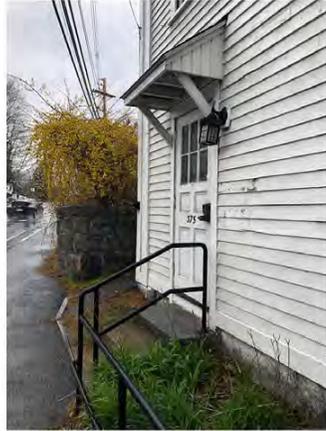
IMG_6485.JPG

South Stepped Entrance Leading from Great Road into Stair Hallway

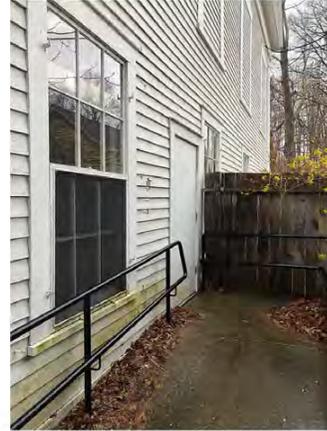
IMG_6484.JPG

Existing "Accessible" Ramp at East Side of Building; Insufficient Landing and Door Clearances

- Replace the marginally compliant accessible entrance into the first floor of the Ell by removing the existing 1:12 ramp and its smaller-than-required landing at the 90-degree change in direction, along with removing the entrance door that does not provide adequate maneuvering clearance. The ramp will be replaced with an accessible walkway of maximum 1:20 running slope. The Ell entry will be replaced with a compliant door at grade that will lead to a lowered entry foyer.

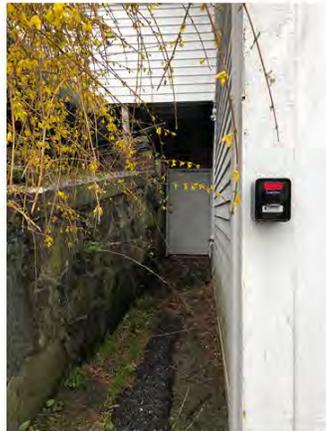
IMG_6480.JPG

36" Wide Service Alley Between Stone Retaining Wall and Adjacent 1895 Ell; Entrance to First Floor Above; Walkway to be Widened for Accessible Entrance to Ell

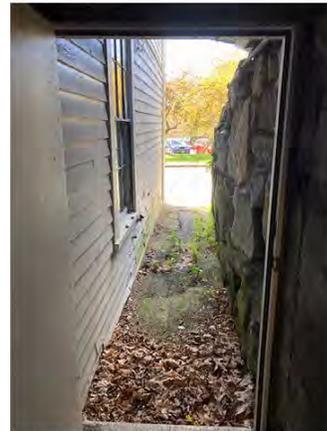
IMG_6764.JPG

View from Utility Room at Service Alley; Stone Wall is Bulging and Requires Repair; Area to be Reconfigured for Accessible Entrance
