FIVE OPTIONS

Stow Town Hall Renovation
375 Great Road / Stow MA

MILLS WHITAKER ARCHITECTS LLC

01 August 2022

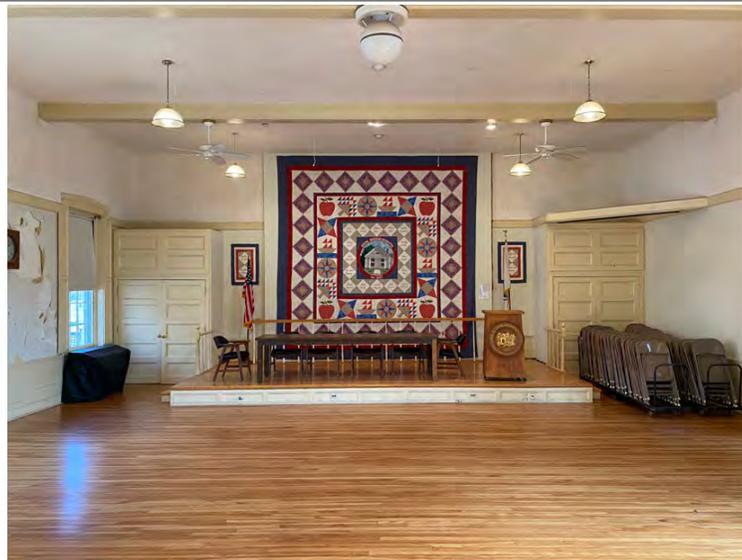
VIEW OF GREAT HALL FROM ENTRANCE FOYER

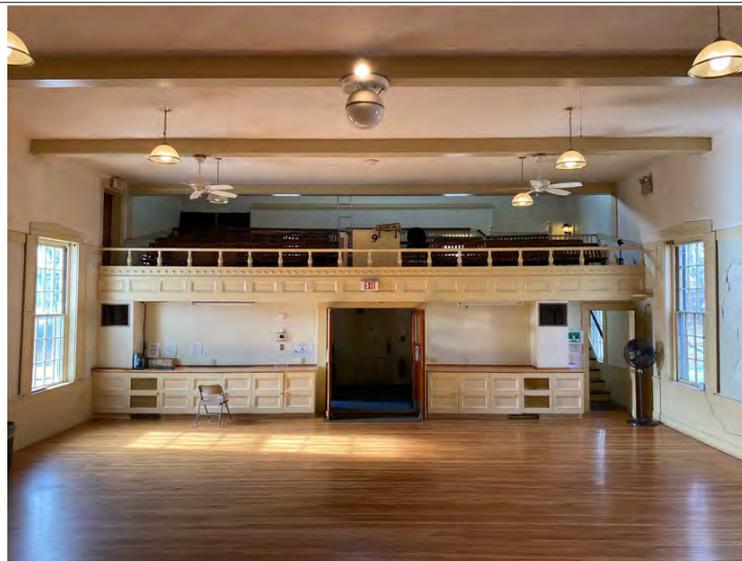
VIEW OF GREAT HALL & BALCONY FROM STAGE AREA

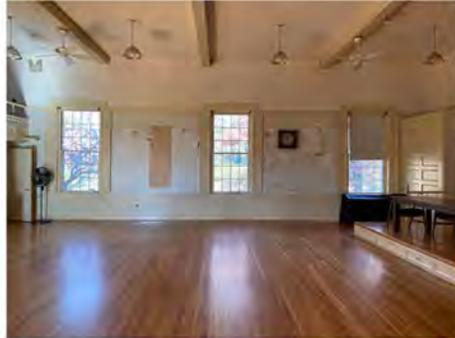
IMG_8211.JPG

Looking North from Ell Across Great Hall;
Three Original Window Openings in Wall Beyond;
Raised Wood Dais (Stage) at Right Along East Wall

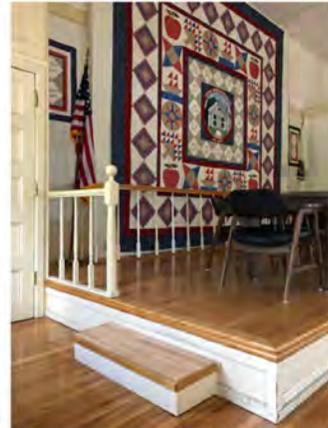
IMG_6817.JPG

12" Rise via Treads at Each End of Existing Stage;
Circa 2000 Storage Closet at Left;
Large Central Quilt and Two Flanking Quilts
from 2000 Commemorate the Town

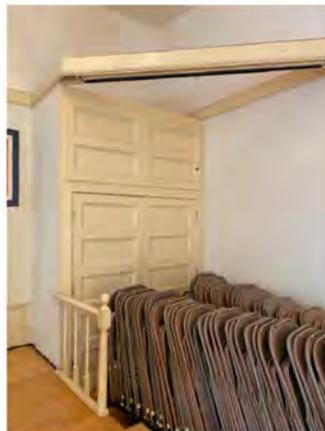
IMG_8216.JPG

Circa 2000 Storage Unit at South End of Stage with
Chair Storage Trolleys Blocking Doors; Projection
Screen at Diagonal Brace Above; This Corner to be
Location for an Accessible Ramp to Stage

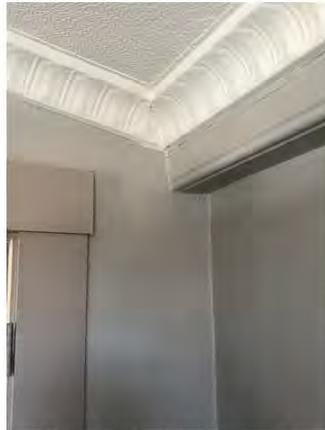
IMG_6810.JPG

Detail of Painted Tin Ceiling and Crown at First Floor Office Below Balcony of Great Hall Above

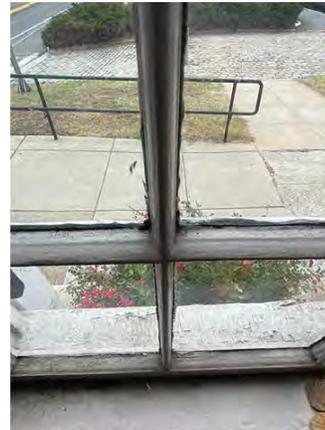
IMG_8457.JPG

Original Window Sash with Typical Greek Revival Style Mullins

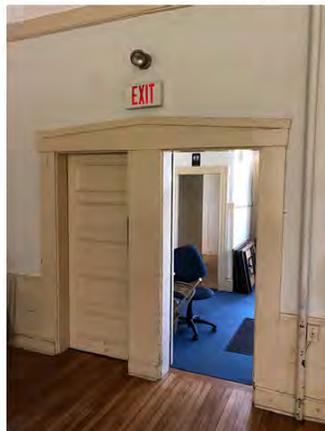
IMG_6806.JPG

Pair of 32" Doors from Great Hall into 1895 Ell; Project to Retain Original Framed Opening and will Provide Accessible Door in Center with Equal Sidelights

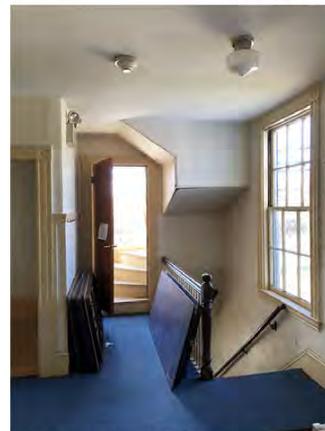
IMG_6724.JPG

Existing Entrance Area of 1895 Ell with Corner Stairs; Stairs to be Rebuilt and Vertical Access to be Provided via a Proposed Limited Use Elevator Adjacent to Stairs

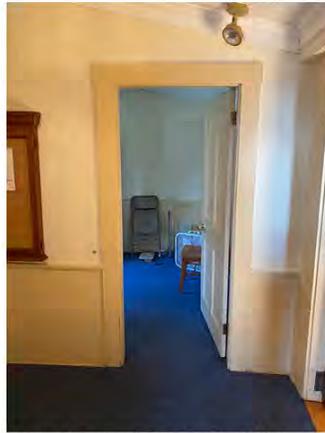
IMG_8212.JPG

Typical Flat Interior Casings in 1848 Foyer; Rush Wood Wainscoting; Painted Tin Ceiling

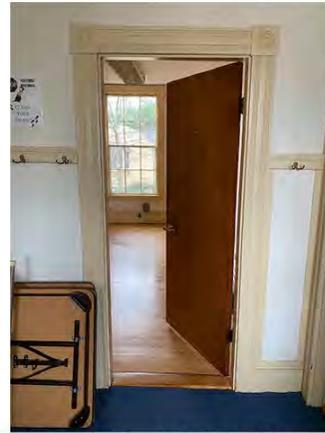
IMG_8425.JPG

Typical Belly Band Interior Casings with Rosettes in 1895 Ell at Windows at Doors; No Wainscoting and Painted Plaster Ceilings; Maple Flooring Below Carpet

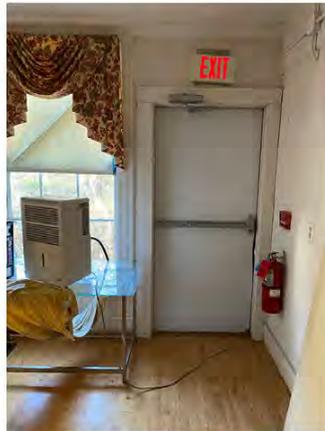
IMG_8202.JPG

Interior View of "Accessible" Door at Ground Floor from Exterior Ramp will be Removed as part of the Project; Adjacent Window to Remain and be Restored

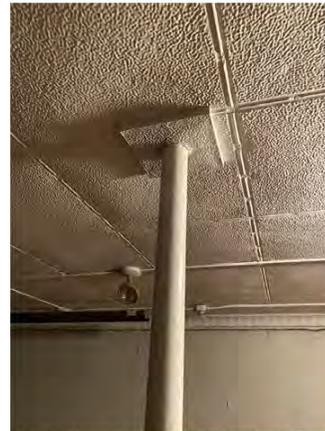
IMG_8361.JPG

Textured Painted Tin Ceiling in Office Area of Ground Floor; Simple Clad Column Capital Typical Where in Finished Area

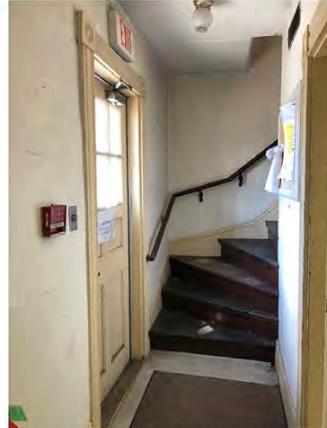
IMG_6775.JPG

Winder Stairs in 1895 Ell at Ground Floor with Adjacent Exit Door Leading to Great Road

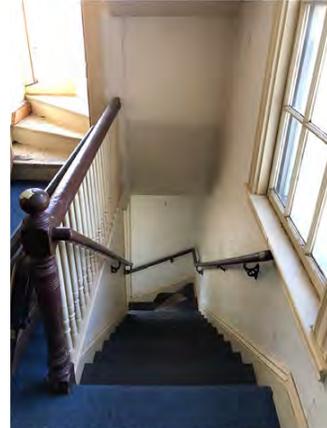
IMG_6731.JPG

View in 1895 Ell from First Floor Down Stairs to Ground Floor with Winders at Turn Below

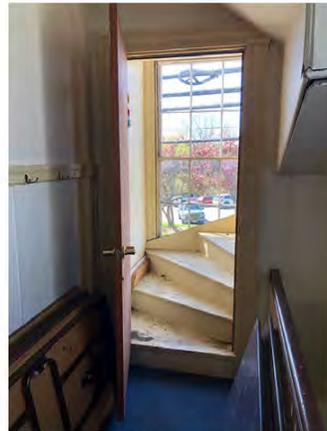
IMG_6732.JPG

Attic Stairs in Ell Originating at First Floor; Winders at Each of Two Turns in Stair Run

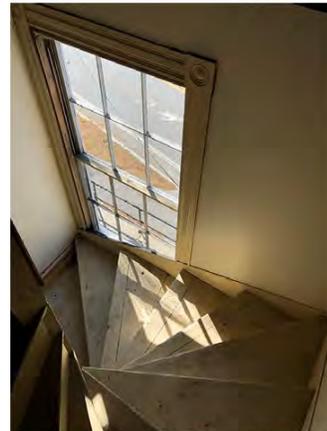
IMG_6743.JPG

View from Attic of Ell Down Stairs; Original Window at South Facade to be Restored

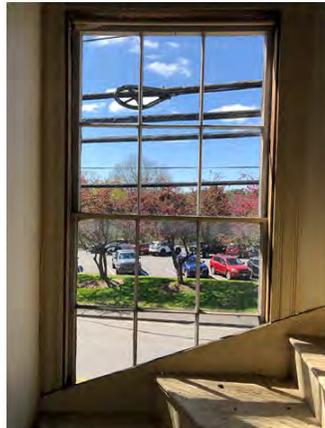
IMG_6733.JPG

Attic Stair Adjacent to Window in South Facade of 1895 Ell with Original Sash to be Restored

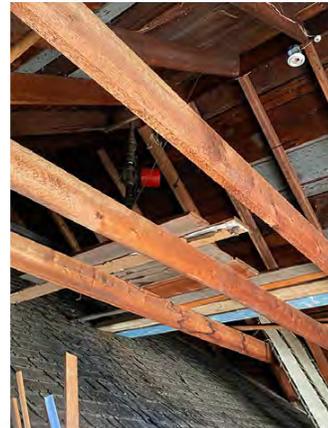
IMG_8189.JPG

Exposed Collar Ties and Rafters of 1895 Ell in Attic

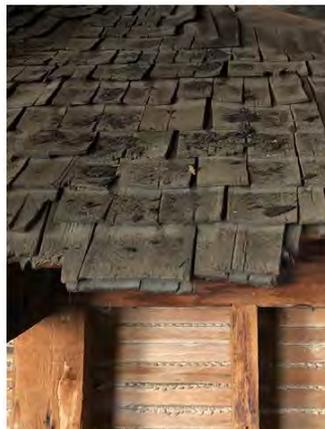
IMG_6738.JPG

Exposed Former Wood Shingles on South Slope of Original Roof Visible in 1895 Attic of Ell

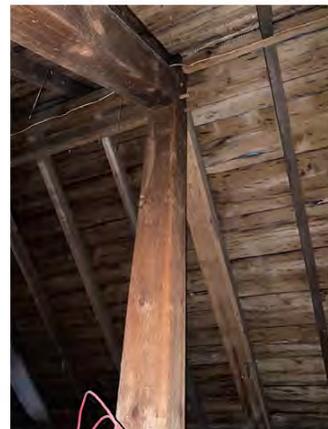
IMG_8158.JPG

Timber King Post in 1848 Concealed Upper Attic Area

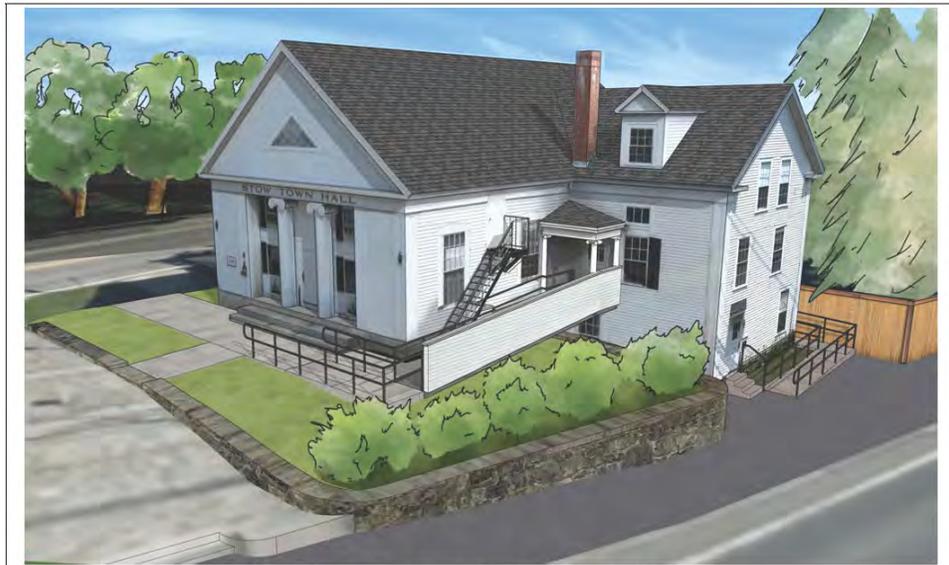
EXISTING AERIAL VIEW SKETCH OF 1848 BUILDING AND 1895 ELL WITH BALCONY FIRE ESCAPE, ENTRY RAMP TO ELL, GROUND FLOOR ENTRY RAMP

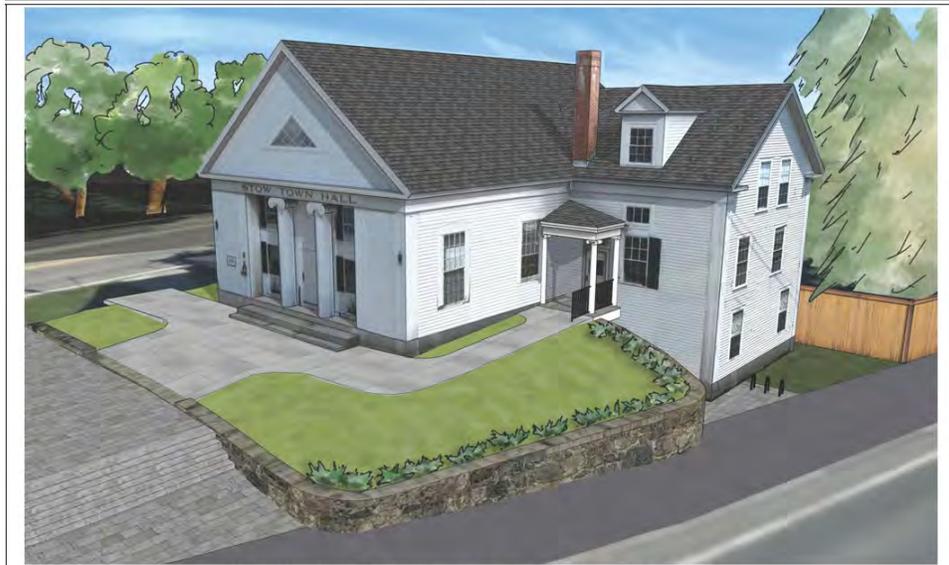
PROPOSED AERIAL VIEW SKETCH OF 1848 BUILDING AND 1895 ELL WITH SITE SIMPLIFIED TO RESTORE 1895 APPEARANCE AFTER ADDITION

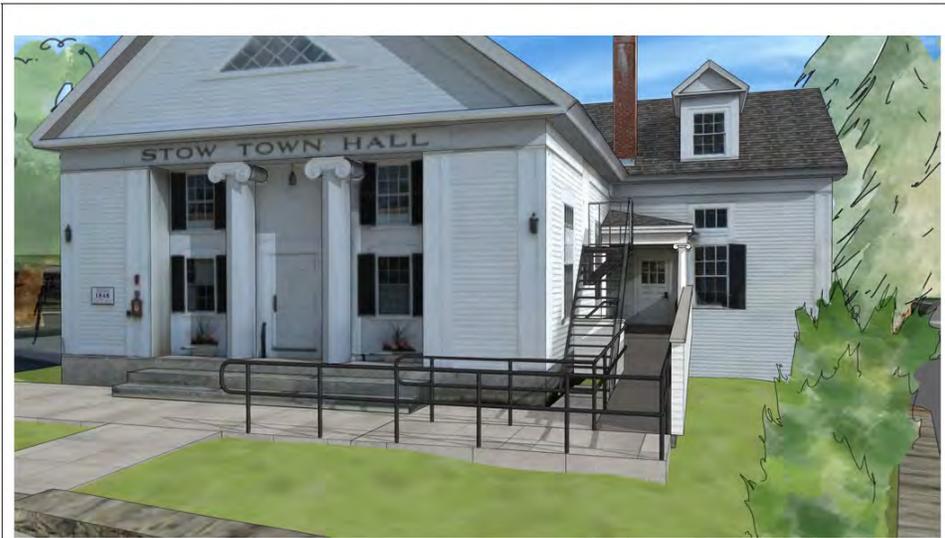
EXISTING GRADE LEVEL SKETCH OF 1848 BUILDING AND 1895 ELL WITH BALCONY FIRE ESCAPE AND ENTRY RAMP TO ELL

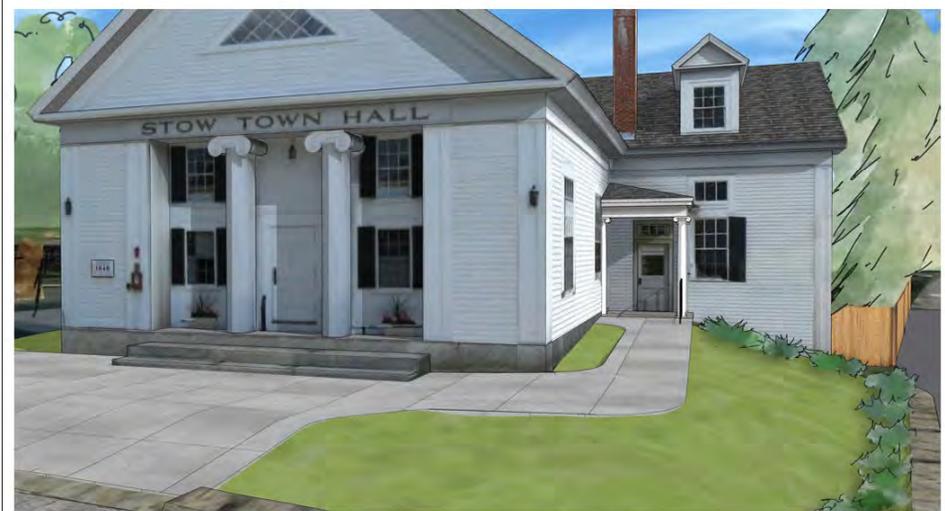
PROPOSED GRADE LEVEL SKETCH OF 1848 BUILDING AND 1895 ELL WITH BALCONY FIRE ESCAPE REMOVED AND ENTRY RAMP TO ELL REPLACED WITH ACCESSIBLE WALKWAY

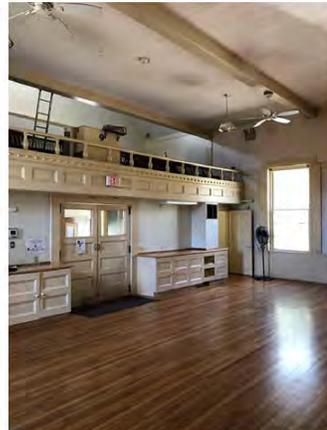
IMG_6807.JPG

*View of Great Hall with Original Balcony Above;
Stair to Balcony at Northwest Corner of Hall*

Great Hall is comprised of a flexible use first floor space with loose seating and a 12" high stage at the east end. A tiered balcony at the west end serves as a mezzanine level providing supplemental seating for when the building was used historically for town meetings. The five tiers of the balcony level incorporate loose wooden seating that is a mix of deacon's benches and folding chairs in groupings of two's and three's. A total of 71 persons could occupy the loose benches and chairs. The balcony is reached via a 32" door to a 41" wide winder stair in the northwest corner of the first floor. A second means of egress is provided on the south wall via an emergency exit door to an exterior fire escape.

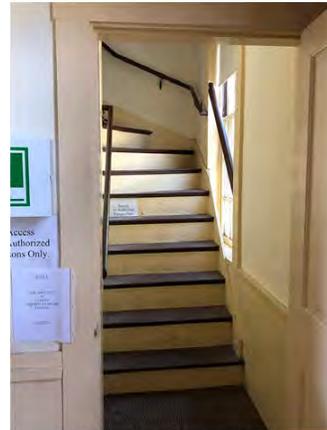
IMG_6786.JPG

*Stair from Great Hall to Balcony;
Winders at Turn and Discontinuous Railings;
Proposed Project to Replace Railings for Continuity*

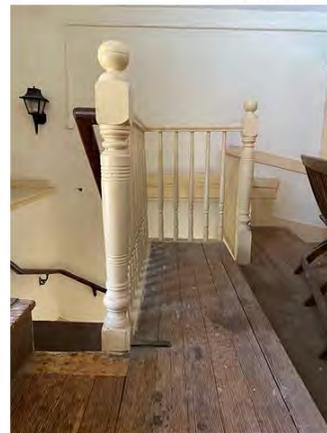
IMG_8240.JPG

Upper Landing at Tier 4 of Balcony with Stair Beyond

- Modify the fourth seating tier at the balcony to allow for one wheelchair space on that platform. A companion seat would be a loose chair adjacent to the wheelchair since there are no fixed seats on the balcony level. Modify the third and fifth seating tiers to allow for maneuvering clearance for the wheelchair and provision of the accessible viewing area.

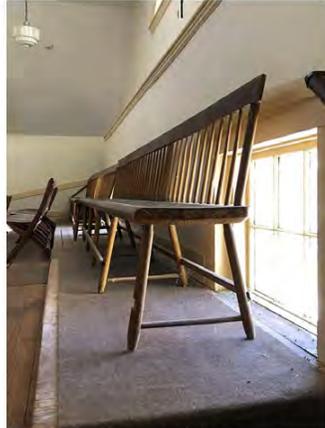
IMG_6788.JPG

Tier 5 of Balcony with Pair of Deacon's Benches

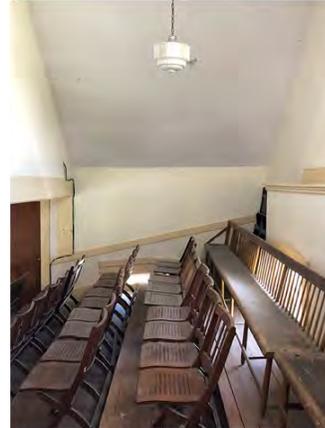
IMG_6789.JPG

*Looking South at Tiered Seating of Balcony;
No Seats are Fixed in Place*

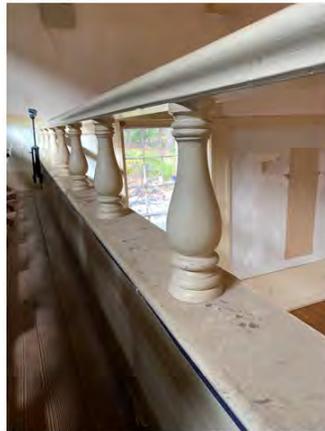
IMG_8166.JPG

Original Spandrel and Balustrade at Open Side of Balcony

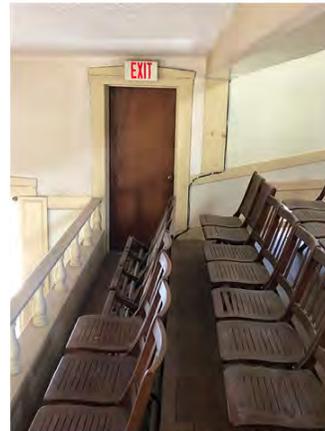
IMG_6800.JPG

*Existing Exit Door to Exterior Fire Escape to be
Removed in the Proposed Project Scope*

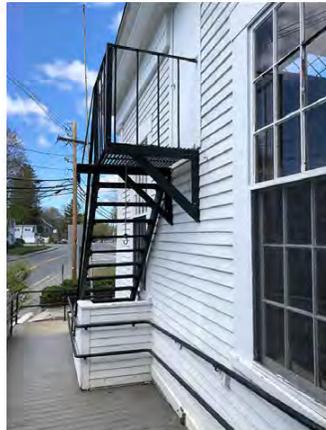
IMG_6818.JPG

Exterior View of Fire Escape Serving the Balcony

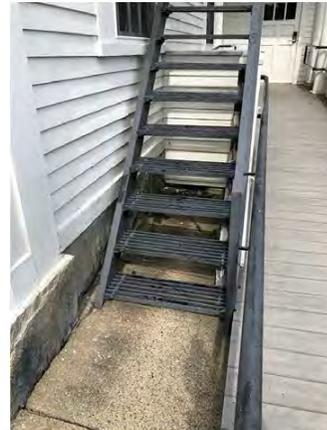
IMG_7786.JPG

Lower Run of Fire Escape Stairs Separated from Adjacent Ramp Leading to 1895 Entrance Beyond

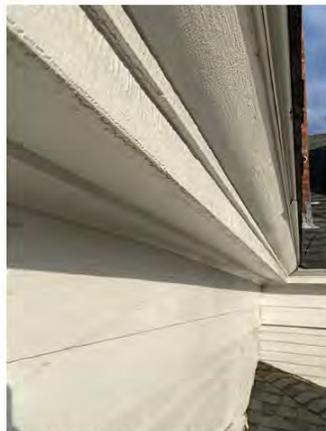
IMG_8483.JPG

Original 1848 Roof Overhang Detail at South Facade

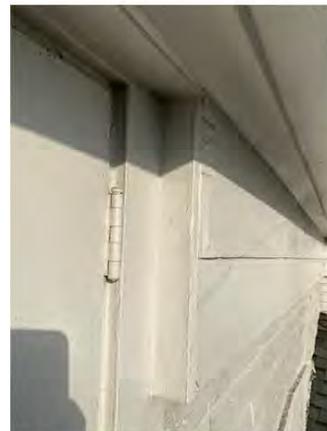
IMG_8484.JPG

Original Dual Board Frieze Interrupted by Fire Escape Exit Door Opening will be Restored

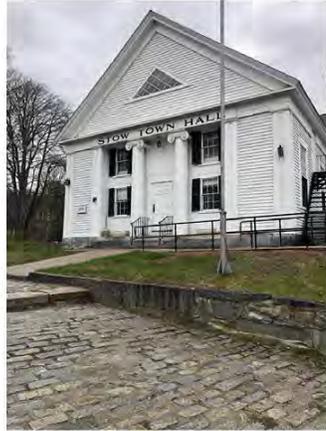
IMG_6488.JPG

Front Facade and Foreground of 1848 Building; Project Proposes to Modify Foreground for Access, Remove Fire Escape & Ramp, Improve Approach to 1895 Entrance & Retain Front Entrance

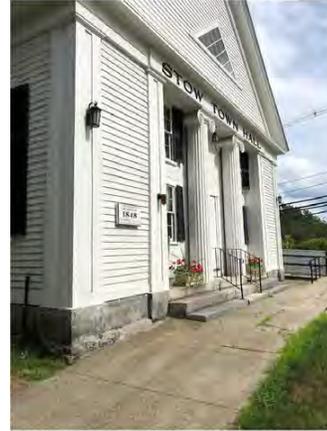
IMG_7783.JPG

Historic Front Entrance on Granite Plinth; Project Proposes to Re-set Lower Two Steps to Re-establish Consistent Riser Heights to Plinth

- Retain the 1848 original front entrance and add a directional sign to the improved first floor accessible entrance into the 1895 Ell. Reset the two granite steps leading up to the plinth to correct settling and restore even heights of risers. Repair and modify the iron rails for better compliance while retaining character. Retain and reset the historic boot scrapers.

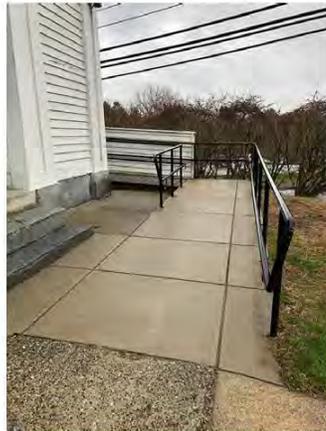
IMG_6462.JPG

Existing Confusing Duality of Accessible Ramp at Right Adjacent to Fire Escape Exit Route at Left

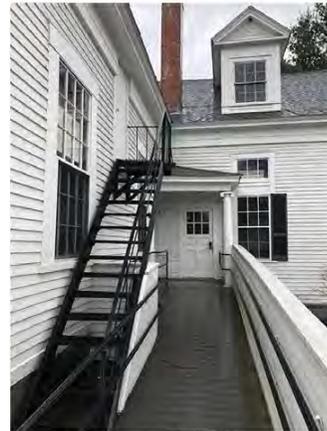
IMG_6463.JPG

Existing Cluttered Side Elevation with Balcony Fire Escape and Accessible Ramp; Project Proposes to Remove Fire Escape and Replace Ramp with Accessible Walkway

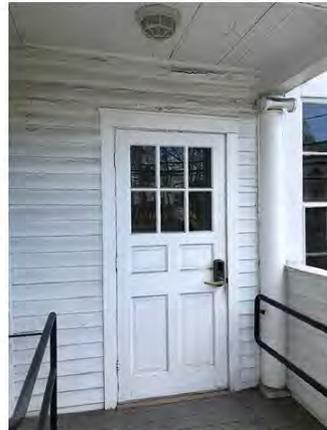
IMG_6819.JPG

Existing "Accessible" Entrance to 1895 Ell with Insufficient Maneuvering Clearance on Pull Side; Project Proposes to Make Door Fully Accessible and Lower Threshold for Replacement of Ramp with Walkway

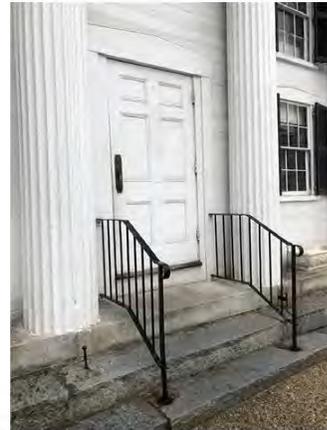
IMG_6461.JPG

Front Entrance with Two Granite Steps up to Plinth, Followed by Step up at Wood Threshold to Floor Level; Rusted Columns Rest on Granite Plinth 9" Below Floor

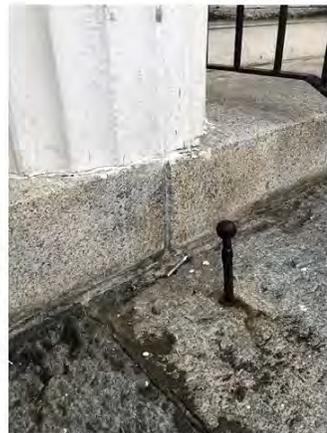
IMG_6470.JPG

Iron Boot Scraper to Left of Entrance; Missing Horizontal Scraper Portion; Column Resting on Granite Plinth

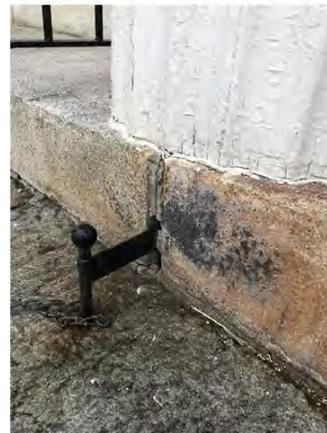
IMG_6469.JPG

Iron Boot Scraper to Right of Entrance; Horizontal Scraper Portion Intact; Column Resting on Granite Plinth

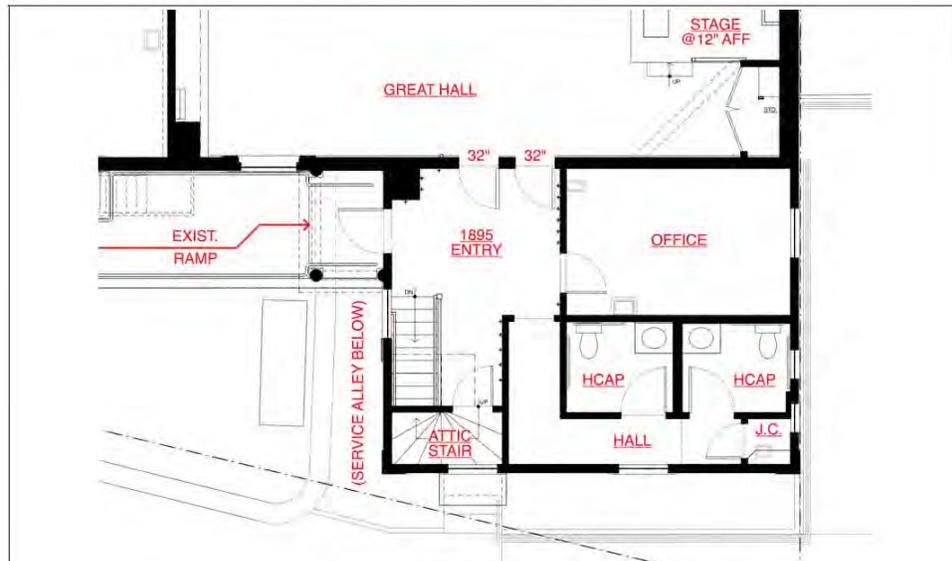
EXISTING ACCESSIBLE RAMP INTO 1895 ENTRANCE AT FIRST FLOOR;
DOOR CLEARANCE AT PULL SIDE INSUFFICIENT; LANDING AT TURN (Not Shown at Left) TOO SMALL

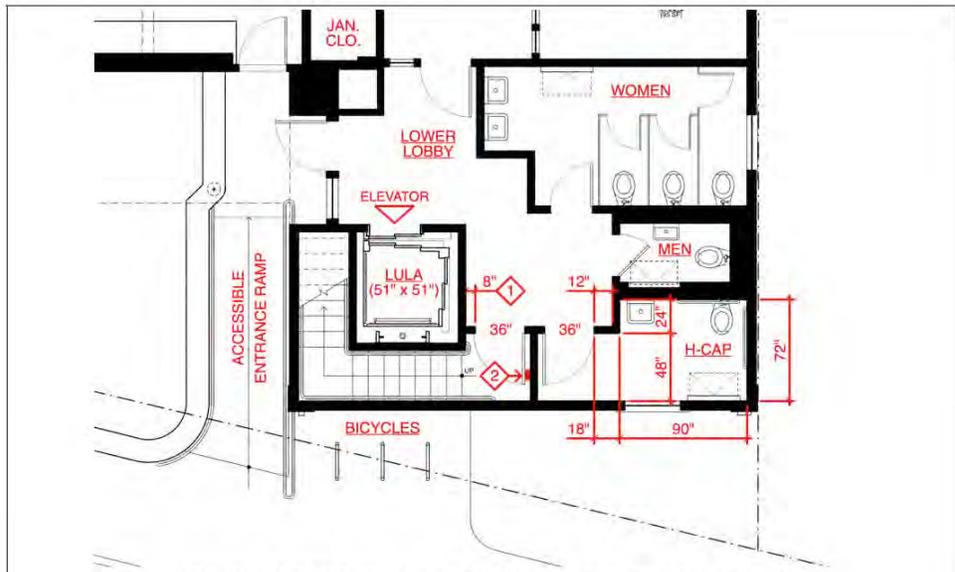
PROPOSED LAYOUT OF LOWER LOBBY & RESTROOMS RESULTS IN STRIKE SIDE CLEARANCE AT STAIR DOOR BEING LIMITED TO 8" DUE TO SURROUNDING ACCESSIBLE FEATURES

It is the Applicant's belief that the estimated cost of \$9,500 for full compliance with 521 CMR 26.6 for the stairway door is excessive without any substantial benefit to persons with disabilities.

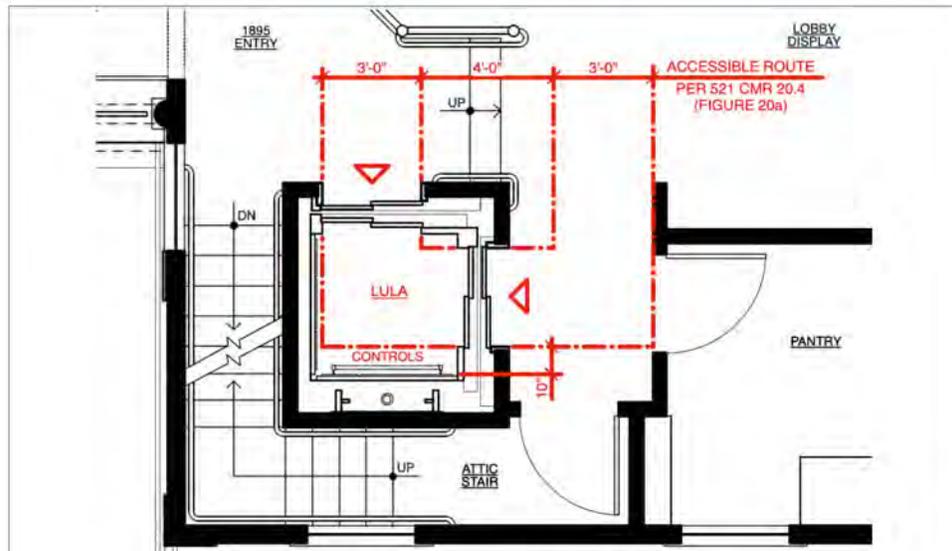
PROPOSED LIMITED USE ELEVATOR AT FIRST FLOOR; FRONT & SIDE DOORS REQUIRED DUE TO PROPOSED REPLACEMENT OF ACCESSIBLE RAMP WITH ACCESSIBLE WALKWAY

It is the Applicant's belief that the estimated credit of (\$113,000) for a 36" x 54" vertical wheelchair lift instead of a 51" x 51" LULA requiring a variance from 521 CMR 28.12.3a is an impracticable substitution without any substantial benefit to persons with disabilities. It is also the Applicant's belief that the added cost of \$300,000 for a passenger elevator instead of a LULA is without substantial benefit.

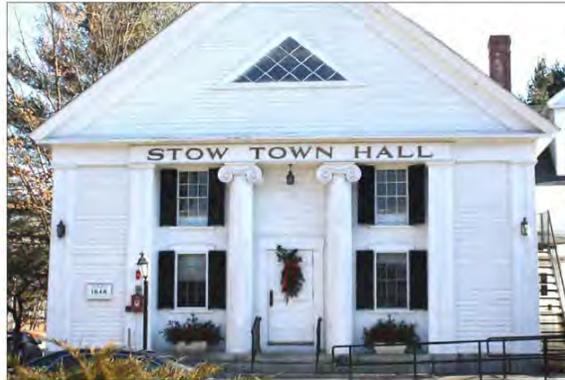
Detail of columns, west elevation, camera facing east.

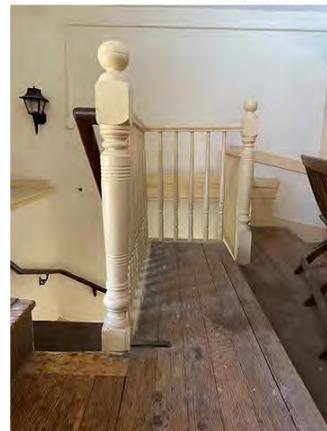
IMG_8240.JPG

Upper Landing at Tier 4 of Balcony with Stair Beyond

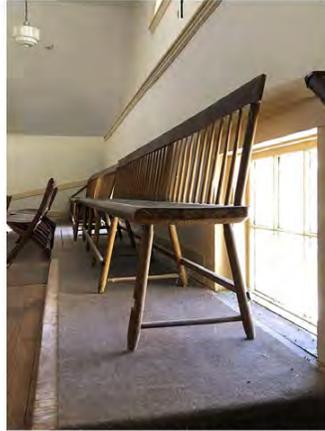
IMG_6788.JPG

Tier 5 of Balcony with Pair of Deacon's Benches

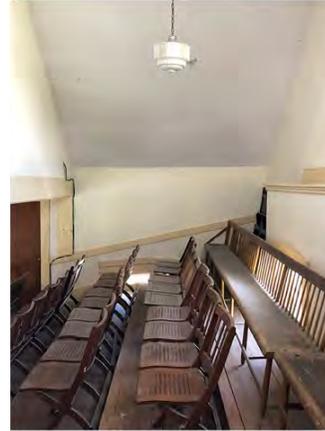
IMG_6789.JPG

*Looking South at Tiered Seating of Balcony;
No Seats are Fixed in Place*

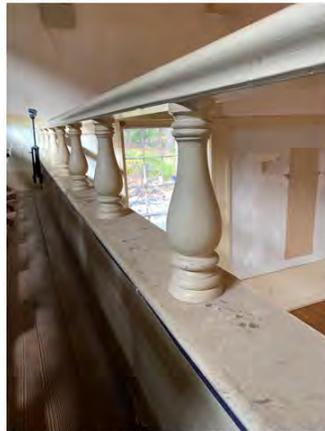
IMG_8166.JPG

Original Spandrel and Balustrade at Open Side of Balcony

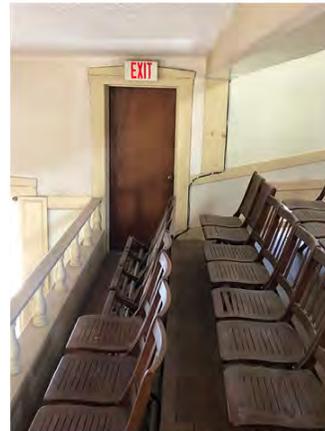
IMG_6800.JPG

*Existing Exit Door to Exterior Fire Escape to be
Removed in the Proposed Project Scope*

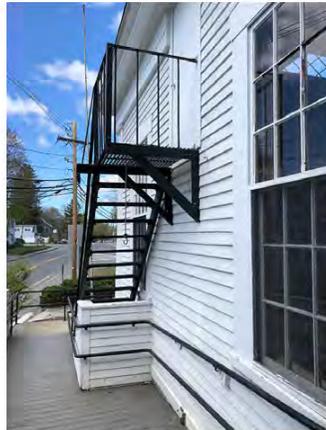
IMG_6818.JPG

Exterior View of Fire Escape Serving the Balcony

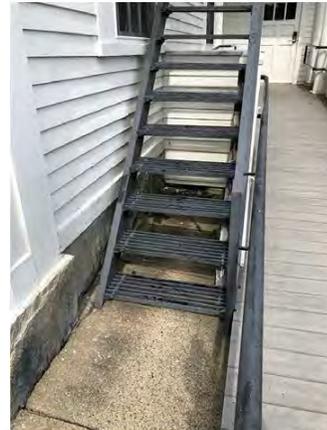
IMG_7786.JPG

Lower Run of Fire Escape Stairs Separated from Adjacent Ramp Leading to 1895 Entrance Beyond

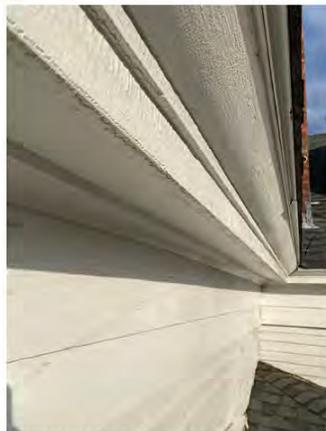
IMG_8483.JPG

Original 1848 Roof Overhang Detail at South Facade

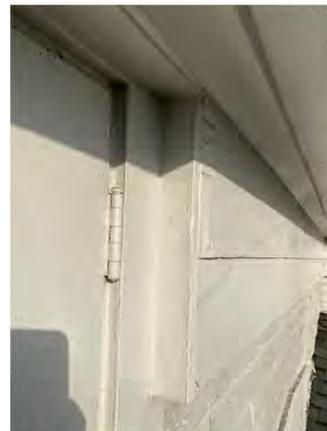
IMG_8484.JPG

Original Dual Board Frieze Interrupted by Fire Escape Exit Door Opening will be Restored

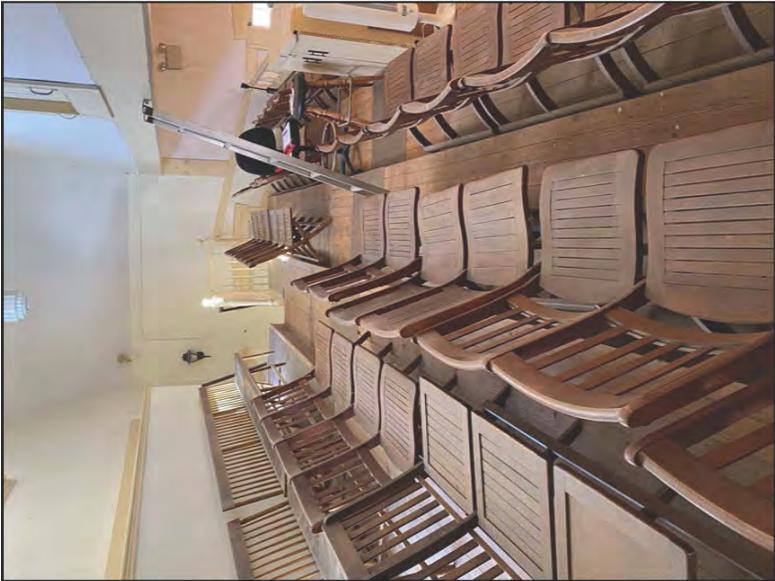
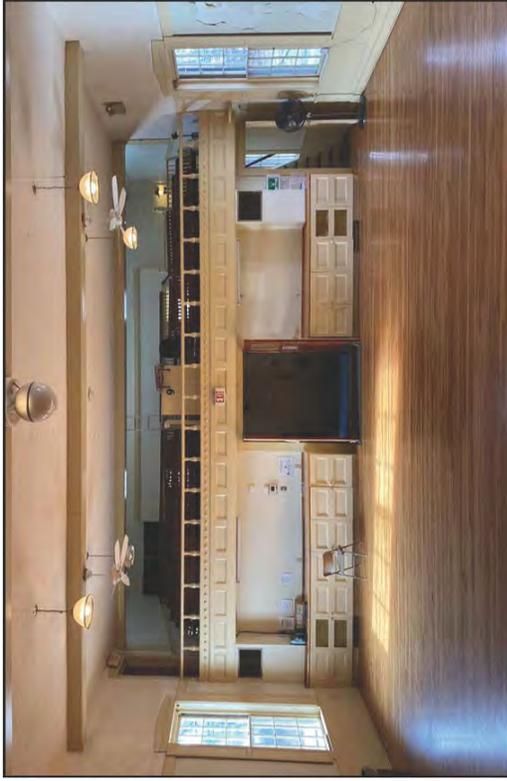
521 CMR 14.1: ACCESSIBILITY TO BALCONY LEVEL

- ❖ Tiered Mezzanine Loose Seating for Great Hall
- ❖ Current Use Limited to Authorized Persons Only
- ❖ \$190,000 Cost for Full Accessibility Compliance

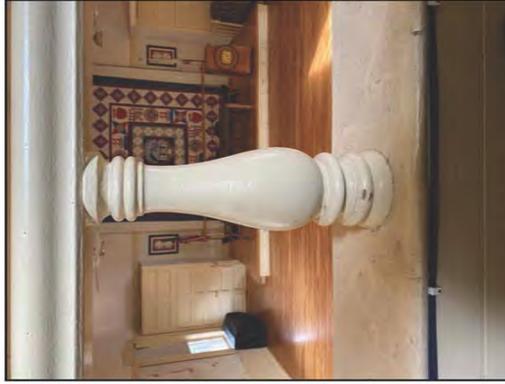
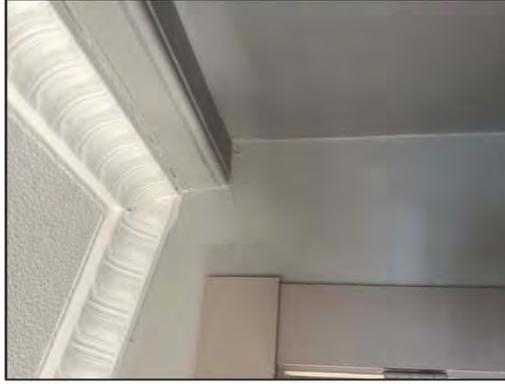
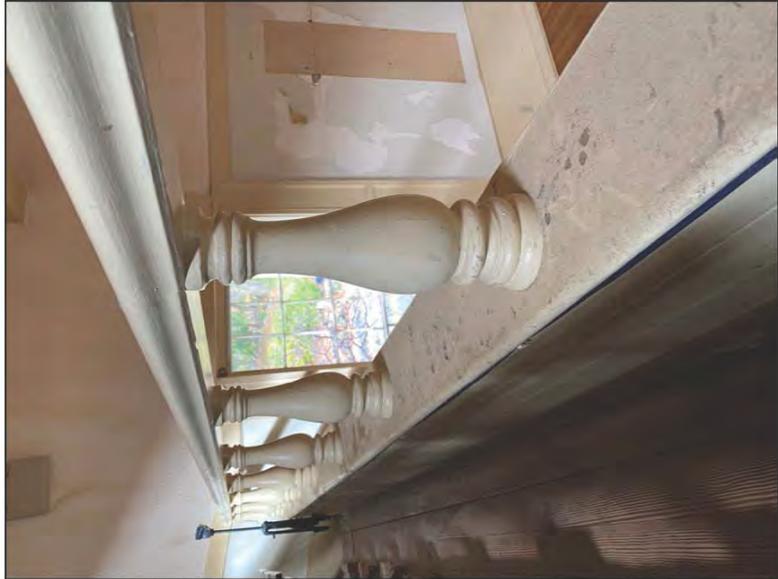
PRESERVATION OF HISTORIC BALCONY FEATURES:

- ❖ 173 Year History of Great Hall Balcony Seating
- ❖ Original Balcony Guard Railing and Balusters
- ❖ Embossed Painted Tin Ceilings Below Balcony

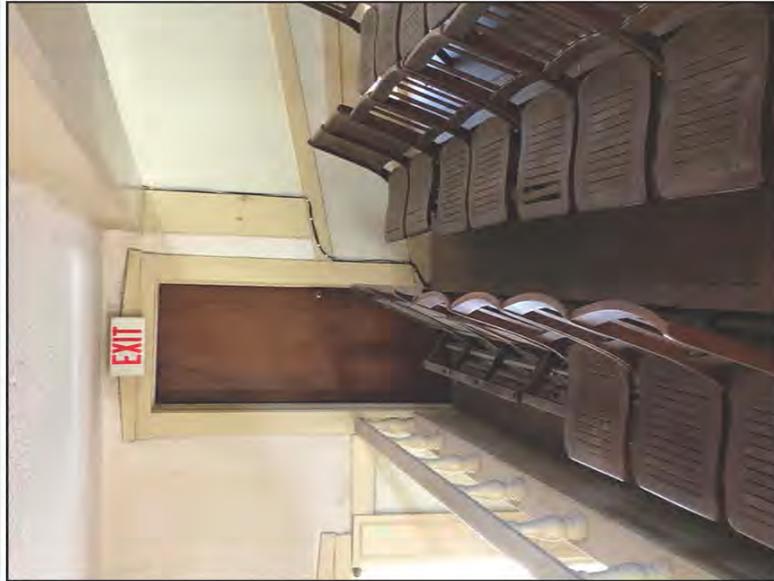
SUMMARY OF BALCONY LEVEL IMPROVEMENTS

- ❖ Reduce Occupant Load from 71 to 40
- ❖ Remove Fire Escape Exit and Stairs
- ❖ Restrict Public Seating to Tiers 3, 4 and 5 to Avoid Low Headroom and Balcony Guard
- ❖ Provide Fixed Post Stanchions and Control Ropes at Tier 2 Below the Great Hall Beam
- ❖ Infill Floor at Tier 0 to Match Tier 1
- ❖ Replace Handrails with Continuous Railings at Both Sides of Stairs
- ❖ Restrict Use in Accordance with Town Policy

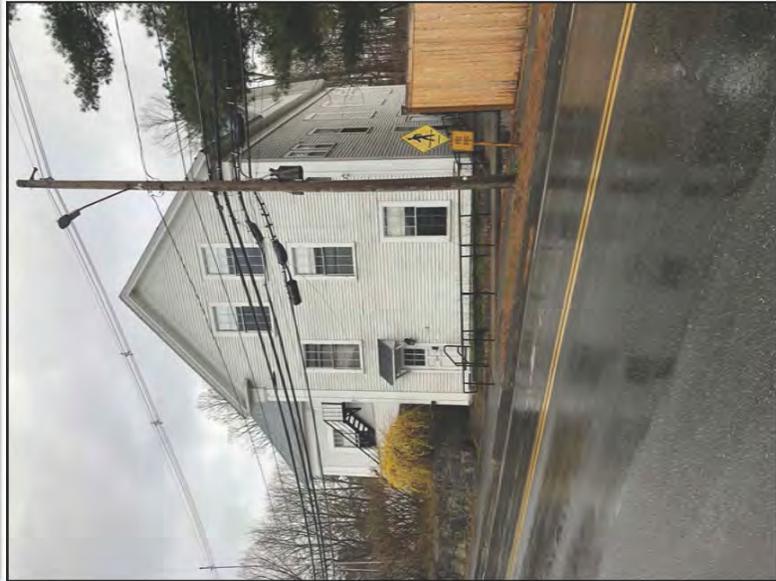
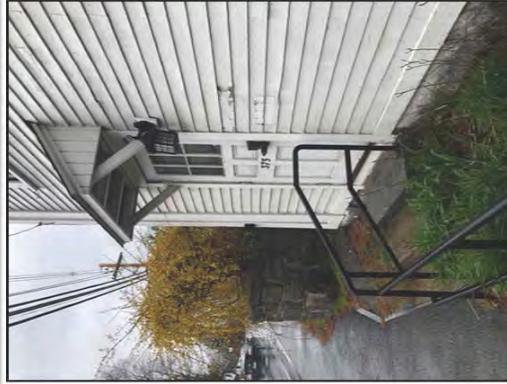
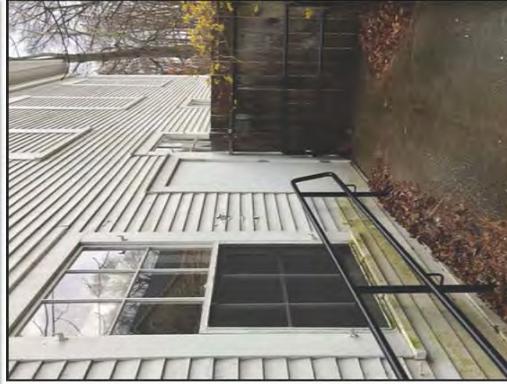
521 CMR 25.1: ENTRANCE TO GROUND FLOOR

- ❖ Remove Multiple Existing Awkward Entrances
- ❖ Relocate Lower Entry to be Below Upper Entry
- ❖ \$160,000 Cost for Full Accessibility Compliance

COST of COMPLIANCE to 521 CMR 25.1 GROUND FLOOR ENTRY	
25.1: PROVISION OF ACCESSIBLE ENTRANCE TO GROUND FLOOR	
\$7,500	Selective Demolition of Original Stone Retaining Wall
\$38,250	Concrete Footings and Replacement Retaining Wall
\$18,750	Stone Veneer and Cap to Replicate Original Wall
\$15,000	Additional Excavation for Lowering of Interior Floor Elev.
\$6,250	Trimming Below-Slab Foundation Wall at 1848-1895
\$12,750	Shoring for Removal of Interior Columns & Footings
\$21,000	Replacement Footings and Columns for Lower Fin. Floor
\$5,500	Dual Railings at Ramp (less stair railings per amendment)
\$125,000	Subtotal of Net Construction Cost Estimate
\$35,000	Gen'l Conditions, G.C.'s OH+P, Contingencies + A/E Fees
\$160,000	Est. Cost for Full Compliance at Ground Floor Entry

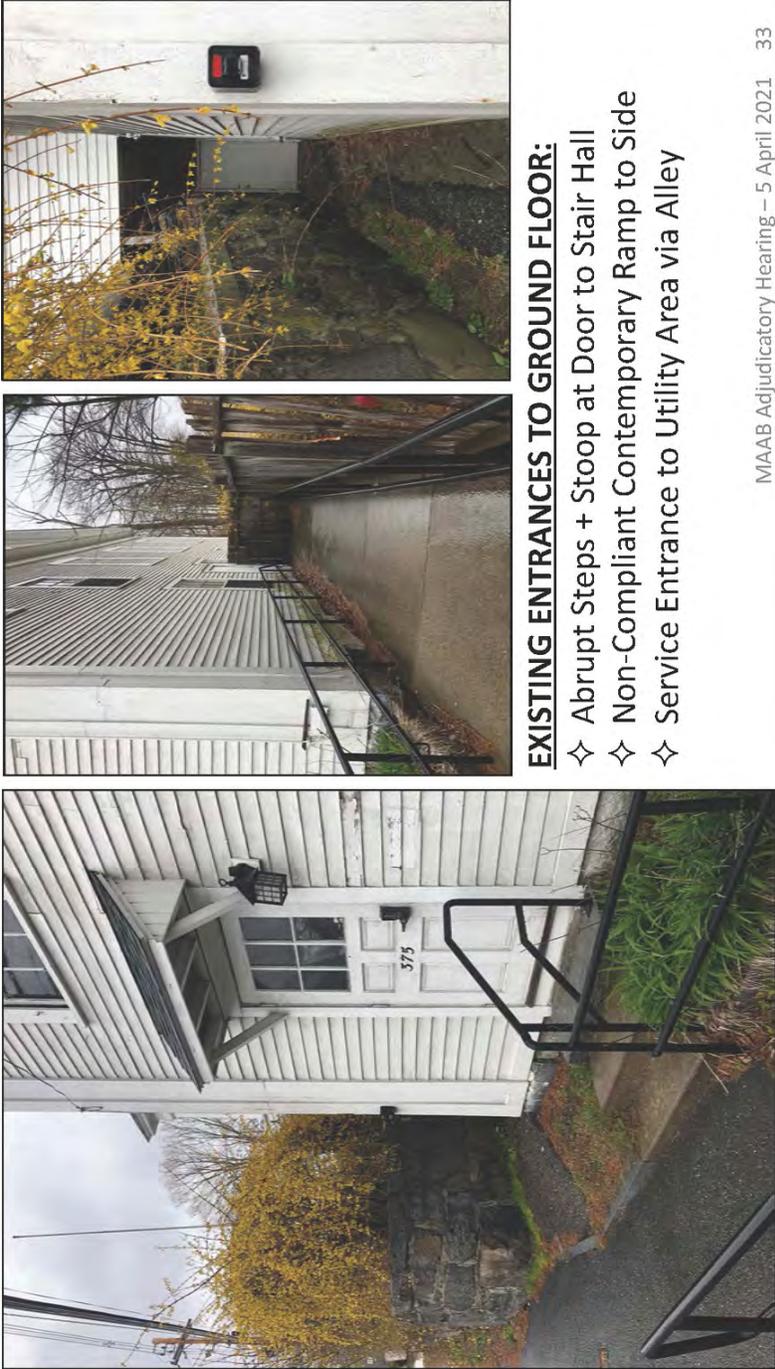
EXISTING ENTRANCES TO GROUND FLOOR:

- ❖ Abrupt Steps + Stoop at Door to Stair Hall
- ❖ Non-Compliant Contemporary Ramp to Side
- ❖ Service Entrance to Utility Area via Alley

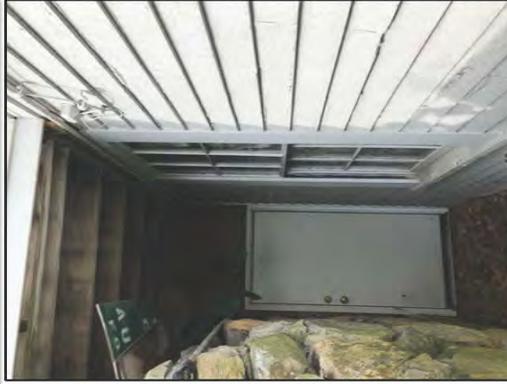
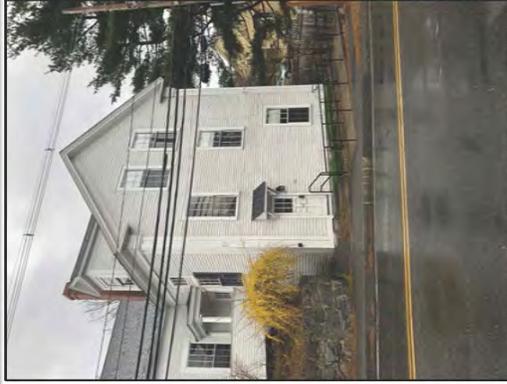
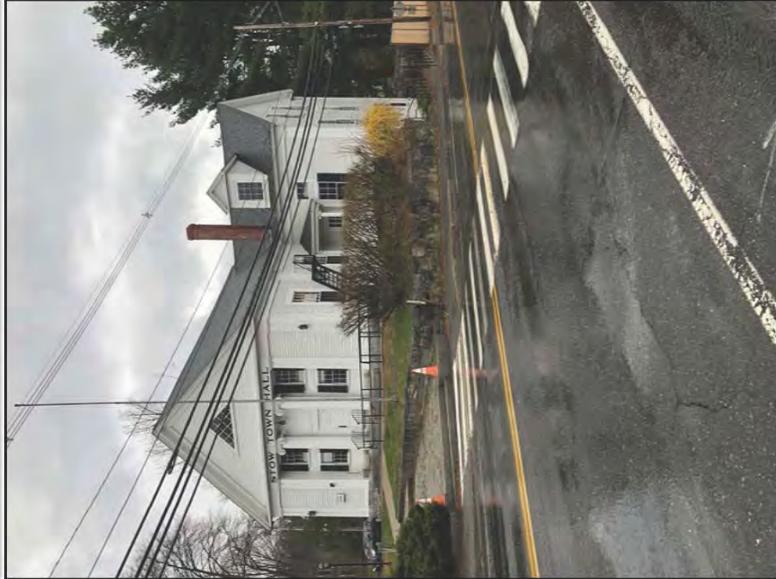
EXISTING ENTRANCES TO GROUND FLOOR:

- ❖ Lower Level Entrances Adjacent to Great Road
- ❖ No Parking or Drop Off Area on the Street
- ❖ 6% + Grade at Sidewalk Adjacent to Great Road

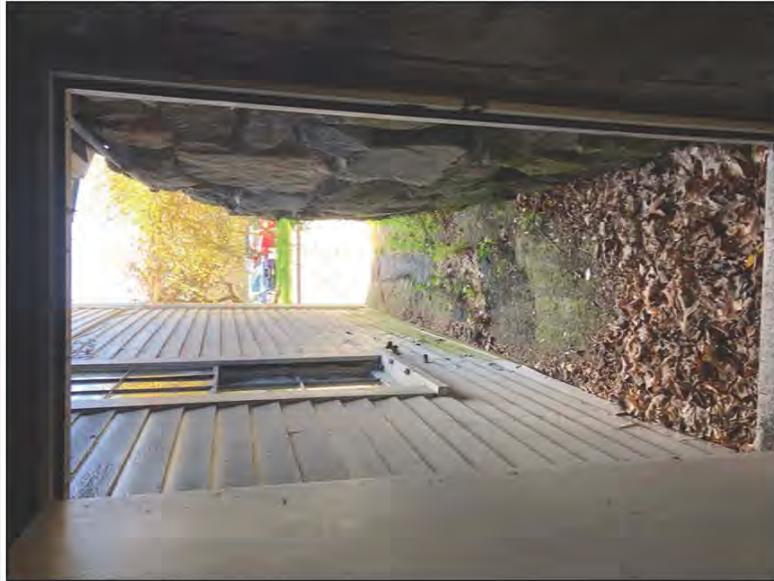
SUMMARY OF GROUND FLOOR ENTRY PROPOSAL

- ✧ Retain and Repair Original Stone Wall in Lieu of Relocation for Ramp Clearance Width.
- ✧ Reduce Amount of Excavation for Lowering of the Ground Floor as Required for a 1:12 Ramp at 14'-8" Long (existing ramp is 43'-8" long).
- ✧ Remove Existing Disjointed Entrances including Contemporary Ramp and Stair Hall Doorway.
- ✧ Integrate Relocated Entrance at Ground Floor with Improved Entrance at First Floor, Aligning Them Vertically and Adjacent to New Elevator.

It is the Applicant's belief that the estimated cost of \$160,000 for full compliance with 521 CMR 25.1 is excessive without any substantial benefits to persons with disabilities.

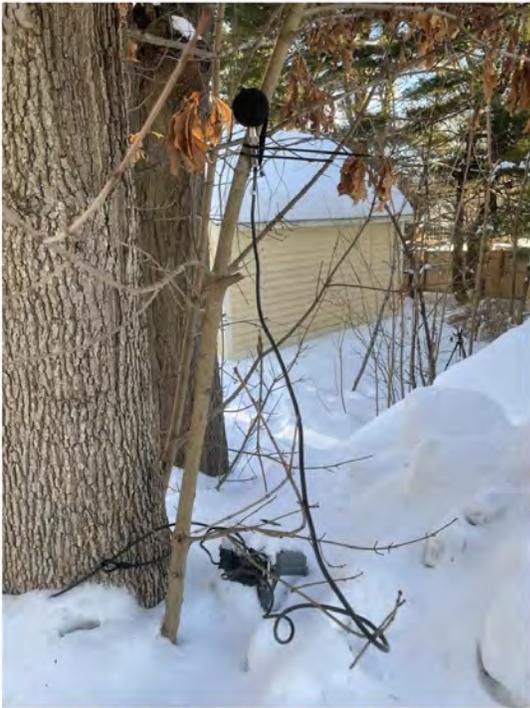
Figure 1: Example of Sound Level Meter Set-Up (Location 1)

To perform our measurements, we placed a combination of Rion NL-52 & NL-62 sound meters (seen below in Figure 1) around the perimeter of the site. The locations (shown in Figure 2 on the following page) were selected to represent the preliminary and alternate locations for the VRF units, as indicated in the project documentation you recently sent to us. The measurement period for Location 1 was Wednesday, February 3rd through Wednesday, February 10th. The measurement period for Locations 2 & 3 was Thursday, February 11th through Tuesday, February 16th. We set the meters to record the hourly sound levels and let them run continuously throughout the measurement period.

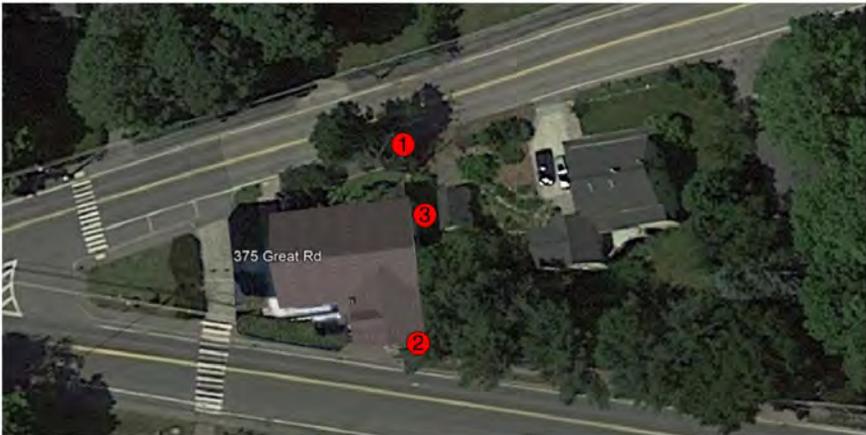
Figure 2: Sound Level Meter Locations

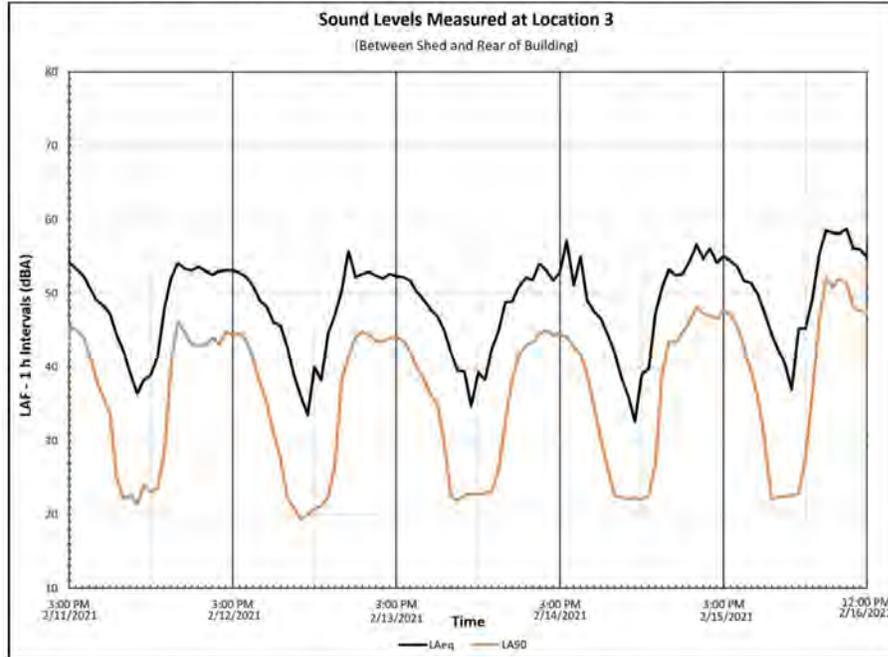
Figure 3. Time History of Location 3

Figure 3 depicts the time history of Location 3, which we understand to be the preferred location at this point. The time histories of Locations 1 & 2 can be found in the appendix. Sound levels shown in orange represent the hourly L90, which is the "background noise" metric described above. For reference, these graphs also show the hourly Leq (in black), which is defined as the equivalent continuous sound level.

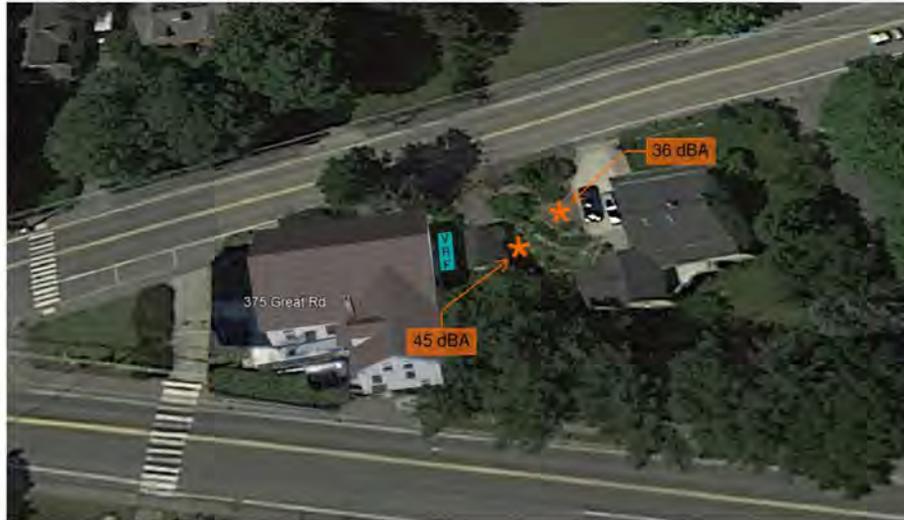
Figure 1: Predicted Noise Levels (Before Mitigation)

We then place receptors at various points of interest where we would like to determine expected sound levels. In this case, the primary receptor is the neighbor's terrace. For reference, we also included a receptor just on the other side of the shed. Without any noise mitigation measures added, our model predicted noise levels of **36 dBA** and 45 dBA at the terrace and shed locations, respectively, substantially exceeding our goals.

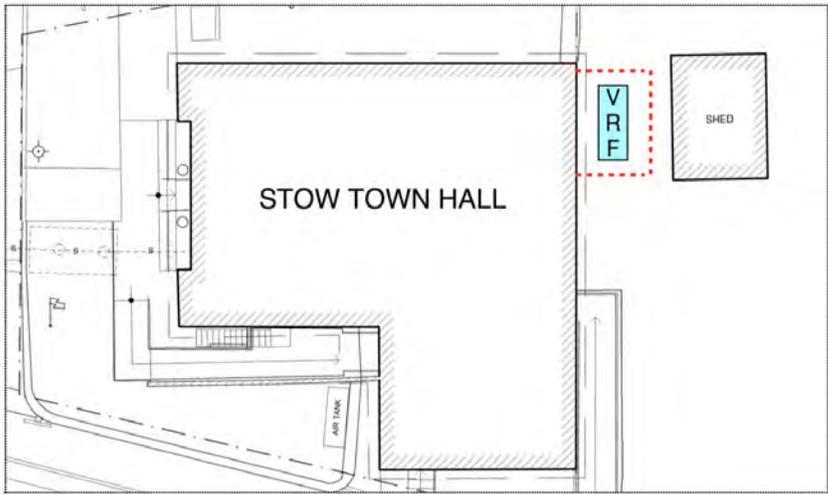
Figure 2: Recommended Location of Barrier Around VRF Units

We incorporated this barrier into our model, recalculated the results, and found **31 dBA** at the terrace and **35 dBA** at the other side of the shed. For some additional context, see the plot of our measured environmental noise levels at Location 3 in Figure 4 on the following page. The noteworthy feature is the background noise history, shown in orange. Though our overall design goal for noise mitigation is based on the quietest hour measurement, note that the ambient noise only drops below 31 dBA (shown as the horizontal red line) between 9 PM and 10 PM most nights, and rises back above that level between 6 AM and 7 AM. This suggests that during the day, the contribution from the VRF units (within the barrier) to the background noise levels may be masked by other environmental noise sources.
