FIVE OPTIONS

Stow Town Hall Renovation
375 Great Road / Stow MA

MILLS WHITAKER ARCHITECTS LLC

01 August 2022

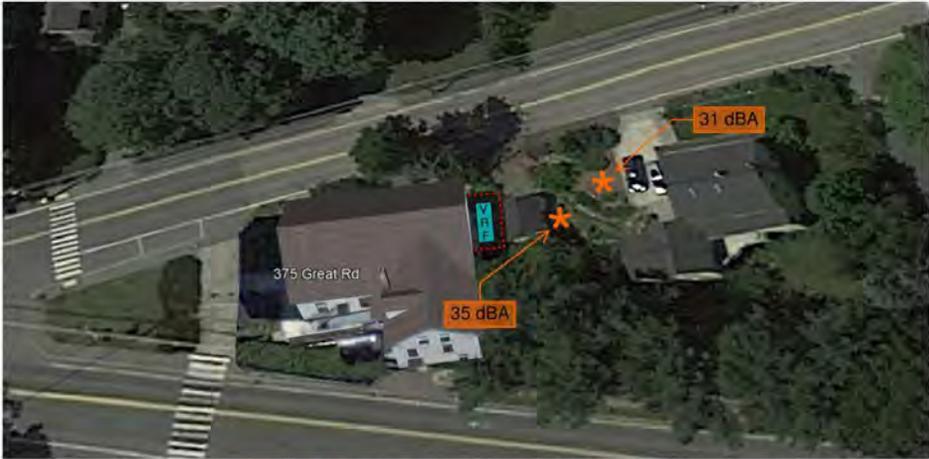
Figure 3: Predicted Noise Levels (with Acoustical Barrier)

We incorporated this barrier into our model, recalculated the results, and found **31 dBA** at the terrace and **35 dBA** at the other side of the shed. For some additional context, see the plot of our measured environmental noise levels at Location 3 in Figure 4 on the following page. The noteworthy feature is the background noise history, shown in orange. Though our overall design goal for noise mitigation is based on the quietest hour measurement, note that the ambient noise only drops below 31 dBA (shown as the horizontal red line) between 9 PM and 10 PM most nights, and rises back above that level between 6 AM and 7 AM. This suggests that during the day, the contribution from the VRF units (within the barrier) to the background noise levels may be masked by other environmental noise sources.

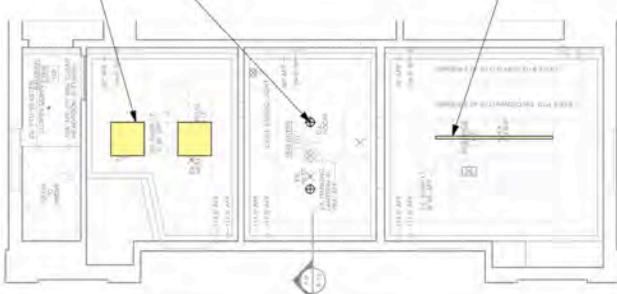
Storage Room
Surface Mounted LED 2x2 Fixture

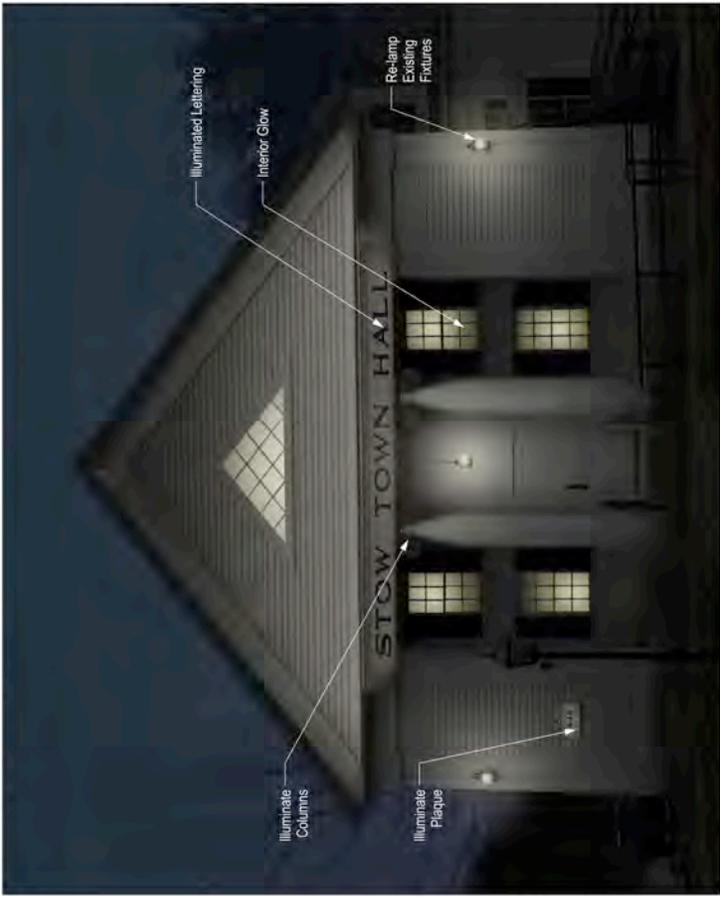
Linear LED Strips

We are proposing four additional layers of lighting to both brighten and accentuate the front facade of the building. Small form-factor surface-mounted LED strips, in outdoor-rated extrusions, are located just below the Stow Town Hall sign and cast a graze of light vertically across the field of letters. A second layer of surface-mounted LED strip will be located on the ledge above the signage letters to cast a sheet or grazing illumination across the slatted vertical wall. This approach exposes the rhythm of the horizontal construction as well as lighting the underside of the overhangs, which in turn helps to define the overall architecture.
