February 1, 2022

Lake Boon Dam Rehabilitation Project

Design Update

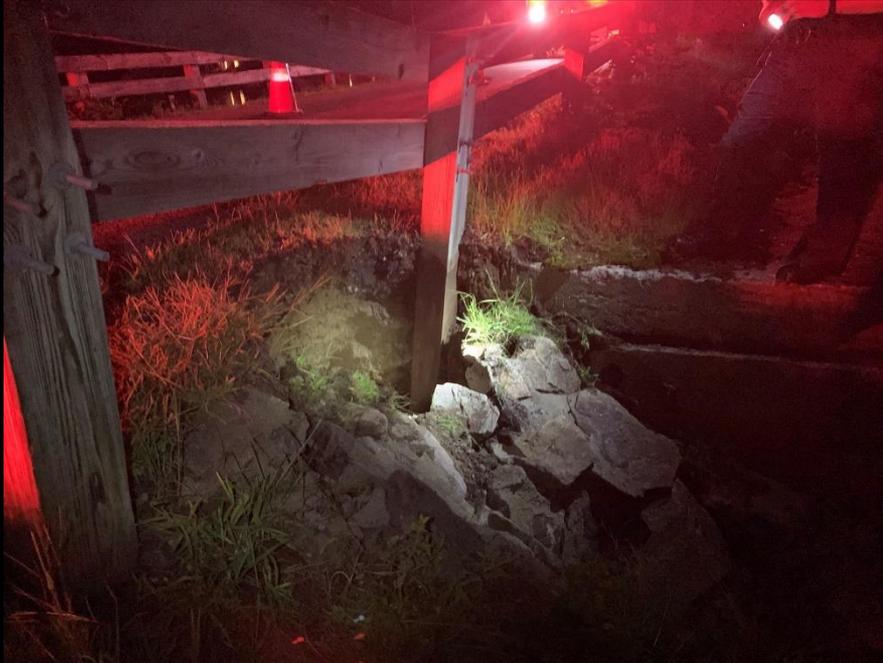
**Sinkhole developed along
spillway**

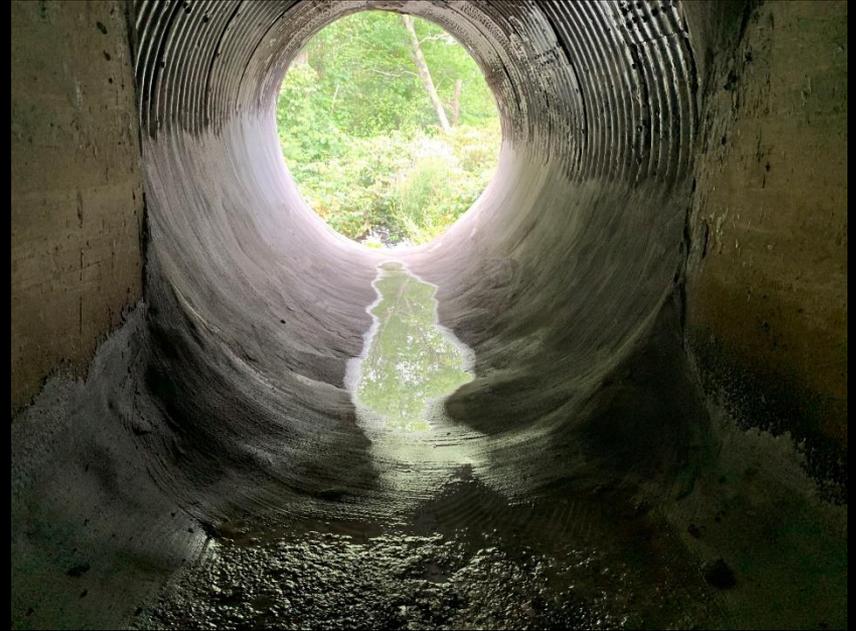
**Spillway voids patched and
repaired**

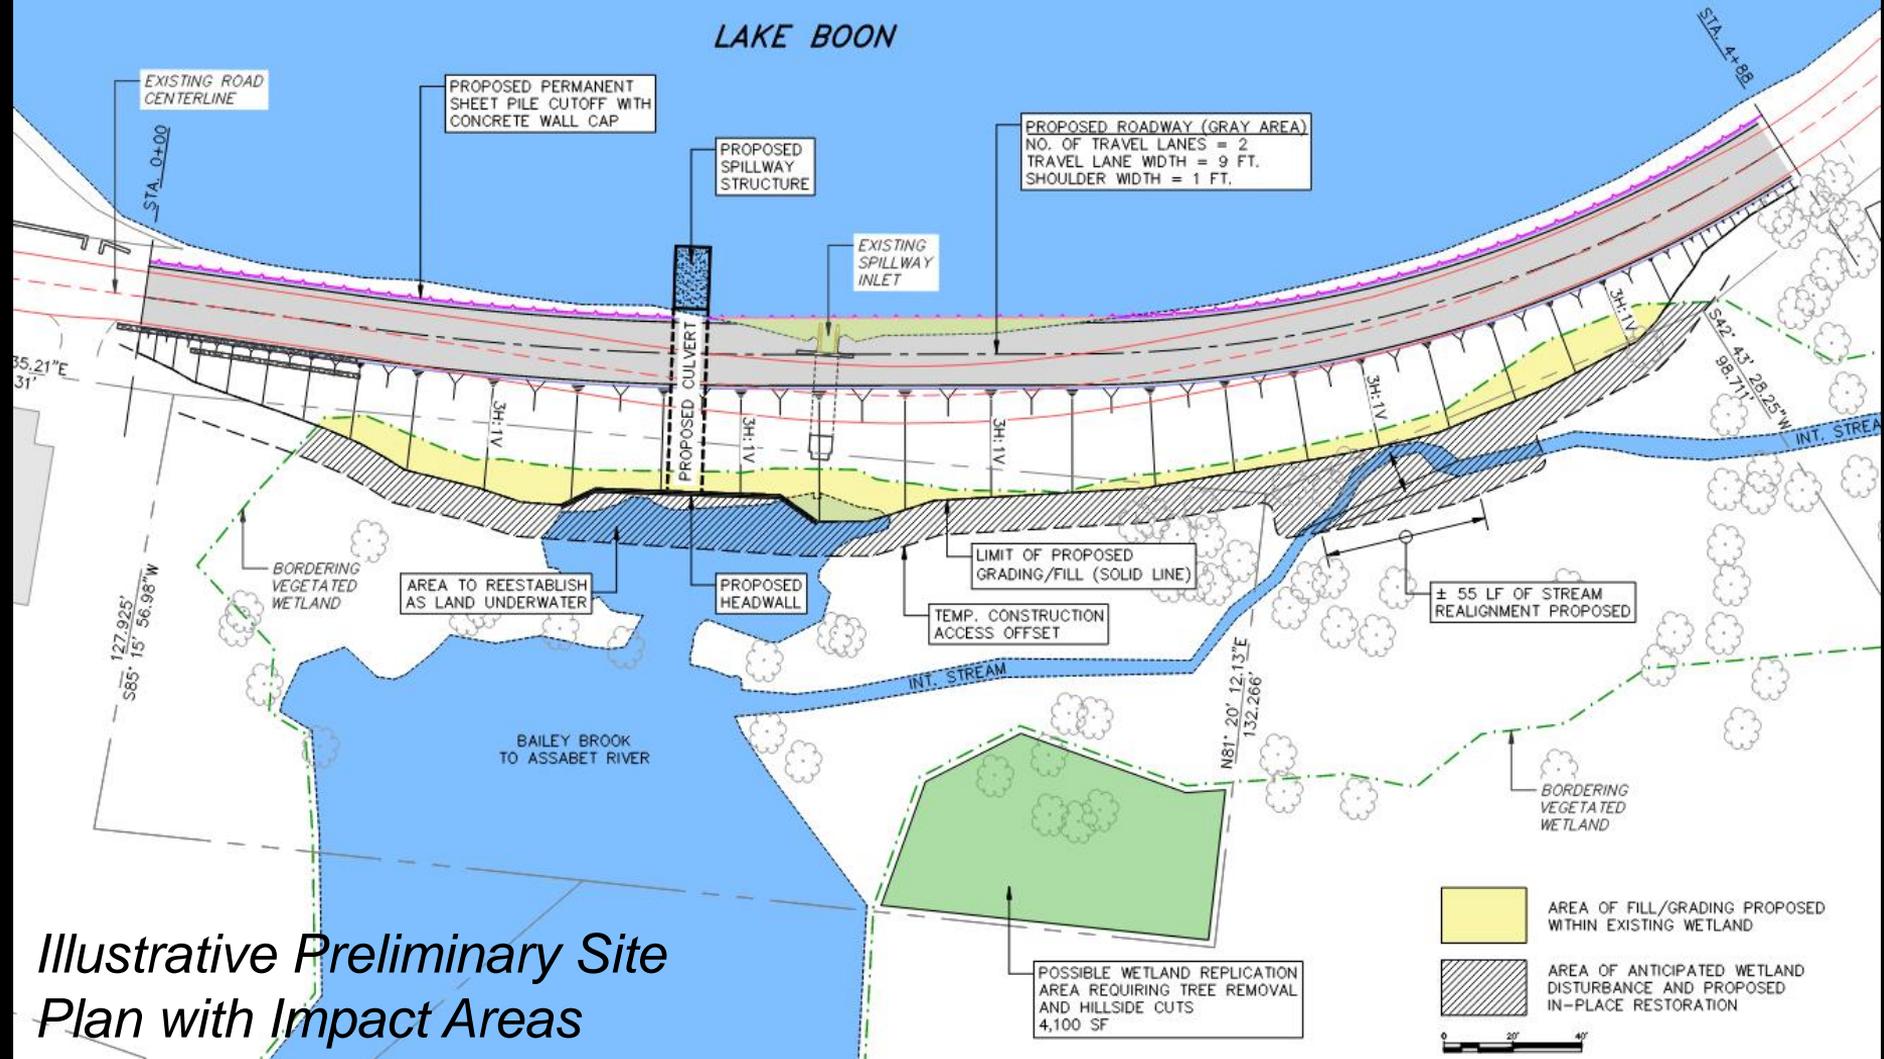
Illustrative Preliminary Site Plan with Impact Areas

- Stays within the footprint of the existing dam
- Reduces vegetated wetland and land underwater impacts
- Less filling in the downstream floodplain
- Optimizes construction access
- Provides new spillway with low-level outlet if/when needed
- Design flood requirements met
- Improved ability to operate reservoir levels without changing current practices
- Maintainable slope with DPW mowing equipment
- Less abutter impacts
