Town of Stow  
**PLANNING BOARD**

June 10, 2021

The purpose of this letter is to bring several stormwater management issues at Spring Hill Estates to the attention of all contractors and property owners currently working at the site. On June 9, 2021, myself, Assistant Planner Malcolm Ragan, and Susan Carter of Places Associates, Inc. visited the site to ensure compliance with the Erosion Control Special Permit. Below is a list of concerns that need to be immediately addressed to ensure the overall health and stability of the site and its surrounds.

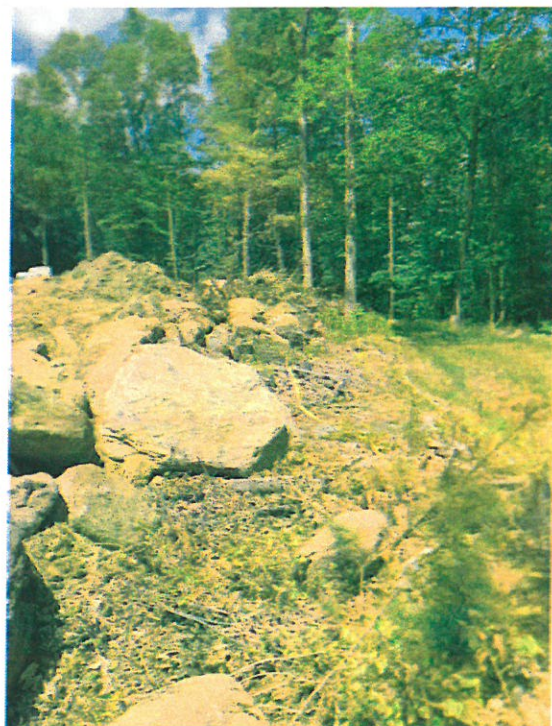
- There are no erosion controls present along the line of clearing associated with Lot 4. A row of dirt covered boulders line the edge of clearing and will provide no mitigation in the event a heavy rain hits the site. Given the slopes present, the contractor should consider hay bales installed on the back side of silt fence to protect against the fence being overwhelmed in a rain event.

All lots under construction should be protected with a similar fence and haybale arrangement once clearing has commenced.

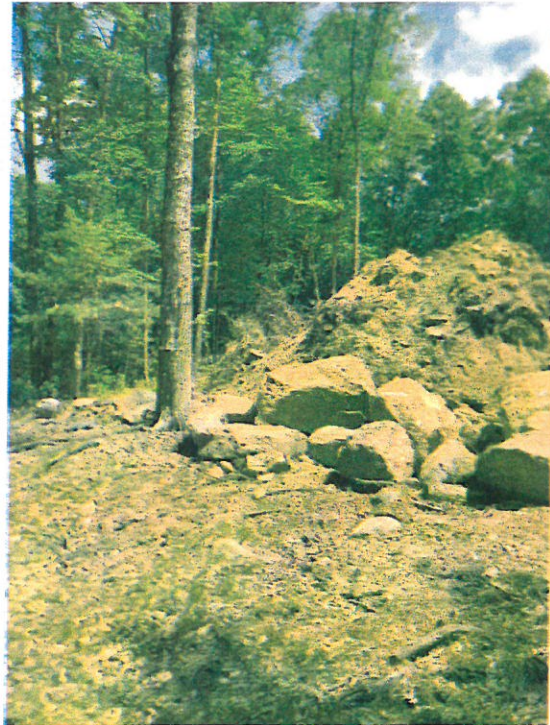
- On June 9, there were multiple piles of loam and stumps on Lot 4. The SWPPP requires any pile in place for longer than three weeks to be covered. It's unclear how long the material pile will be in place, but at the very least, there should be stabilization and erosion controls at the toe of the slope of the pile to avoid sediment from flowing downhill.

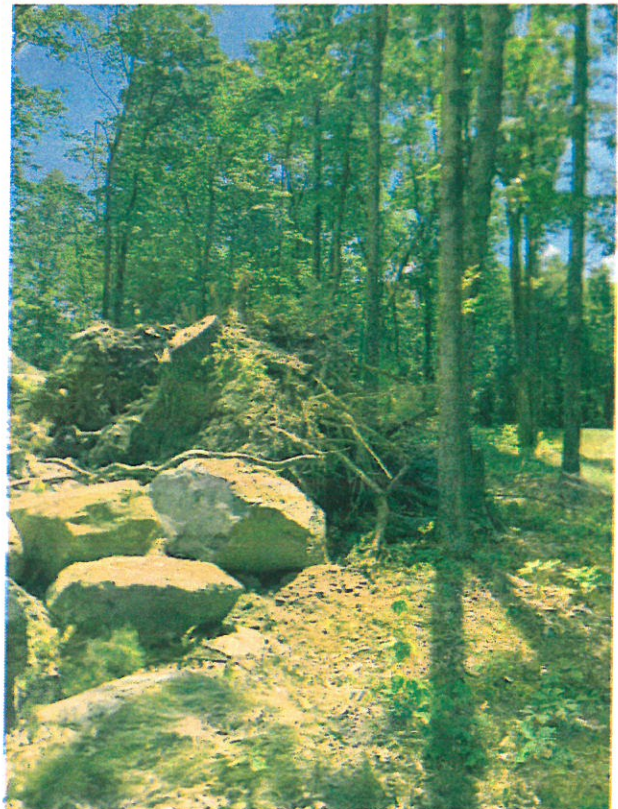
- A pile of stumps was also observed at the bottom of the hill clearing on Lot 4. This pile of dirty stumps will leach out sediments as soon as it rains. This pile should be removed or stabilized with erosion controls in the same manner as the earth material piles noted above.

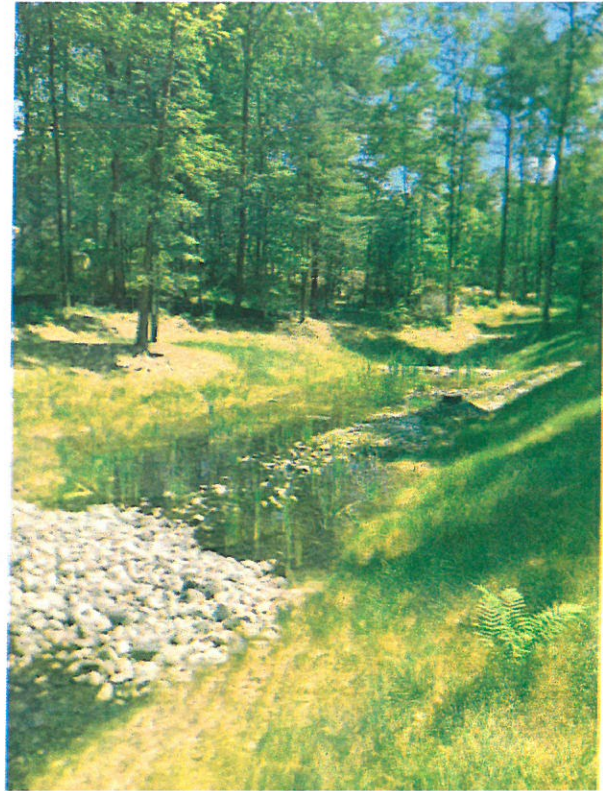
- The inspection on June 9<sup>th</sup> was approximately 9 days since the significant rain event of Memorial Day weekend. However, SMA #1 was still holding water, suggesting that fines have plugged up the recharge capability of the basin. Furthermore, there were several stands of cattails, indicating that standing water and sediment has been consistently present and that the basin.

Once water has cleared from the basin, SMA#1 will need to be dredged to ensure its functionality. Please provide a plan of action for how the owner intends to rectify the issue.
