ROAD SAFETY AUDIT

Great Road (Route 117) at Hudson Road

Town of Stow

August 18, 2022

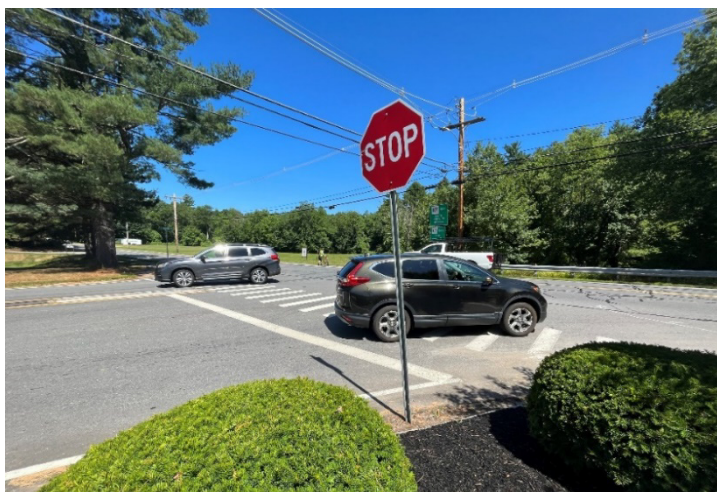
Intersection sight lines are poor throughout the intersection. Many northbound Hudson Road drivers nose out into the intersection with Great Road due to signage at the Gulf gas station, and surrounding vegetation obstructing the view of oncoming vehicles. Westbound Great Road vehicles have impacted sight lines due to a horizontal curve east of the intersection, as well as vegetation and signage. This vegetation includes trees and other upgrowth on the southwest and southeast corners of the intersection, as shown in Figure 3. Poor sight distance may have contributed to crashes 1, 12, 17, 21, 27, and 28. Although Hudson Road is striped as one general purpose lane, it is wide enough for two vehicles to stack side-by-side, which blocks sight lines for drivers both on Hudson Road and Great Road.

Figure 3: The vegetation and signage at this intersection causes Hudson Road northbound drivers to nose out into the intersection before making a turn onto Great Road.

- Evaluate options to mitigate the high speeds on Great Road, such as speed feedback signs, increased enforcement, and/or speed reduction pavement markings (optical speed bars)
- Evaluate the feasibility of adding a left turn lane to the Great Road westbound approach.
- Evaluate lane configuration on Hudson Road northbound approach.
- Evaluate intersection control and consider reconstructing as a modern roundabout, four-way stop, or as a signalized intersection (provided respective warrants are met).*
- Evaluate median on Hudson Road and modify or eliminate as needed. If possible, provide pedestrian refuge within the median.
- Coordinate with property owners to trim vegetation to improve intersection sight lines.
- Consider decreasing effective curb radii to slow high speed turns.

- Consider enhancing stop sign with an LED flashing stop sign to emphasize stop control at Hudson Road northbound.*
- Consider restriping shoulders on Hudson Road to slow high speed turns and reduce instances of double stacking.

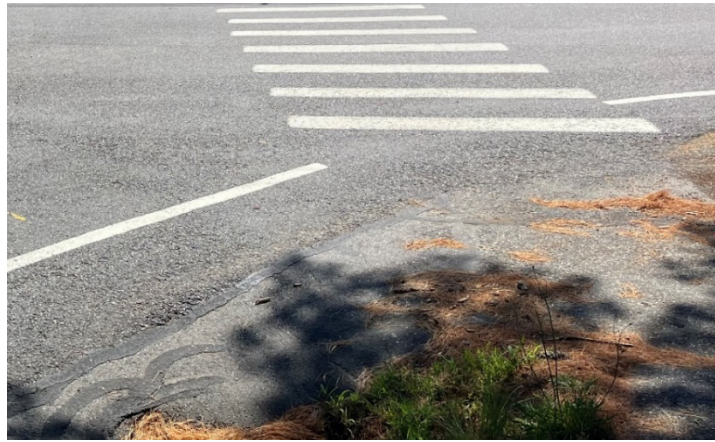
There are sidewalks on the south side of Great Road. They are narrow (approximately 4' wide) and in acceptable condition. The sidewalks on the southeast intersection corner are concrete and the sidewalks on the southwest corner are asphalt. An approximately 75-foot-long painted crosswalk is provided across the southern leg of the intersection. The length of the crosswalk extends pedestrian exposure to vehicle conflicts while crossing the two lanes. There is no detectable warning panel at the southwest curb ramp, which does not appear to be ADA-compliant. The southeast curb ramp is also designed as an apex-style ramp, potentially giving the impression to low-sight individuals that there is a marked crosswalk across Great Road. Drivers were observed rolling through the stop sign at Hudson Road northbound and stopping on the crosswalk to get better sight lines before turning onto Great Road. Advanced signage was not provided to denote the pedestrian crossing. Audit team members noted that this intersection is frequented by pedestrians originating from the adjacent condos from the nearby Village at Stow. The existing mountable median does not meet current standards as a pedestrian crossing island. A crosswalk provided across Hudson Road roughly 300 feet south of the intersection also accommodates foot traffic from the Village at Stow. This crossing is not accompanied by signage or any additional pedestrian accommodations. Sidewalks extending from the intersection on the eastern side of Hudson Road terminate prior to this crosswalk, leaving a gap in the pedestrian network. Further pedestrian demand is generated by events held in the field north of the intersection at or near the intersection. A future catalyst of pedestrian demand will be the new coffee shop opening in the Gulf gas station lot.

Figure 4: Non-compliant curb ramp on the southwest corner of the study intersection.

- Evaluate ADA compliance of all curb ramps and upgrade if necessary.
- Evaluate pedestrian desire lines to determine where and if additional accommodations are needed.
- Consider adding an ADA-compliant pedestrian crossing island to the crosswalk to reduce the crossing distance.
- Evaluate potential bicycle accommodations or alternate routes.

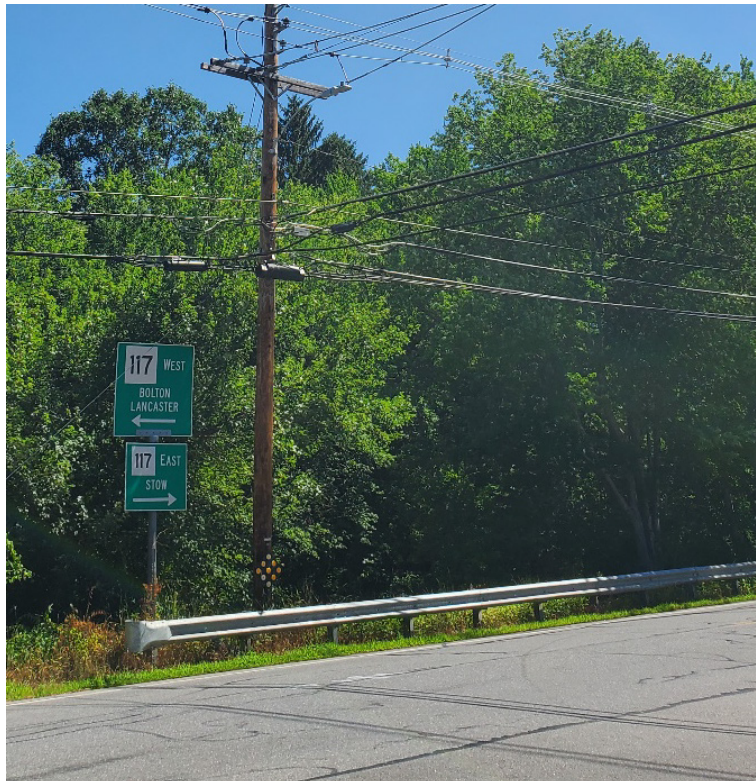
Figure 5: Existing guardrail with lack of reflective markers for visibility and faded object marker.

- Evaluate all signage for MUTCD compliance and reflectivity; upgrade as needed.
- Improve guardrail visibility with reflective markers.
- Consider adding advanced intersection signage for all intersection approaches.
- Consider improving Hudson Road street sign location and size.
- Consider installing an overhead flashing beacon to increase awareness of the intersection.*

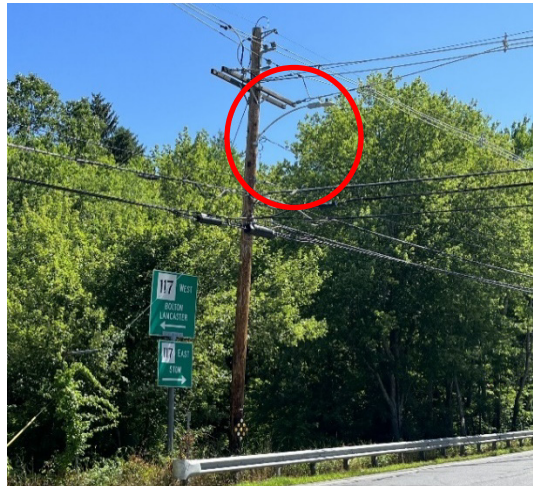
Only one overhead light was observed at the Great Road and Hudson Road intersection. Light sources from the Gulf gas station are located on the private lot adjacent to the intersection, but only one light pole was observed specifically for the intersection. Overall, 20% of recorded crashes at this intersection from 2017 to 2021 occurred at night.

Figure 6: Single light at the intersection of Great Road at Hudson Road.

- Evaluate lighting at this intersection and consider installing lighting where necessary to improve visibility and safety in low-light conditions.
- Evaluate drainage at this intersection to ensure it is adequate.

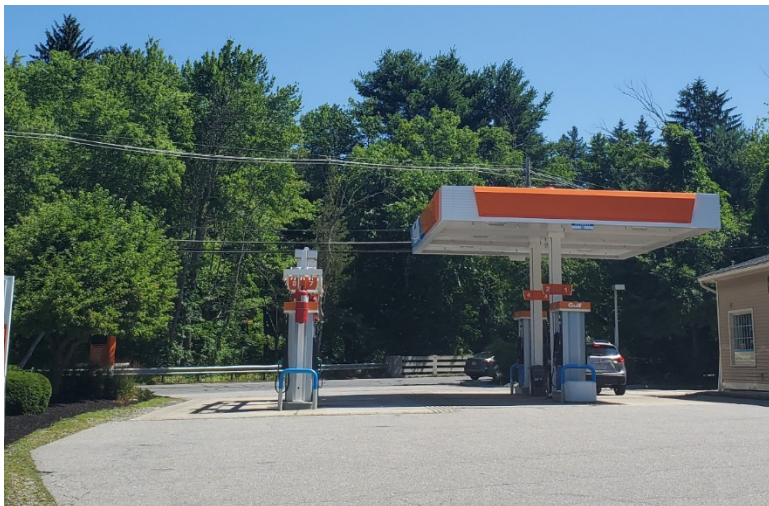
There are four driveways within the vicinity of the study intersection. Each driveway is at least 30 feet wide, potentially posing a safety concern for conflict between incoming and outgoing drivers. The Gulf gas station driveway on Great Road is the subject of various safety concerns. Drivers have been known to use the gas station driveways as a cut through when there is significant backup at the intersection. The proximity of Hudson Road and the gas station driveway on Great Road can result in conflicting movements between vehicles turning left out of the Gulf gas station exit and vehicles turning right from Hudson Road onto Great Road. Crash 11 is an example of this conflict occurring during the study period and leading to a crash. This proximity may also lead drivers to think that vehicles are turning left onto Hudson Road when they instead are turning left into the Gulf Station driveway, as observed in crashes 23 and 30.

Figure 7: Wide gas station driveway used as a cut through onto Great Road.

- Evaluate reducing the width of driveways to reduce safety concerns near this intersection.
- Evaluate limiting movements from the Gulf gas station driveway onto Great Road to right-in/right-out only.
- Evaluate coordinating with property owners to merge the Gulf gas station exit on Hudson Road with that of the liquor store directly to the south in order to distance access from the intersection.

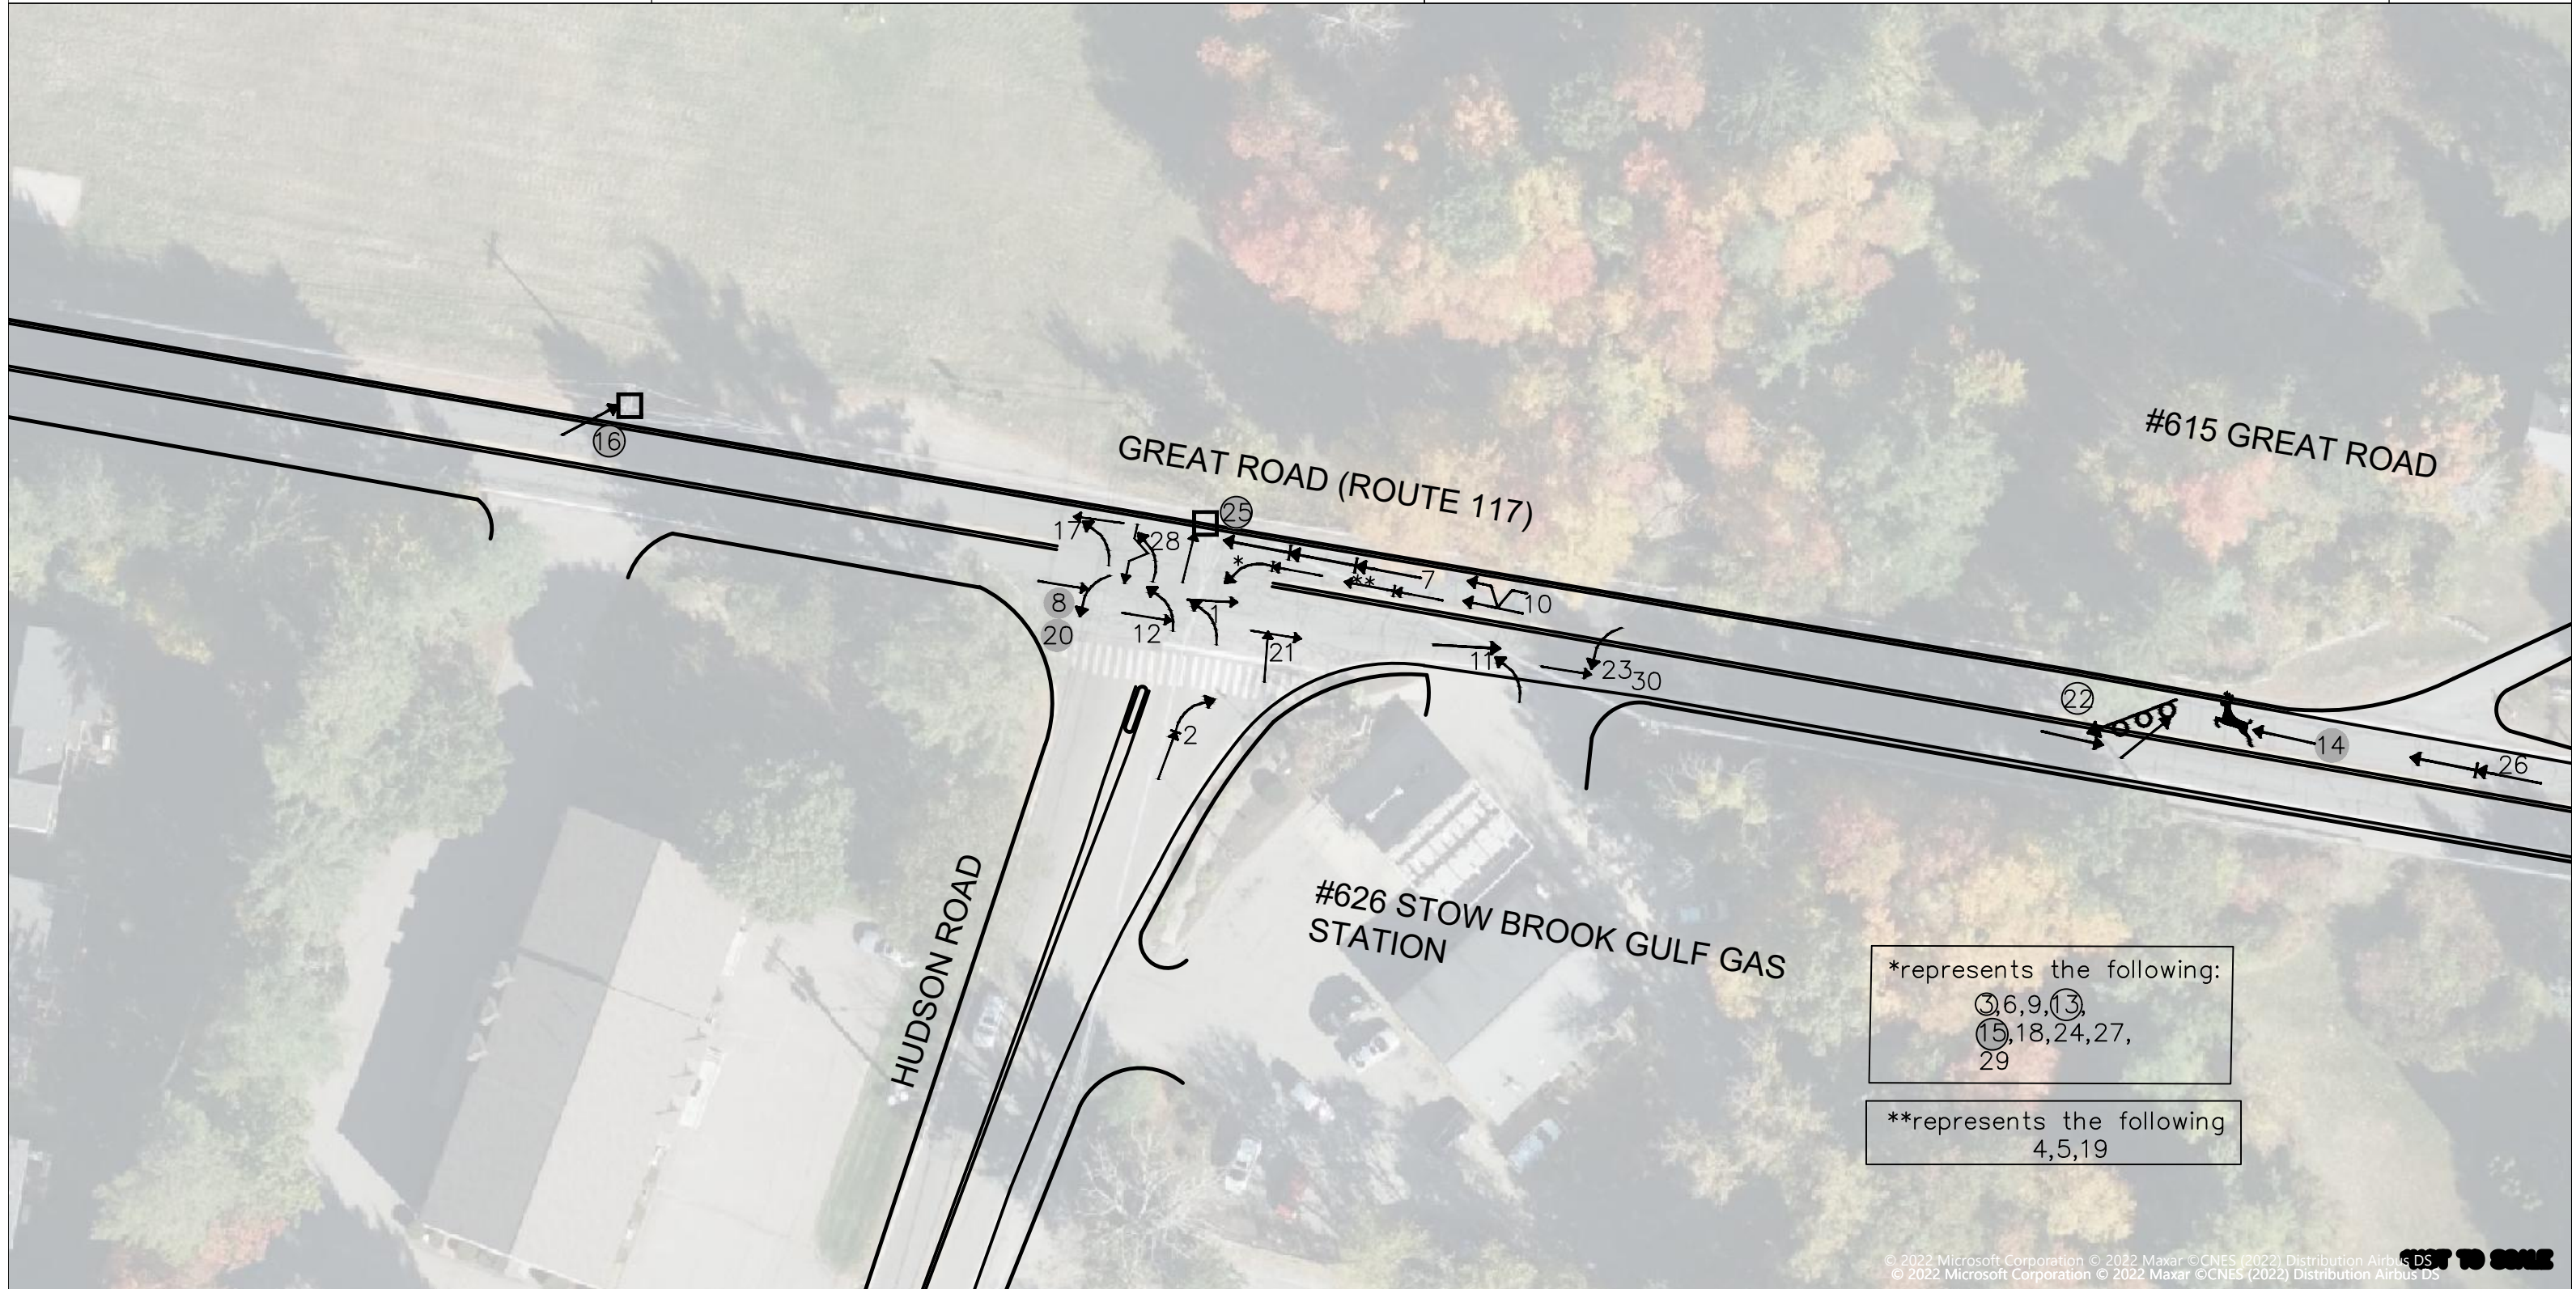
COLLISION DIAGRAM

*represents the following:
 3, 6, 9, 13,
 15, 18, 24, 27,
 29

**represents the following
 4, 5, 19
