NATURAL RESOURCES INVENTORY

STOW ACRES Randall Road, Stow, MA

November 2023

Prepared for the Town of Stow, MA BSC Project No. 99110.00

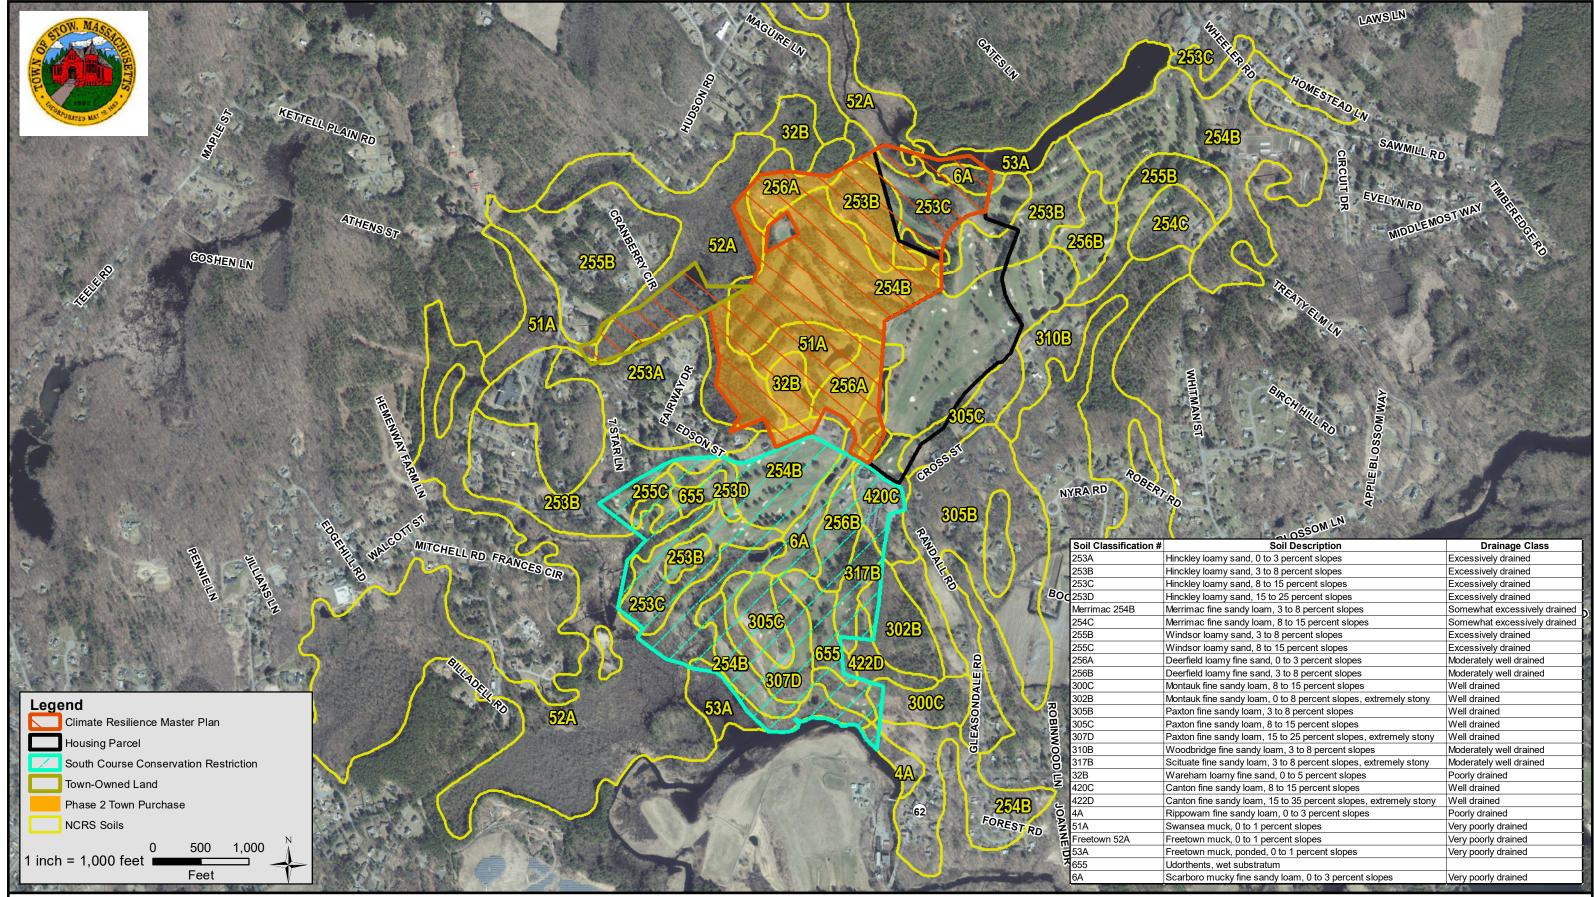
### Soil Map Stow, MA

055	The second s			
Soil Description	Drainage Class			
ckley loamy sand, 0 to 3 percent slopes	Excessively drained			
ckley loamy sand, 3 to 8 percent slopes	Excessively drained			
ckley loamy sand, 8 to 15 percent slopes	Excessively drained			
ckley loamy sand, 15 to 25 percent slopes	Excessively drained			
rimac fine sandy loam, 3 to 8 percent slopes	Somewhat excessively drained			
rimac fine sandy loam, 8 to 15 percent slopes	Somewhat excessively drained			
ndsor loamy sand, 3 to 8 percent slopes	Excessively drained			
ndsor loamy sand, 8 to 15 percent slopes	Excessively drained			
erfield loamy fine sand, 0 to 3 percent slopes	Moderately well drained			
erfield loamy fine sand, 3 to 8 percent slopes	Moderately well drained			
ntauk fine sandy loam, 8 to 15 percent slopes	Well drained			
ntauk fine sandy loam, 0 to 8 percent slopes, extremely stony	Well drained			
ton fine sandy loam, 3 to 8 percent slopes	Well drained

ton fine sandy loam, 8 to 15 percent slopes	Well drained			
ton fine sandy loam, 15 to 25 percent slopes, extremely stony	Well drained			
odbridge fine sandy loam, 3 to 8 percent slopes	Moderately well drained			
tuate fine sandy loam, 3 to 8 percent slopes, extremely stony	Moderately well drained			
reham loamy fine sand, 0 to 5 percent slopes	Poorly drained			
nton fine sandy loam, 8 to 15 percent slopes	Well drained			
nton fine sandy loam, 15 to 35 percent slopes, extremely stony	Well drained			
powam fine sandy loam, 0 to 3 percent slopes	Poorly drained			
ansea muck, 0 to 1 percent slopes	Very poorly drained			
etown muck, 0 to 1 percent slopes	Very poorly drained			
etown muck, ponded, 0 to 1 percent slopes	Very poorly drained			
orthents, wet substratum				
arboro mucky fine sandy loam, 0 to 3 percent slopes	Very poorly drained

The Site is dominated by soils that are designated as Prime Farmland (Merrimac 254B) and Farmland of Statewide Importance (Deerfield 256A, Hinckley 253B, and Hinckley 253C). The wetland system connecting the North Course to the South Course is mapped as Scarboro mucky fine sandy loam (Scarboro 6A) and the Driving Range is primarily classified as Wareham loamy fine sand (Wareham 32B) with Swansea muck (Swansea 51A) associated with the canal system defining the northern extent of the Driving Range Study Area. Freetown muck is also mapped under the wetland system on the west side of the Study Area (See **Figure 9** in **Attachment A**).

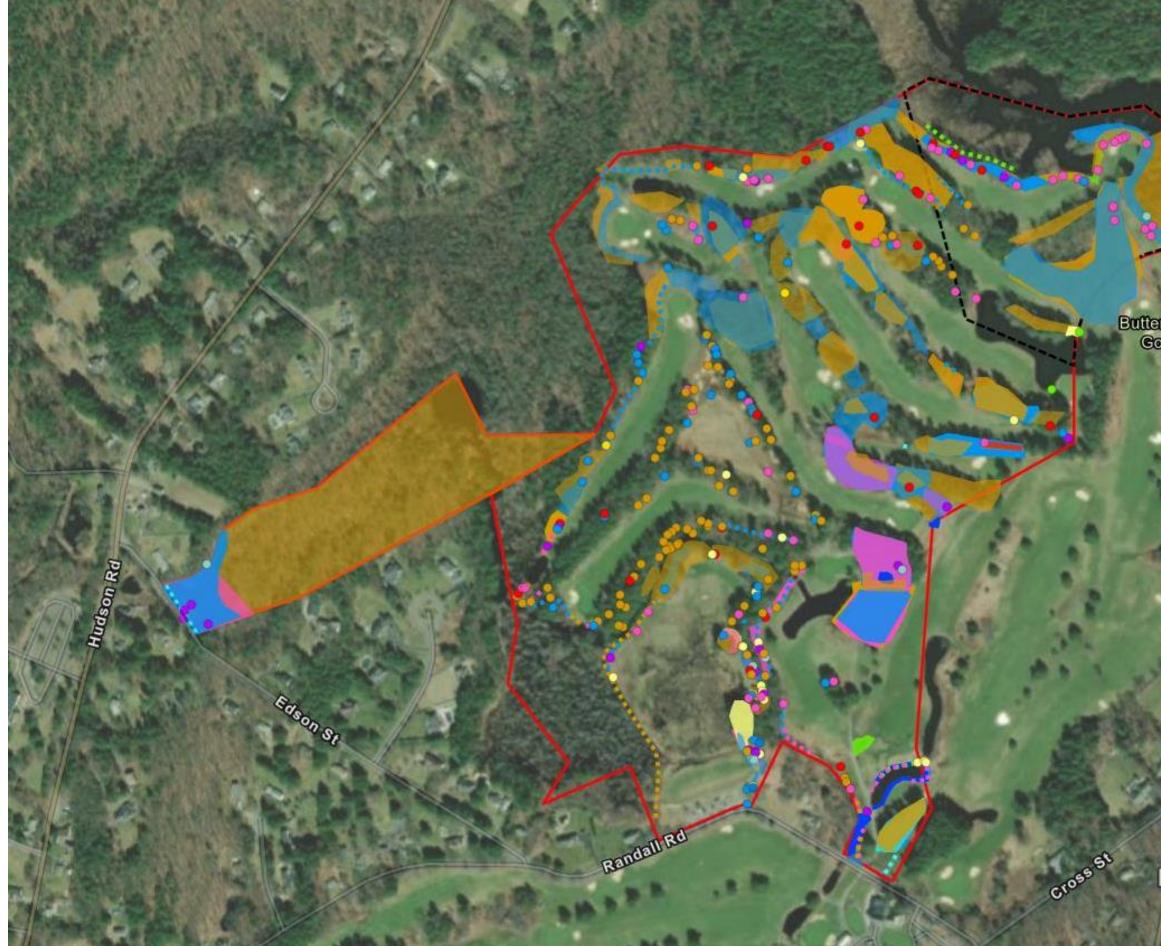
- Asiatic bittersweet
- Autumn olive
- Burning bush; Winged euonymus
- Common buckthorn
- European barberry
- European buckthorn; glossy buckthorn
- Japanese barberry
- Morrow's honeysuckle
- Multiflora rose
- Purple loosestrife

Results of the invasive mapping effort have been collected in an on-line ArcGIS web viewer and are presented **in Figure 10** in **Attachment A**.

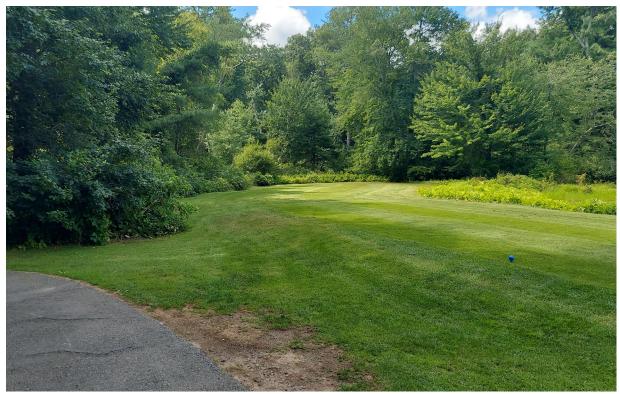
#### Site 1: The Rookery

A golf tee was created by filling a wetland. Excavating that historic fill but leaving an upland island creates potential nesting habitat for wildlife that need upland conditions for nesting but that prefer the isolation created by a wetland complex.

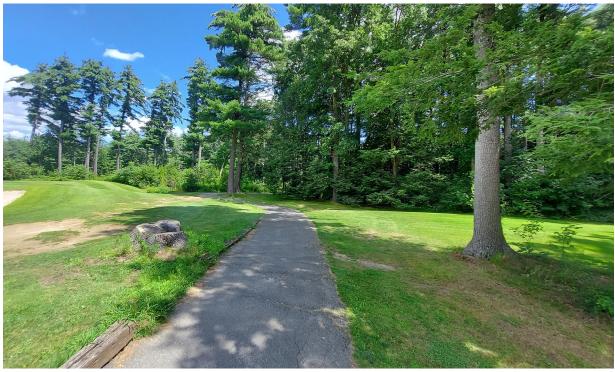
### Site 2: Spruce Bog

Farthest away from human influences on the site in the northwest of Stow Acres, the wetland forest can be encouraged, with opportunities for Spruce and Fir dominated wetlands.

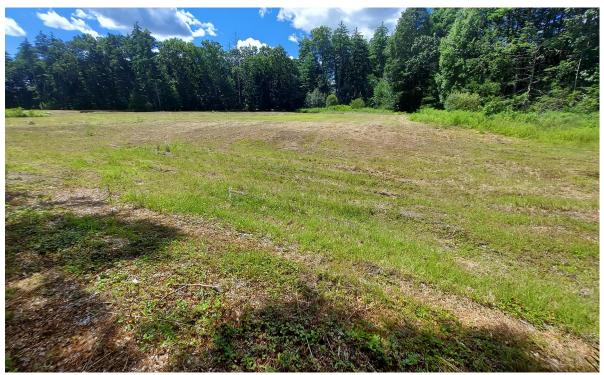
#### Site 3: Upland Meadow

A fallow field in the middle of the Stow Acres site presents opportunities for developing pollinator habitat with native meadow plantings.

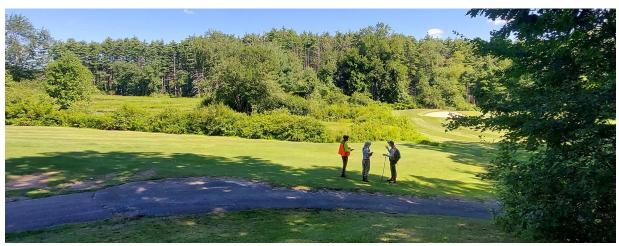
#### Site 6: Habitat Integration & Drainage

Existing site features that could provide important stormwater treatment of the planned residential neighborhood and that has interesting wildlife habitat enhancement opportunities.

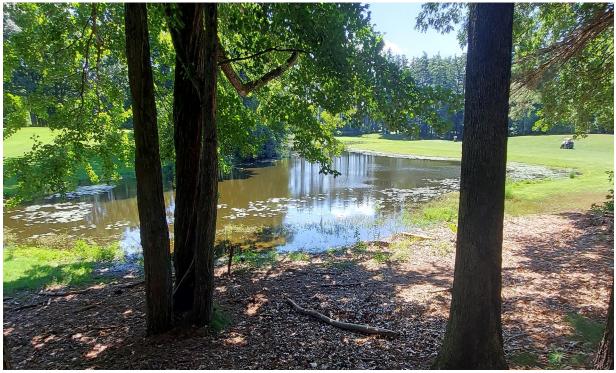
#### Site 8: Pond Restoration and Outdoor Recreation

The natural Dogbone Pond can be restored and enhanced with goals of natural history observation, education, and possibly recreational fishing in mind.

A water hazard known as "Dogbone Pond," is a natural pond that has been incorporated into the course since its earliest development. Another small water hazard occurs at the northwestern most portion of the Site. During BSC's August site visit, the latter pond was observed to be heavily vegetated with duckweed (*Lemna* spp), which may indicate potential issues with nutrient loading that may need to be addressed in future management plans for the Site.

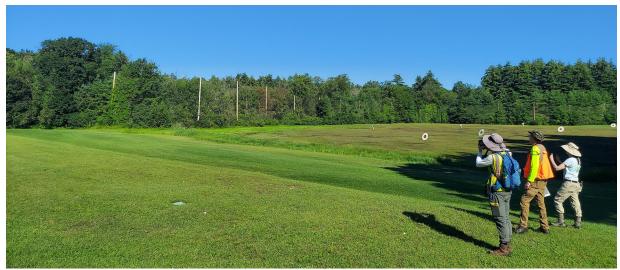
#### Site 10: Wetland Restoration at the Driving Range

Historic mapping resources indicate that the Driving Range was once a wetland ecosystem. It has been significantly altered through time to retain dry conditions (to the extent it was feasible) but the area presents an excellent opportunity to recreate functioning wetland habitat with a natural stream course.

The Driving Range is located at the south-west corner of the Site which is bound to the west by a wooded swamp that is actively maintained by beaver (*Castor canadensis*). A series of dug canals and natural stream flowage drains a large man-made pond in the south of the Study Area. This connects with the beaver wetland and drains southward under Randall Road through the center of the 18-hole golf course south of Randall Road, ultimately connecting with the Assabet River and its floodplain wetlands north of Orchard Hill in Stow.
