TOWN OF STOW, MASSACHUSETTS

Dry Weather Outfall Screening Report

APRIL 2022

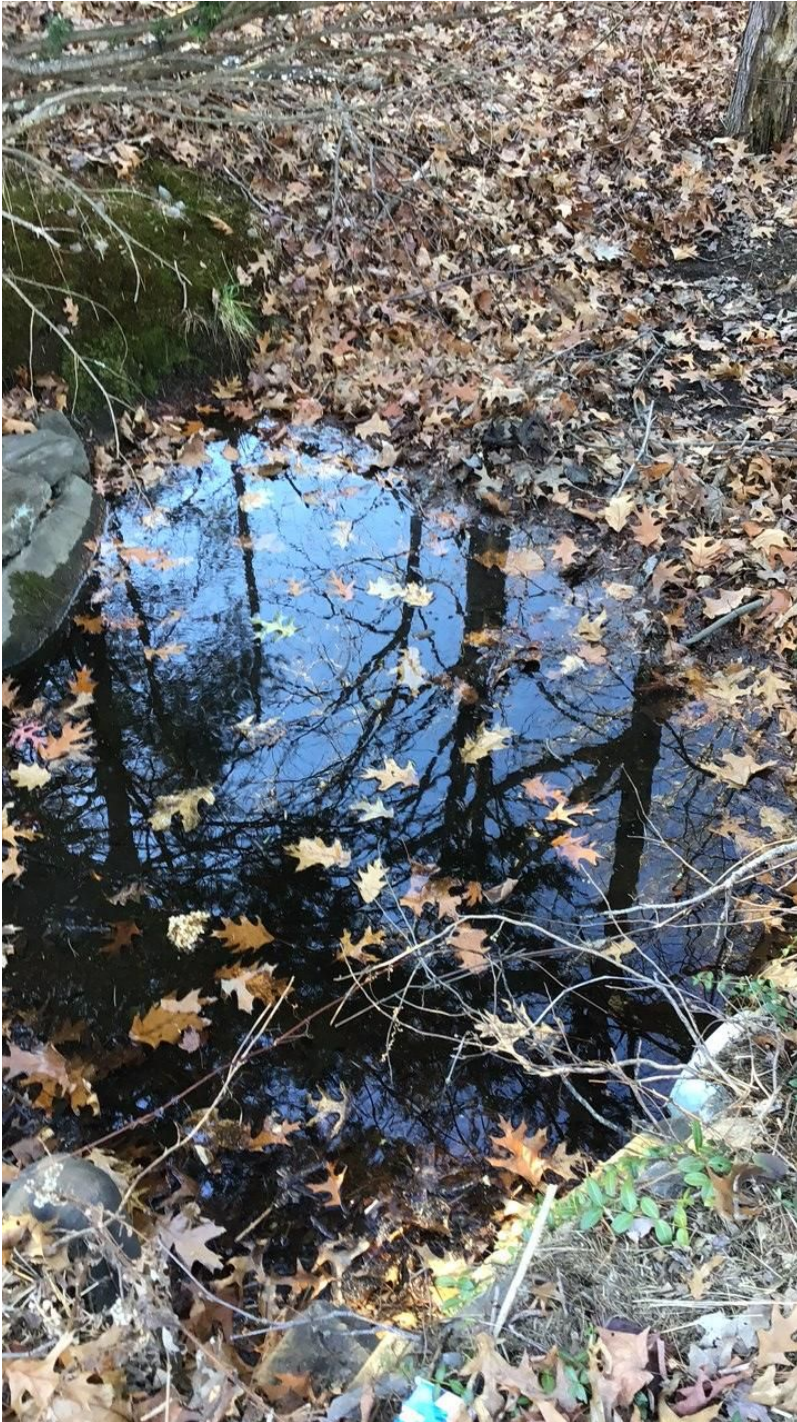
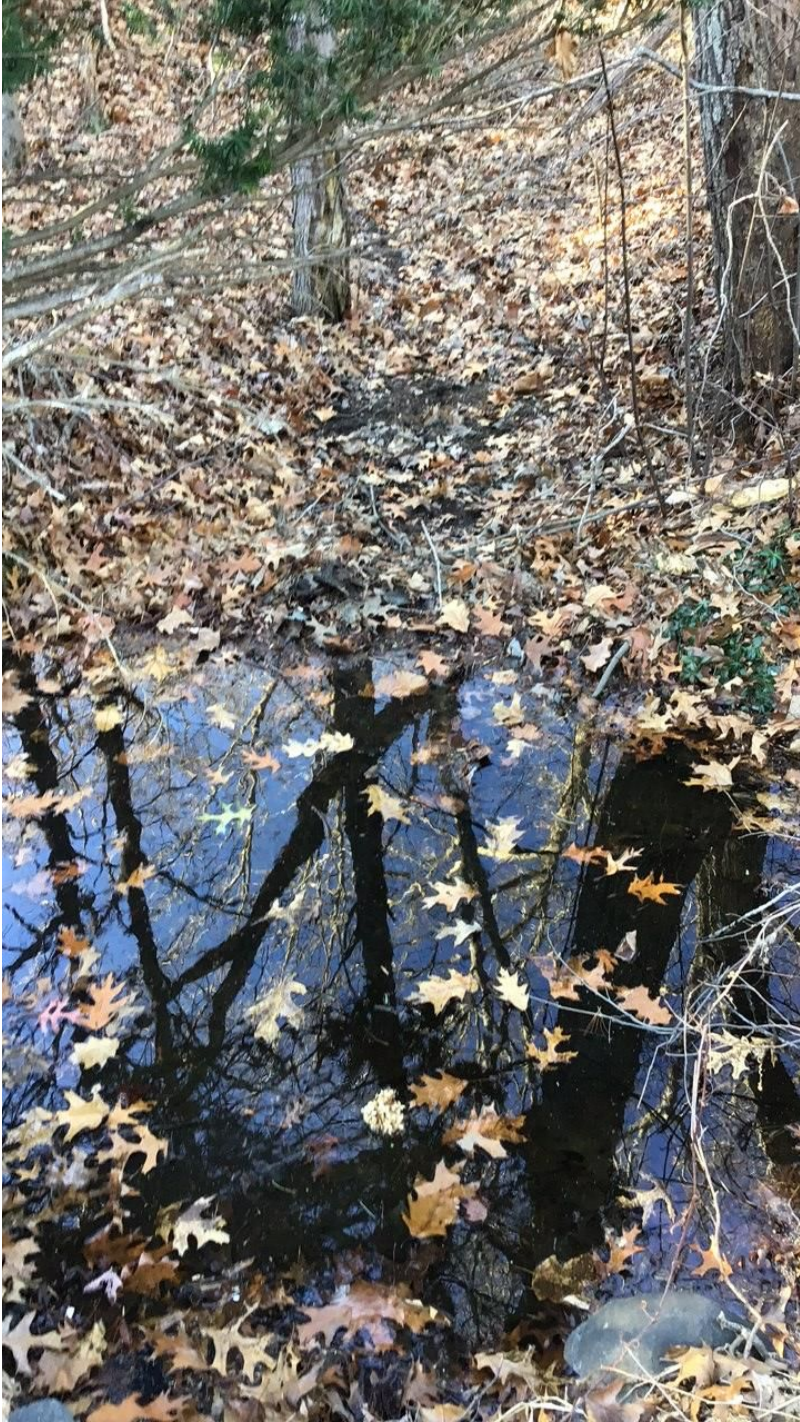
<b>Ownership</b>	Public
<b>Outfall Type</b>	Headwall
<b>Other Outfall Type</b>	
<b>Material</b>	PVC
<b>Shape</b>	Circular
<b>Diameter/Dimension (in)</b>	10
<b>Condition</b>	Good
<b>Sediment</b>	Open/None
<b>Erosion/Scouring</b>	No
<b>BMP Visible</b>	Other
<b>Other BMP Type</b>	None

<b>Evidence of Pollution (select all that apply)</b>	None
<b>Odor</b>	None
<b>Flow Clarity</b>	N/A (not flowing)
<b>Flow Color</b>	N/A (not flowing)
<b>Flow Color Description</b>	
<b>Evidence of Staining</b>	No
<b>Evidence of Abnormal Vegetation</b>	No
<b>Outfall Damage, Deposits, Growth on Outfall, or Other Indicators of Illicit Discharge</b>	No
<b>If yes, please describe:</b>	
<b>Potential Sources/Actions Taken</b>	
<b>Needs follow up?</b>	No
<b>Reason for follow up:</b>	
<b>General Comments</b>	Pipe partially submerged, no evidence of flow or illicit discharge.

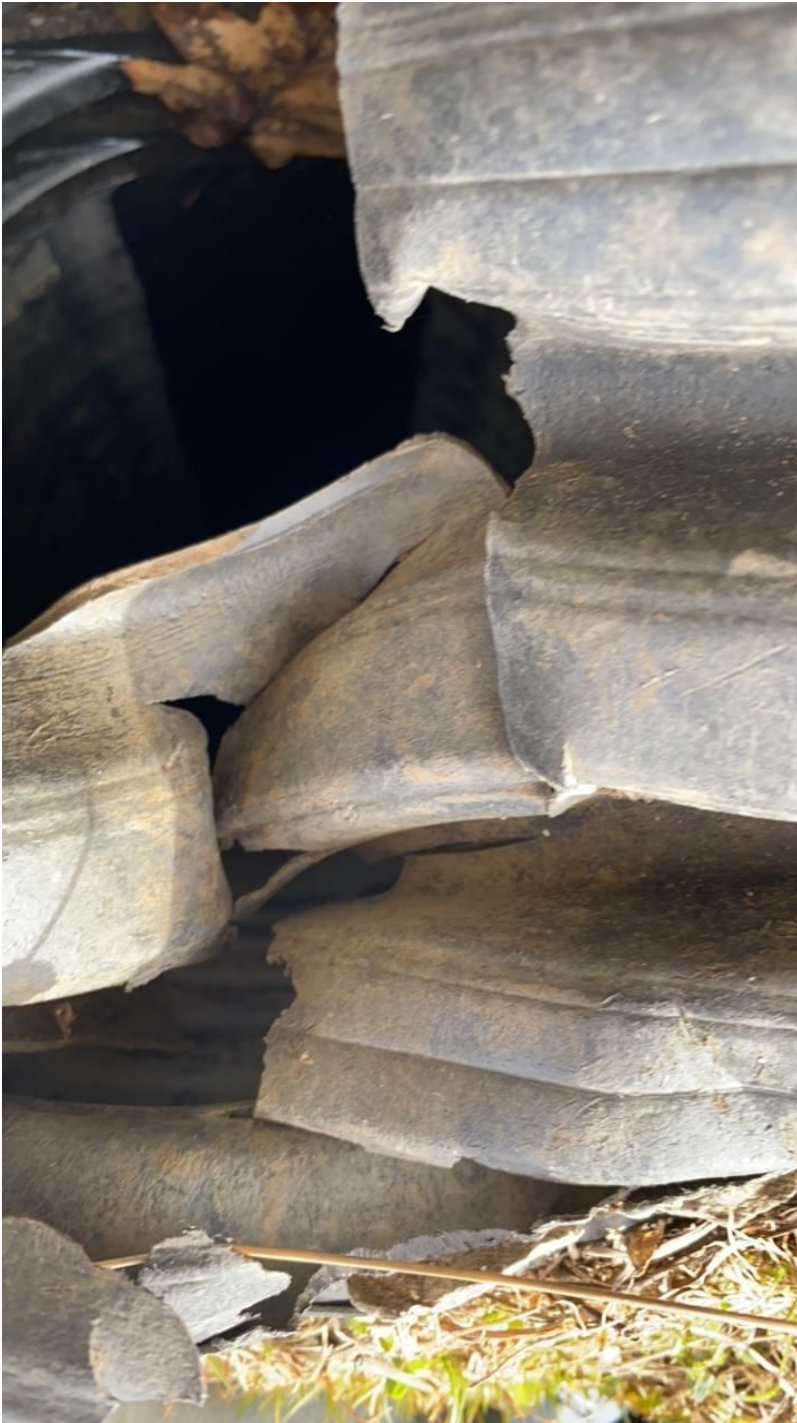
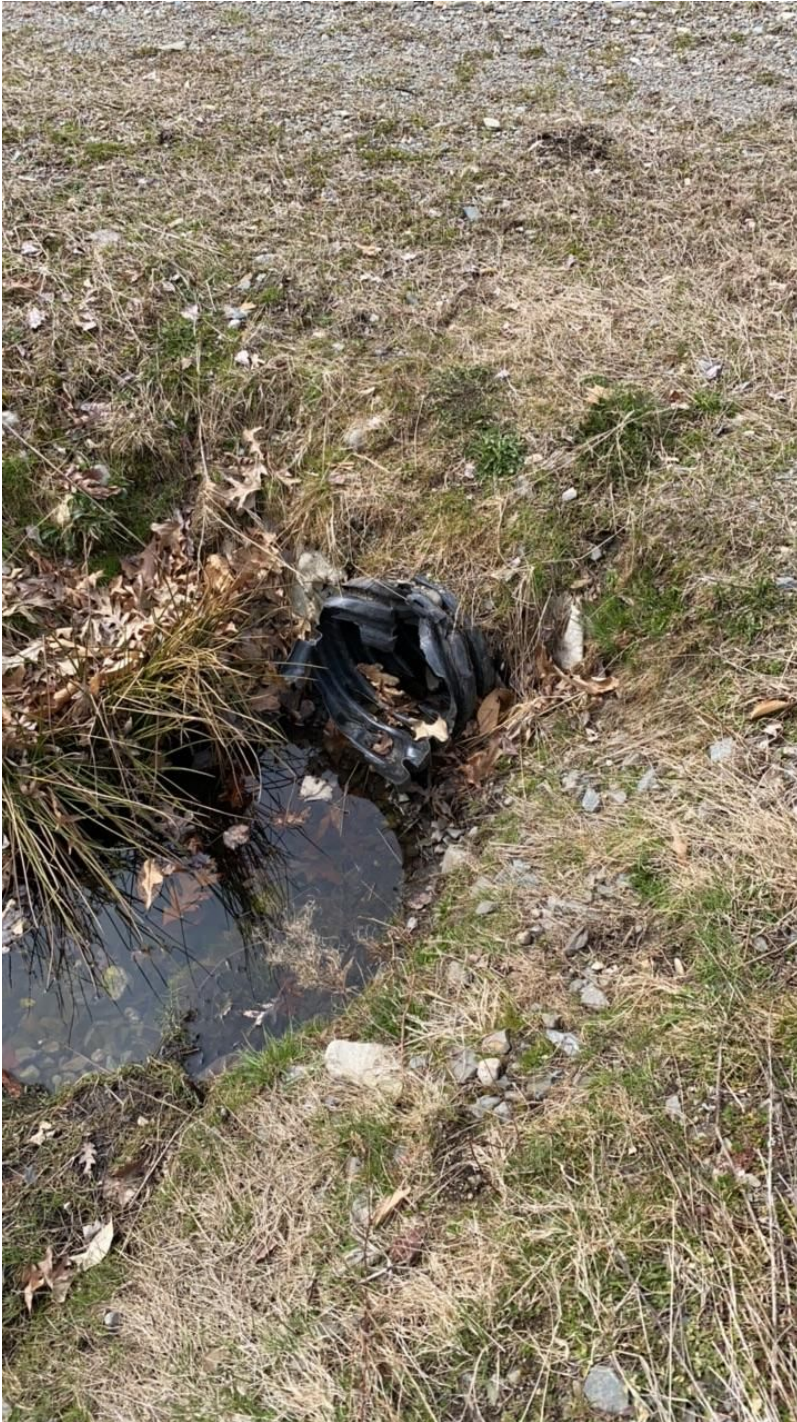
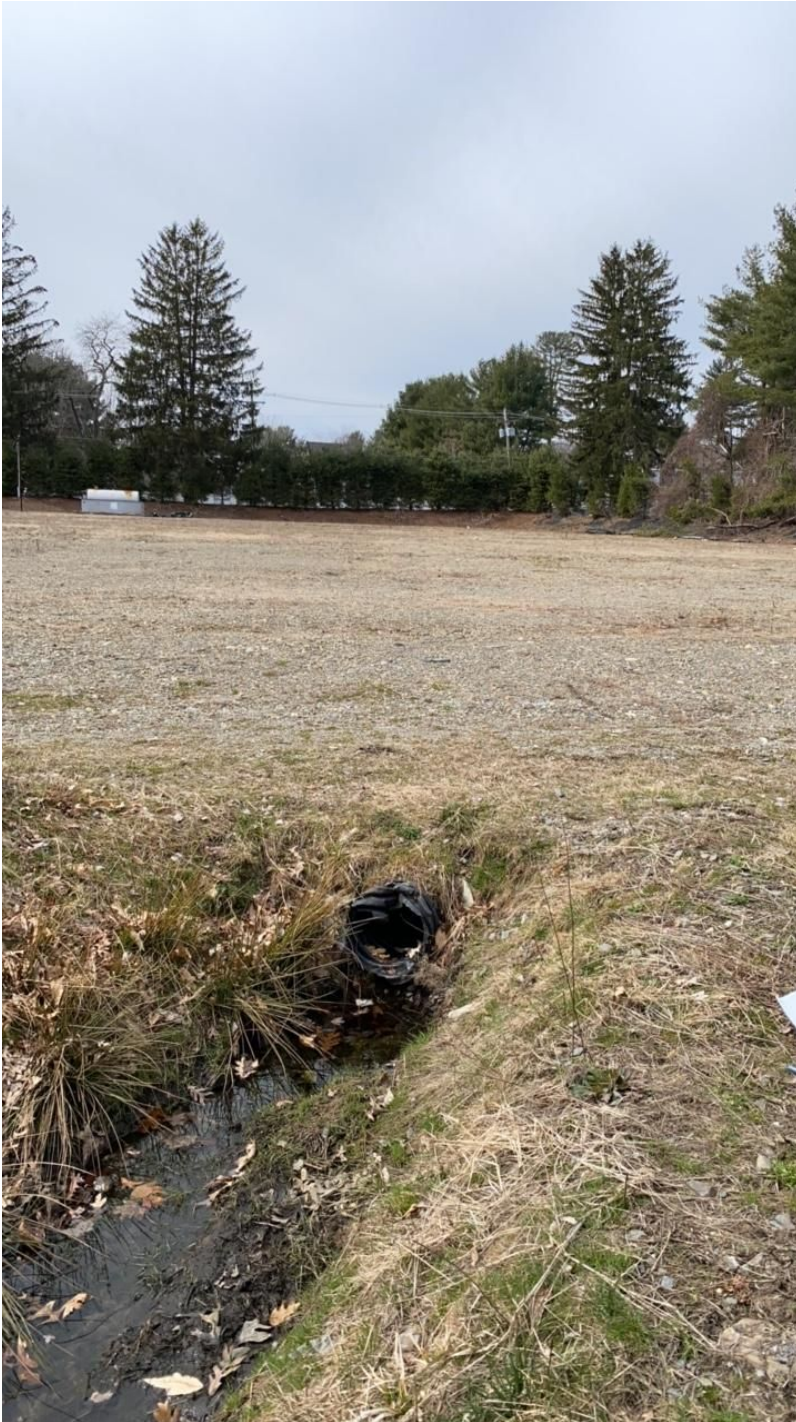
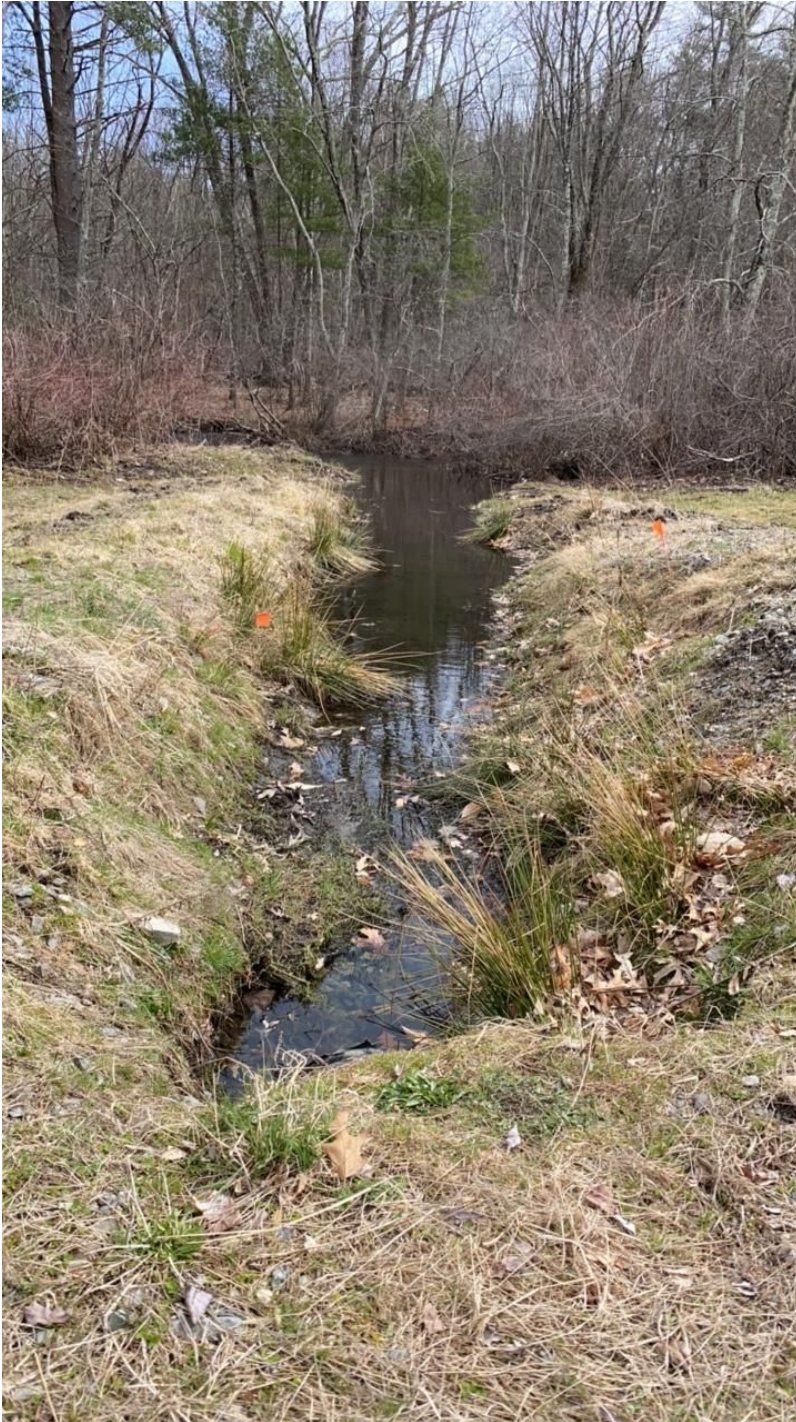
<b>Evidence of Pollution (select all that apply)</b>	None
<b>Odor</b>	None
<b>Flow Clarity</b>	Clear
<b>Flow Color</b>	Clear
<b>Flow Color Description</b>	
<b>Evidence of Staining</b>	No
<b>Evidence of Abnormal Vegetation</b>	No
<b>Outfall Damage, Deposits, Growth on Outfall, or Other Indicators of Illicit Discharge</b>	No
<b>If yes, please describe: Potential Sources/Actions Taken</b>	
<b>Needs follow up?</b>	No
<b>Reason for follow up:</b>	
<b>General Comments</b>	Small amount of standing water in pipe.

<b>Ownership</b>	Public
<b>Outfall Type</b>	Pipe End
<b>Other Outfall Type</b>	
<b>Material</b>	PE
<b>Shape</b>	Circular
<b>Diameter/Dimension (in)</b>	14
<b>Condition</b>	Good
<b>Sediment</b>	Open/None
<b>Erosion/Scouring</b>	No
<b>BMP Visible</b>	Other
<b>Other BMP Type</b>	None

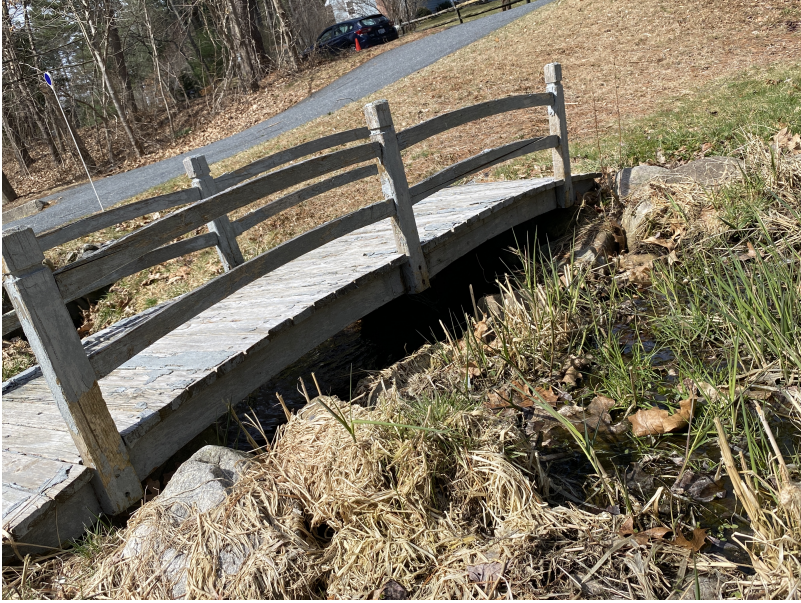
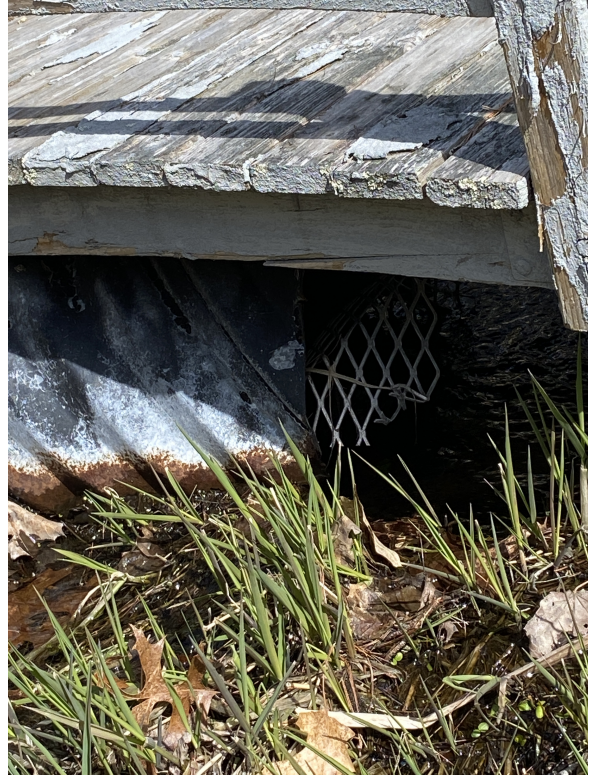
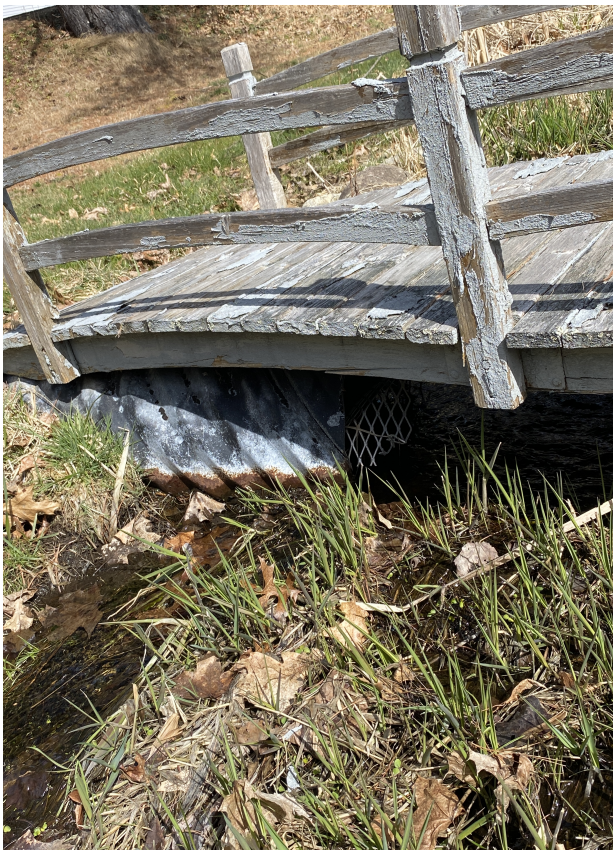
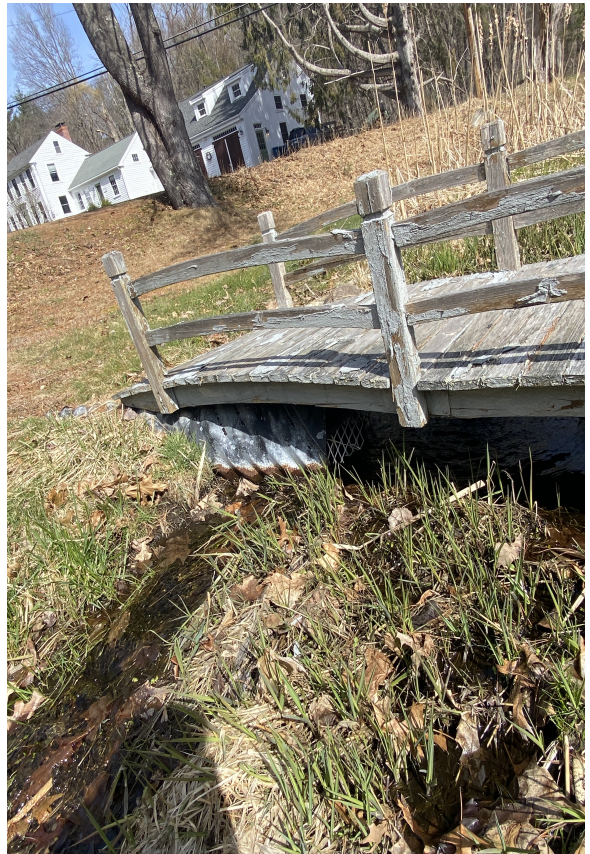
<b>Ownership</b>	Public
<b>Outfall Type</b>	Pipe End
<b>Other Outfall Type</b>	
<b>Material</b>	CMP
<b>Shape</b>	Circular
<b>Diameter/Dimension (in)</b>	12
<b>Condition</b>	Fair
<b>Sediment</b>	1/4
<b>Erosion/Scouring</b>	Yes
<b>BMP Visible</b>	Outlet Guard
<b>Other BMP Type</b>	None

<b>Evidence of Pollution (select all that apply)</b>	None
<b>Odor</b>	None
<b>Flow Clarity</b>	N/A (not flowing)
<b>Flow Color</b>	N/A (not flowing)
<b>Flow Color Description</b>	
<b>Evidence of Staining</b>	No
<b>Evidence of Abnormal Vegetation</b>	No
<b>Outfall Damage, Deposits, Growth on Outfall, or Other Indicators of Illicit Discharge</b>	No
<b>If yes, please describe: Potential Sources/Actions Taken</b>	
<b>Needs follow up?</b>	No
<b>Reason for follow up:</b>	
<b>General Comments</b>	Outfall is partially submerged, discharges into culvert flow. Did not seem like it was flowing, no evidence of illicit discharge.

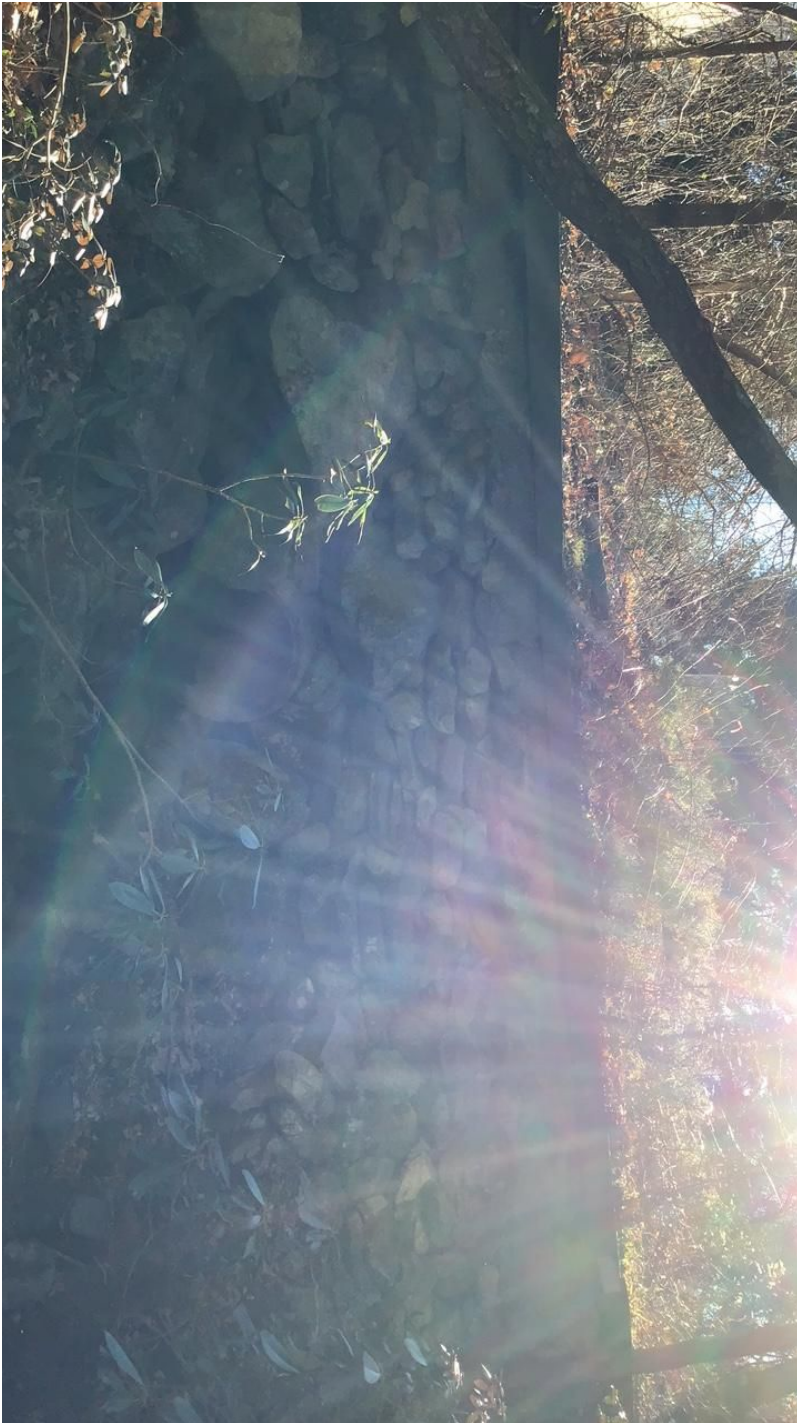
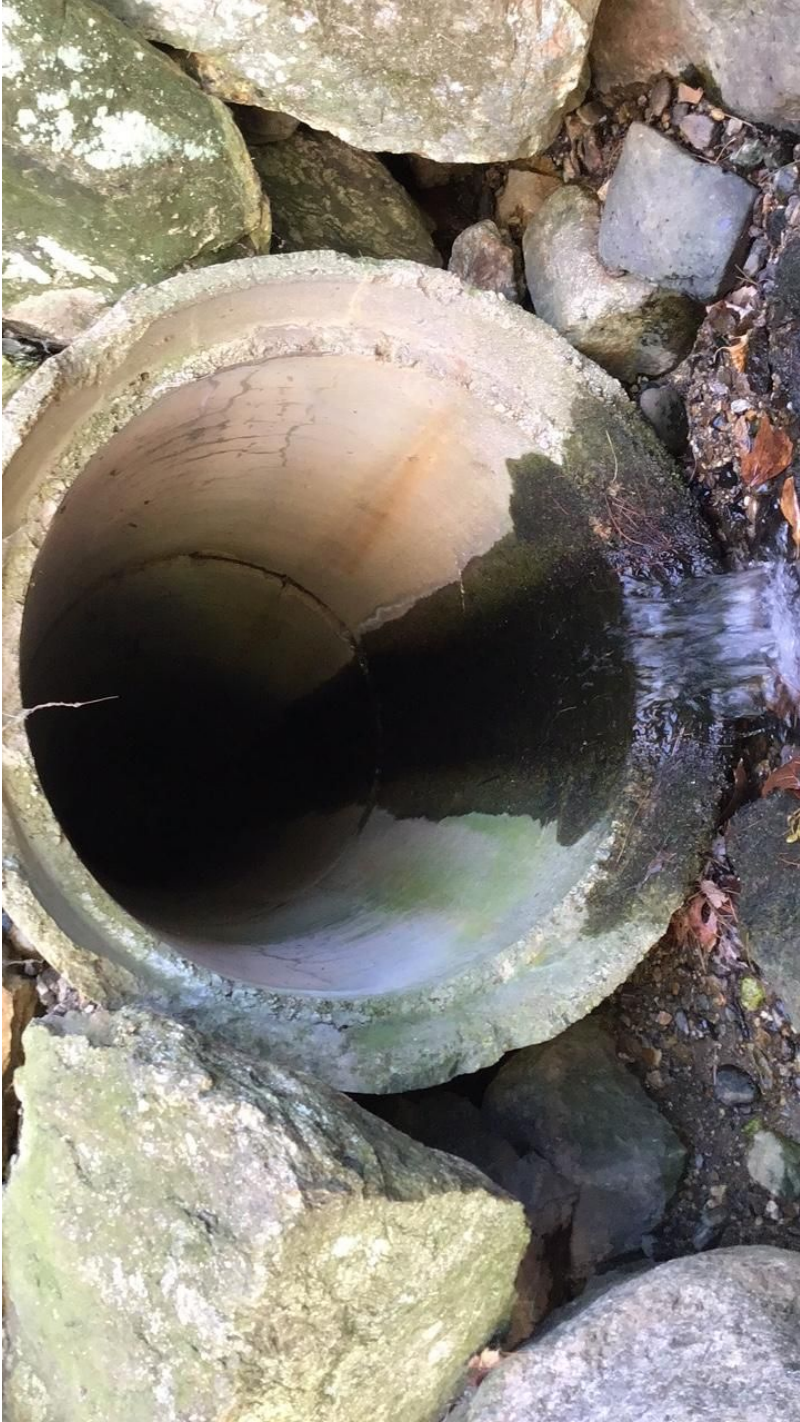
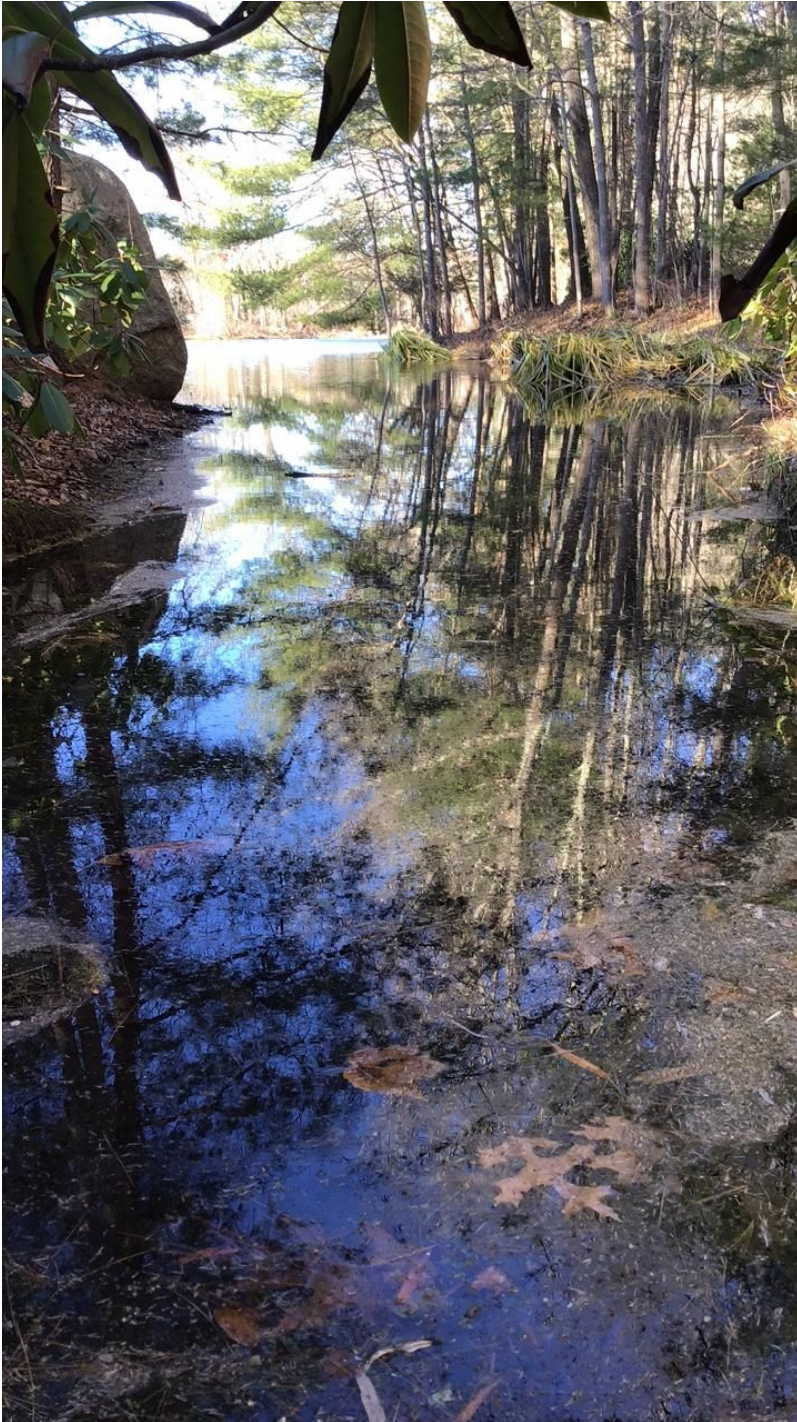
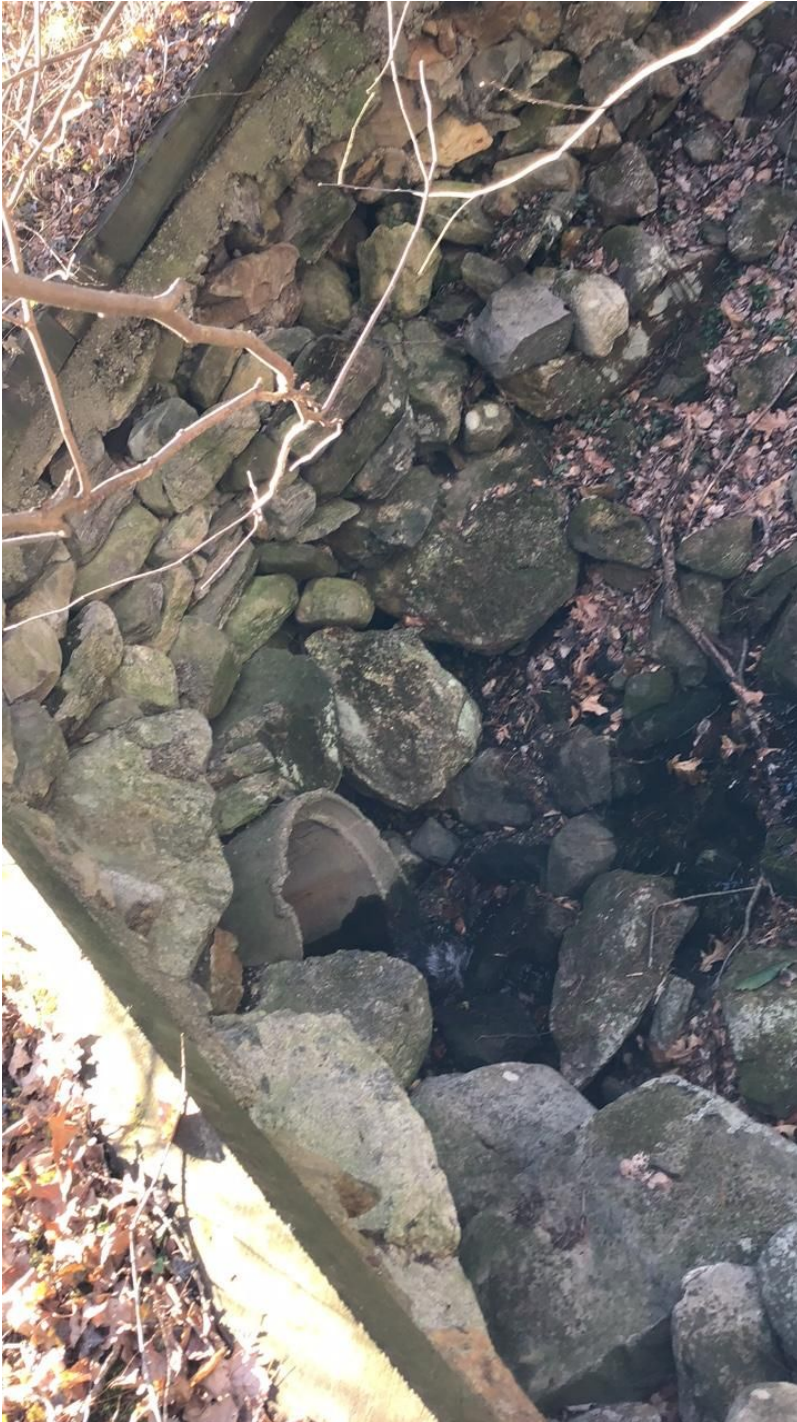
<b>Evidence of Pollution (select all that apply)</b>	None
<b>Odor</b>	None
<b>Flow Clarity</b>	Clear
<b>Flow Color</b>	Clear
<b>Flow Color Description</b>	
<b>Evidence of Staining</b>	No
<b>Evidence of Abnormal Vegetation</b>	No
<b>Outfall Damage, Deposits, Growth on Outfall, or Other Indicators of Illicit Discharge</b>	No
<b>If yes, please describe: Potential Sources/Actions Taken</b>	
<b>Needs follow up?</b>	Yes
<b>Reason for follow up:</b>	Return for sampling due to flow.
<b>General Comments</b>	Steady flow was observed for both site visits. No evidence of illicit discharge. Return for sampling.

<b>Ownership</b>	Public
<b>Outfall Type</b>	Headwall
<b>Other Outfall Type</b>	
<b>Material</b>	RCP
<b>Shape</b>	Circular
<b>Diameter/Dimension (in)</b>	30
<b>Condition</b>	Good
<b>Sediment</b>	Open/None
<b>Erosion/Scouring</b>	No
<b>BMP Visible</b>	
<b>Other BMP Type</b>

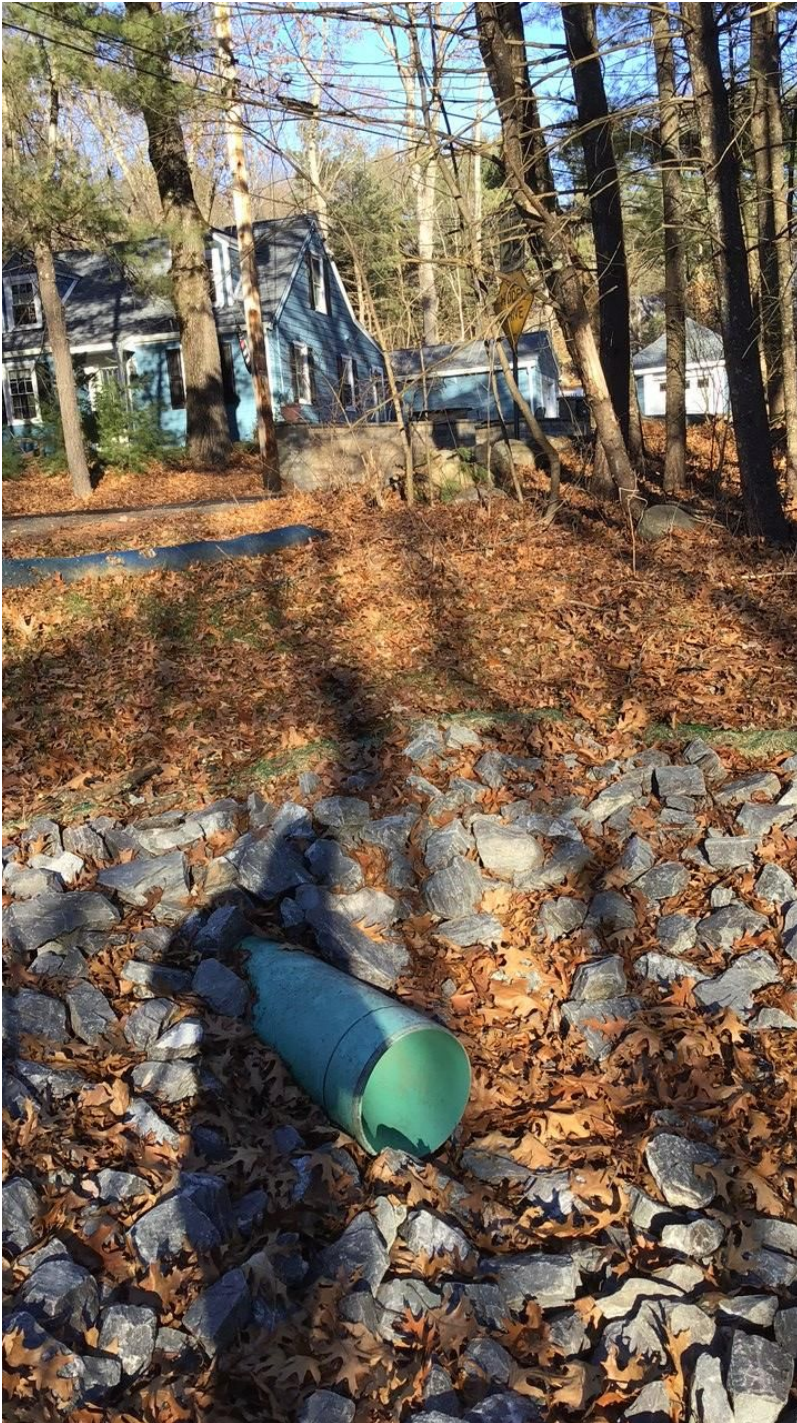
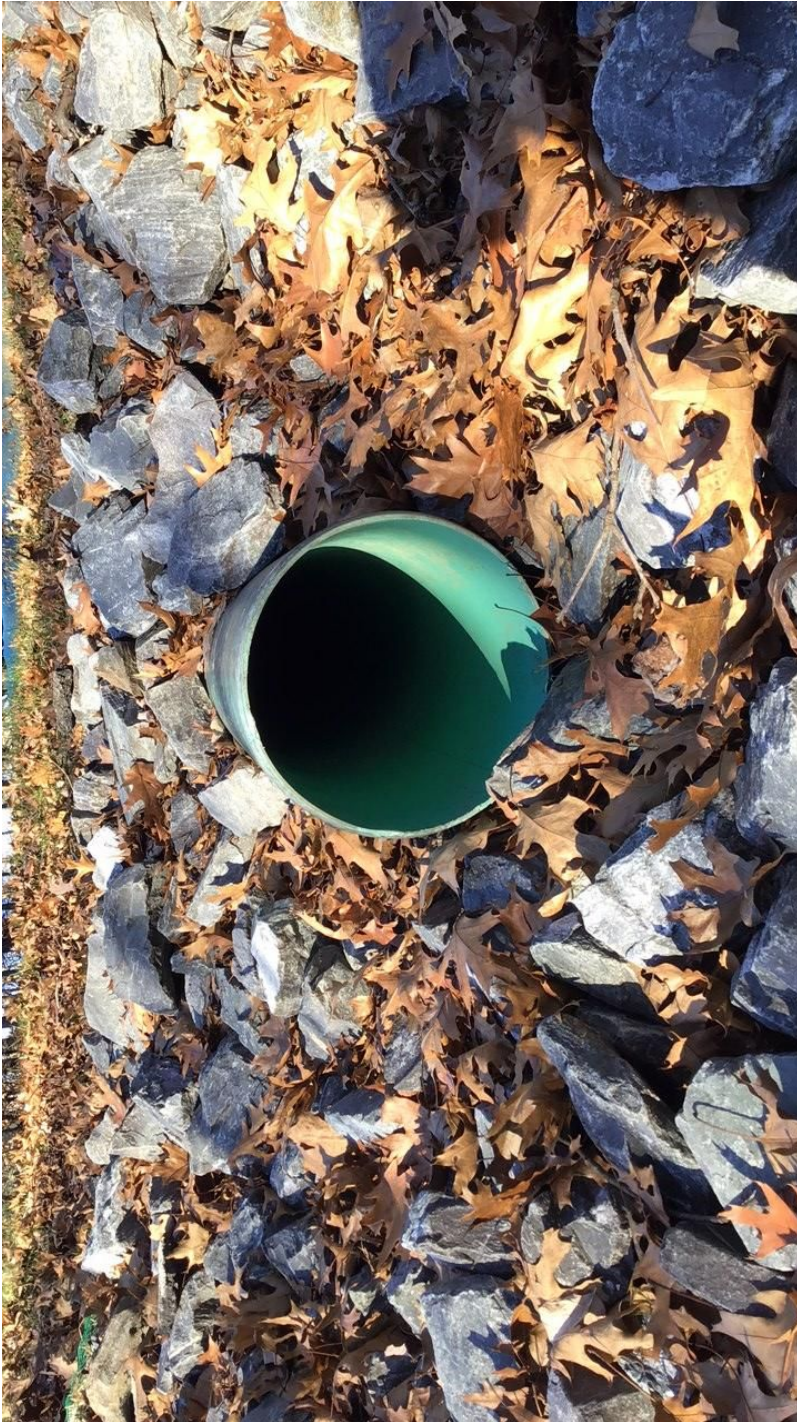
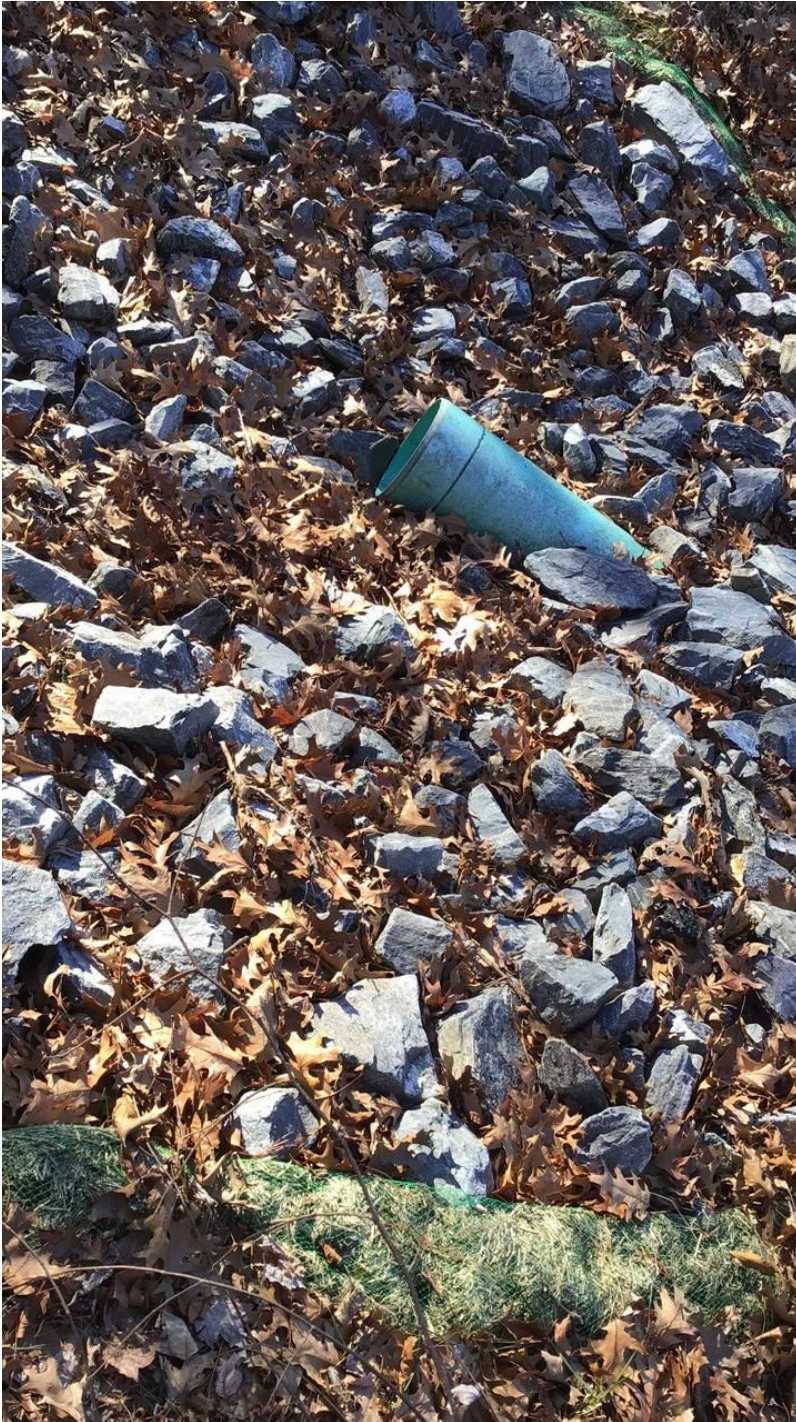
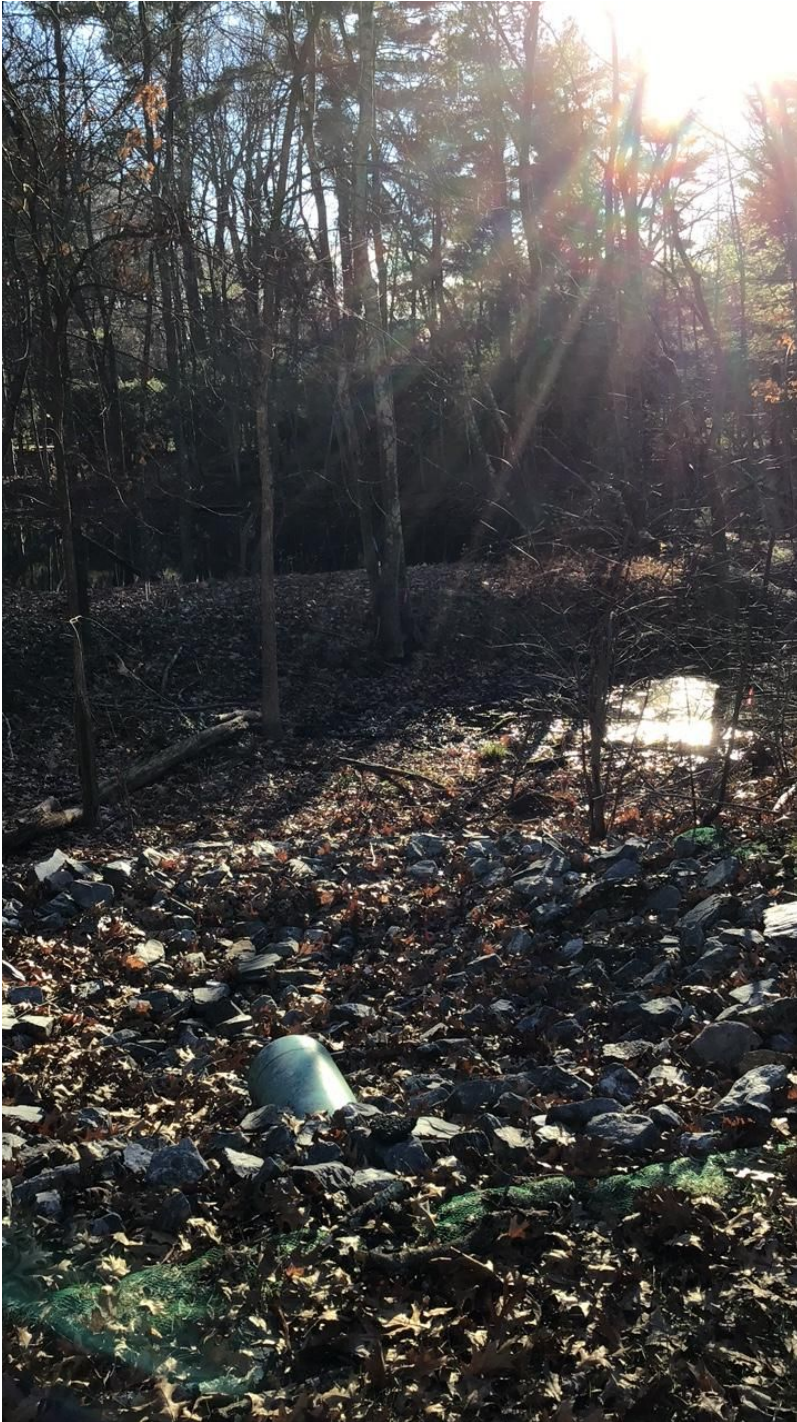
<b>Ownership</b>	Public
<b>Outfall Type</b>	Pipe End
<b>Other Outfall Type</b>	
<b>Material</b>	PVC
<b>Shape</b>	Circular
<b>Diameter/Dimension (in)</b>	12
<b>Condition</b>	Good
<b>Sediment</b>	Open/None
<b>Erosion/Scouring</b>	No
<b>BMP Visible</b>	Other
<b>Other BMP Type</b>	Rip rap and a straw sock.

<b>Evidence of Pollution (select all that apply)</b>	None
<b>Odor</b>	None
<b>Flow Clarity</b>	N/A (not flowing)
<b>Flow Color</b>	N/A (not flowing)
<b>Flow Color Description</b>	
<b>Evidence of Staining</b>	No
<b>Evidence of Abnormal Vegetation</b>	No
<b>Outfall Damage, Deposits, Growth on Outfall, or Other Indicators of Illicit Discharge</b>	No
<b>If yes, please describe:</b>	
<b>Potential Sources/Actions Taken</b>	
<b>Needs follow up?</b>	No
<b>Reason for follow up:</b>	
<b>General Comments</b>	Outfall is new, recent construction.
