74 Pine Point Road – Review of Drainage – E. Dodd

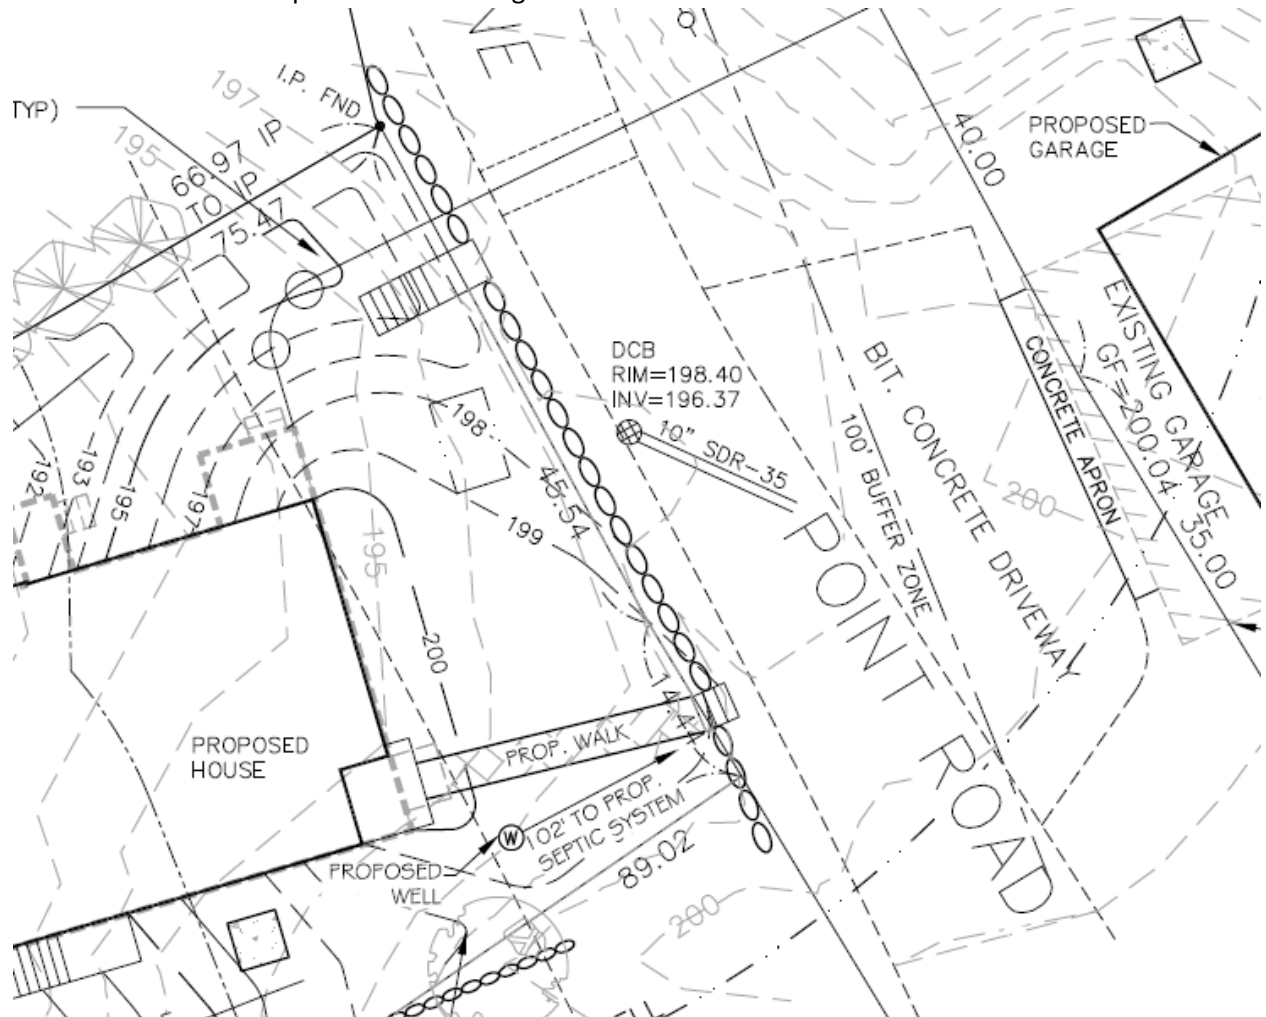
4. Runoff from the dwelling and Pine Point Road in the front yard is partially controlled by infiltration units below the surface covered with loam, then 6" if granular well graded soil/aggregate mixture to the chambers surrounded with ¾" to 2" washed crushed, angular stone. There is a 1' drop from the dwelling to the road.

1. The profile of Pine Point Road has not changed. The catch basin has not changed. The catch basin rim is at 198.4 feet. Pine Point Road slopes from 200' on the East side (72 lot) to 199' on the West side (76 lot) with a dip to 198' at the catch basin. Nothing has changed. Runoff from the road and surrounding parcels is still directed to the catch basin. The capacity of the catch basin is not known.

2. The stone wall remains in place along the lake side of Pine Point Road.
3. There are swales on either side of the proposed dwelling directing runoff from the roof and any runoff from Pine Point road to Pea Stone Diaphragm for infiltration. If the catch basin cannot keep up with the runoff, the excess runoff is directed through the stone wall to the front yard and then partially infiltrated to the infiltration chambers with excess runoff directed to the swales.
