Environmental Notification Form

Lake Boon Dam Repairs and Improvements Project

Re: Environmental Notification Form
Lake Boon Dam Repairs and Improvements Project
Barton Road in Stow, Massachusetts

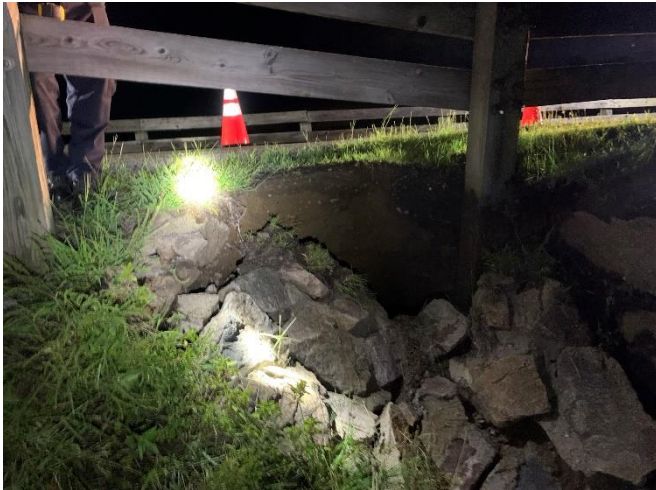
Figure 2: Photograph of sinkhole showing collapsed layer of grouted riprap and guardrail post falling into hole.

In the Summer of 2021, one of the dam deficiencies evolved following an extended period of precipitation and resulted in an emergency response. The safety incident was initially recognized by a

local resident who observed a sinkhole forming on the downstream side of the dam next to the spillway. Stow town officials, engineers and on-call contractors subsequently responded to evaluate and stabilize the sinkhole along with the assistance of members of the Lake Boon Association whose ongoing watershed modeling and monitoring efforts helped inform key decisions, including sizing of bypass pumps. It was ultimately determined that a hole had developed in the bottom of the culvert which allowed water flowing through the culvert to erode the embankment from the inside out, leading eventually to collapse of an unstable 'roof' that was being provided by a layer of grouted surface riprap. The necessary actions that were taken to stabilize the area were

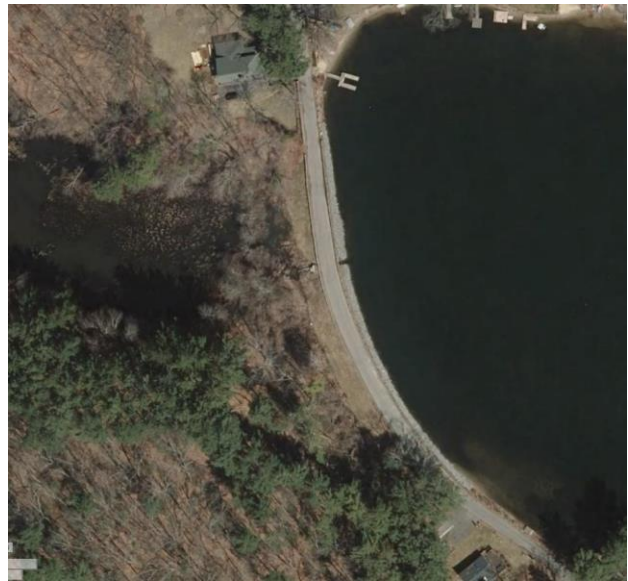
Figure 4: Aerial photograph of Lake Boon Dam (MassGIS, 2019 Imagery).

As indicated above, the crest of the present-day dam embankment is an approximately 16-foot-wide paved roadway. This roadway (Barton Road) provides a transportation link connecting Stow to the bordering town of Hudson and provides residential roadway access to the Lake Boon community. The upstream and downstream faces of the dam (east and west facing, respectively) are earthen slopes formed at variable inclinations, ranging generally from 1:1 (steepest) to 2:1 (flattest). The upstream slope is generally flatter than the downstream slope, and the slope face is protected with a layer of angular stone riprap that covers a 30-mil geomembrane liner. The geomembrane liner, which is submerged beneath the lake surface, was installed during repairs made to the dam in 1999/2000 as an impervious barrier and mitigation measure to block the flow of water seeping from the lake through the pervious embankment. The downstream slope is vegetated and includes a narrow stone-lined drainage swale at the toe, though the swale is mostly concealed by dense vegetation.

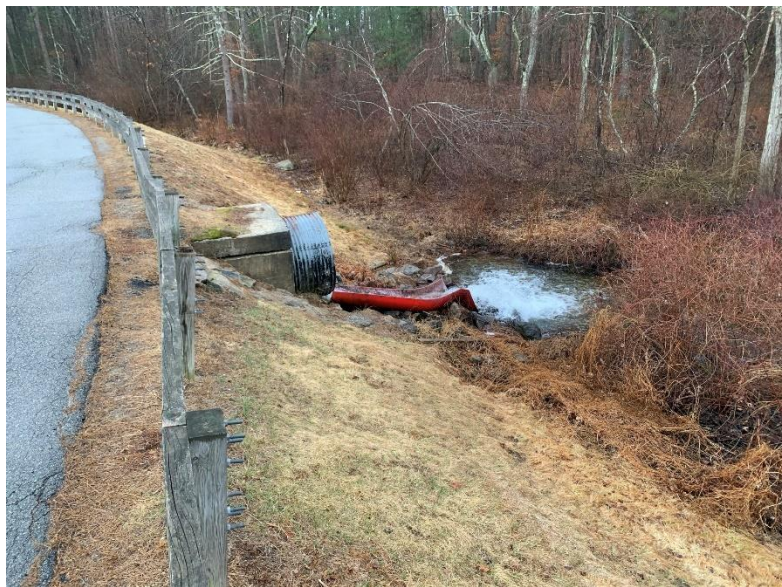
Figure 5: Photograph (March 2021) of dam embankment downstream slope and discharging spillway.

Incorporated into the earthen dam embankment near its midpoint is a culvert-style spillway constructed predominantly of concrete. The spillway feature is an assembly of three adjoined components that serve to protect the dam and surrounding areas by safely conveying excess lake inflows downstream to Bailey's Brook. These three components include the control section, conveyance section, and an extension of the conveyance section. The control section is a three-sided concrete inlet located within the upstream embankment slope. The structure contains wood stoplogs (stacked boards placed horizontally across the inlet opening) that provide lake level control and a metal debris rack for blocking the entry of large objects. The inlet contains 12 to 14 inches of removable stoplogs above additional stoplogs that were grouted in place an unknown number of years ago. The central conveyance section consists of a 5-foot-wide, four-sided concrete culvert located within the embankment beneath the roadway. The culvert receives flow passing over/through the control section. Attached to the main body of the culvert is an extension constructed as a "U" shaped concrete channel with a separate, unattached roof slab. Within this extension is a 5-foot diameter corrugated metal pipe (CMP) that receives flow from the main body of the culvert. The CMP daylight through the embankment approximately half way up the downstream slope. Flow through the corrugated metal pipe is then discharged onto a plastic chute resting on the downstream embankment slope. The plastic chute was added as a retrofit to convey outflows over the

lower part of the embankment slope and dissipate energy after it was discovered that the slope had experienced significant toe erosion.

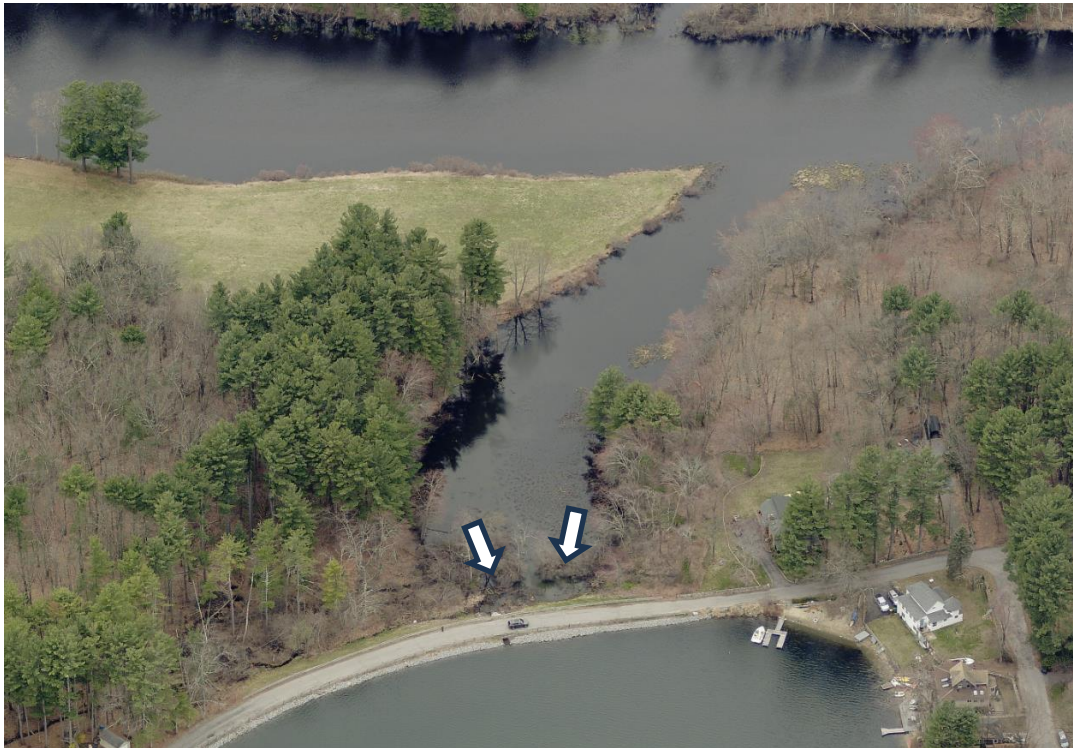
Figure 6: West facing view of Lake Boon Dam, Bailey's Brook, and confluence with Assabet River (EagleView, 2019). The remnant downstream embankment sections separated by the narrow breachway are indicated by arrows.

Flows passed through the spillway collect initially in a shallow tailwater basin at the toe of the dam before navigating further downstream to the wider and more pronounced reach of Bailey's Brook. The tailwater basin is a roughly 100-foot-wide by 35-foot-long oval-shaped area that has formed between the toe of the dam and a smaller 3 to 4-foot-tall downstream embankment. The downstream embankment is separated into two sections at a narrow breachway that is approximately 15-feet-wide from bank to bank. It is understood that this downstream embankment is likely the remnants of the original dam constructed in 1845. The sideslopes of the two embankment sections remain armored with stone in some areas beneath a dense cover of brush.

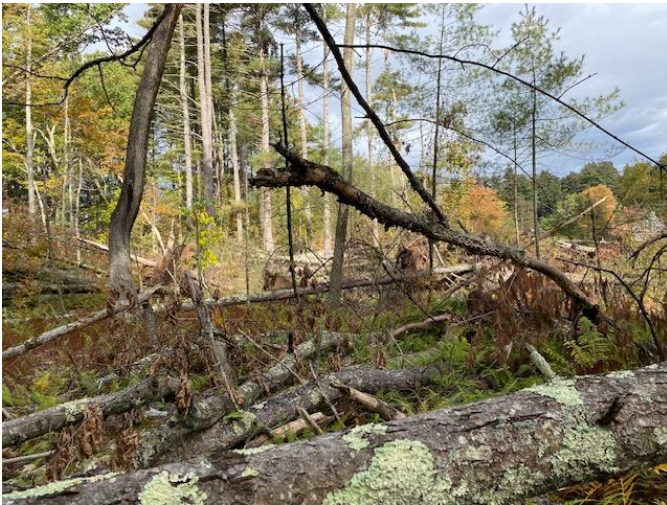
Figure 7: Photo of some of the uprooted trees proposed for removal along the downstream dam embankment.

The project proposes to remove 28 mature trees (primarily white pine) along the downstream embankment in order to facilitate the reconstruction of the slope and to comply with the ODS's required vegetation-free buffer off the dam. The downstream slope of the dam is currently experiencing overturning and uprooting of many of the trees that remain consistently saturated from excessive seepage passing beneath the embankment. Pullout of large lateral root masses has already caused considerable ground disturbance and further exposed saturated, sensitive soils. Removing these trees, many of which are already partially uprooted, is necessary to stabilize the dam embankment. As the photos depicted below illustrate, many of these trees are already uprooted as a result of the failing embankment.

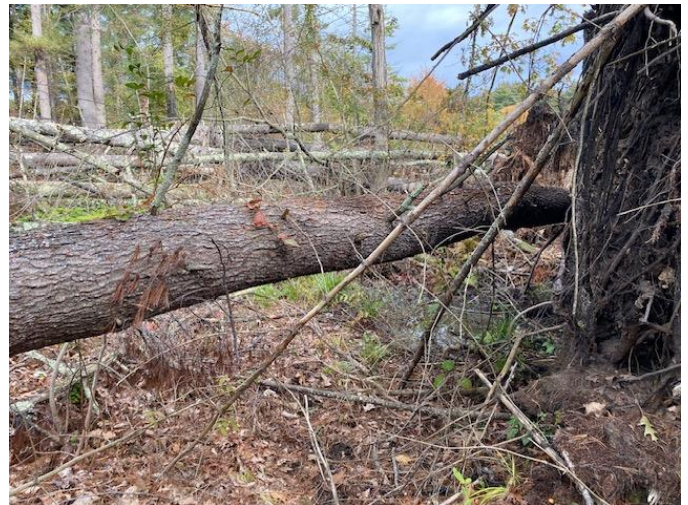
Figure 8: Another view of uprooting of pine trees along the downstream dam embankment. The trees and their roots will be removed.

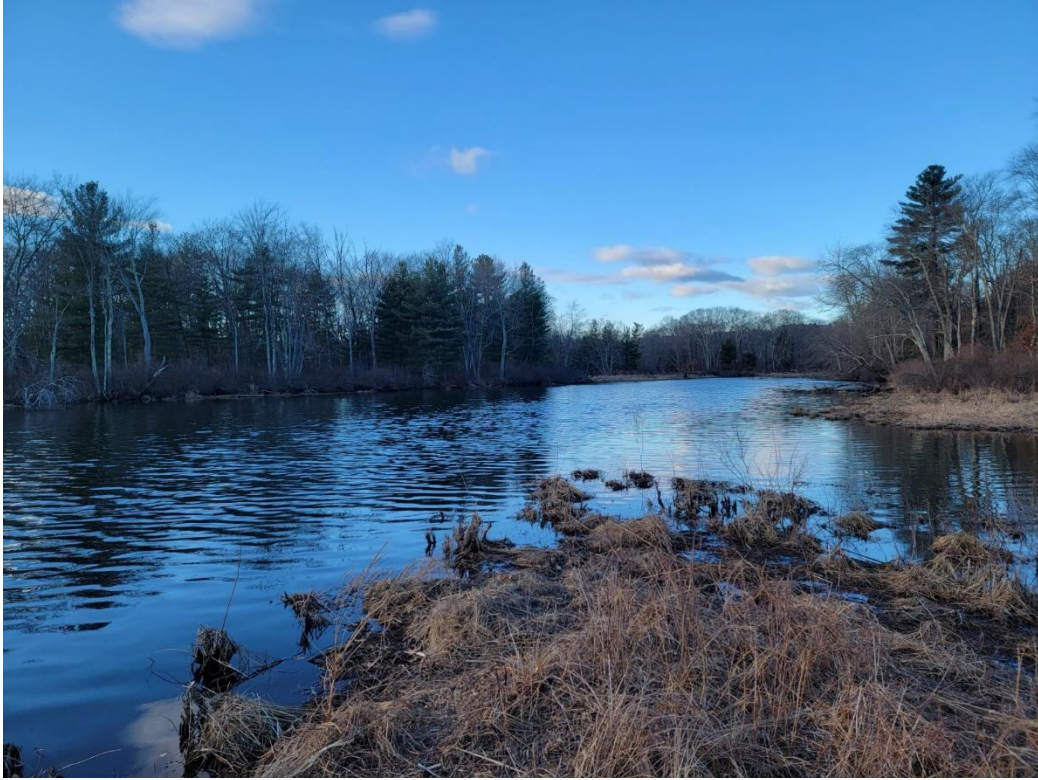
Photo 3: Perennial Stream

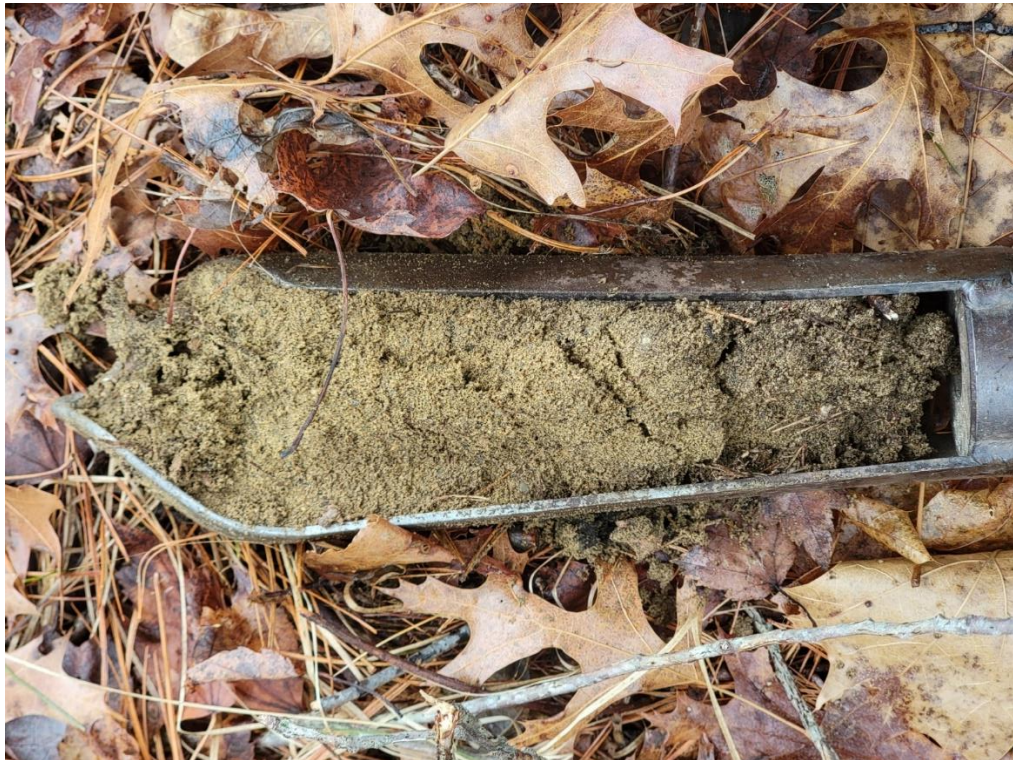
Photo 4: Wetland Soils Observed On Site
